HISTORIC STRUCTURE REPORT

Rye Town Hall

10 Central Road
Rye, NH 03870

September 14, 2018

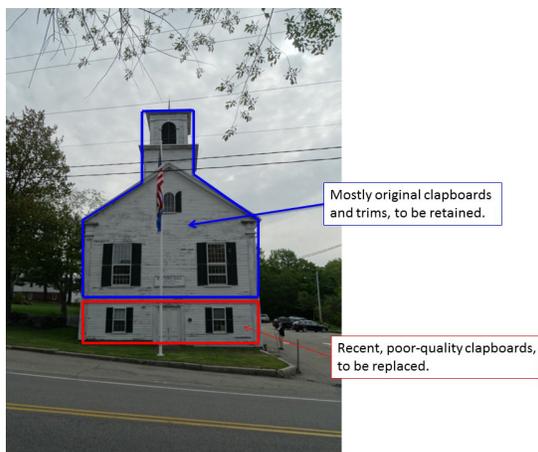
Figure 71: View of west elevation looking east, showing predominantly original areas of clapboards (blue), and modern, poor-quality replacements (red).

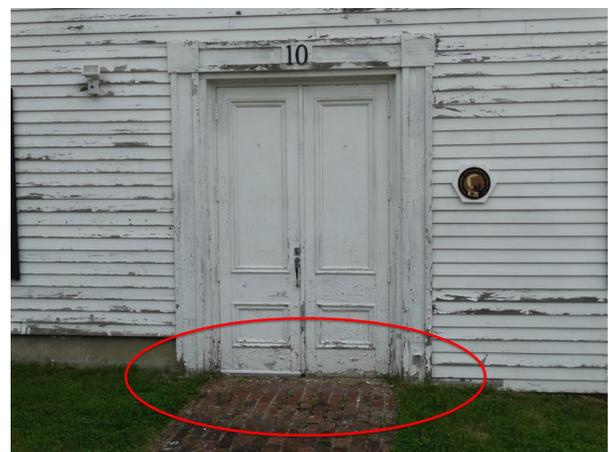
The double-leaf doors on this elevation are original to 1873 and in very good condition. The primary threat to their preservation is splash-back and moisture absorption from the abutting brick sidewalk. The

Figure 72: Detail of original west, main entrance showing area of grade to be lowered and trim and original doors to be consolidated with epoxy.

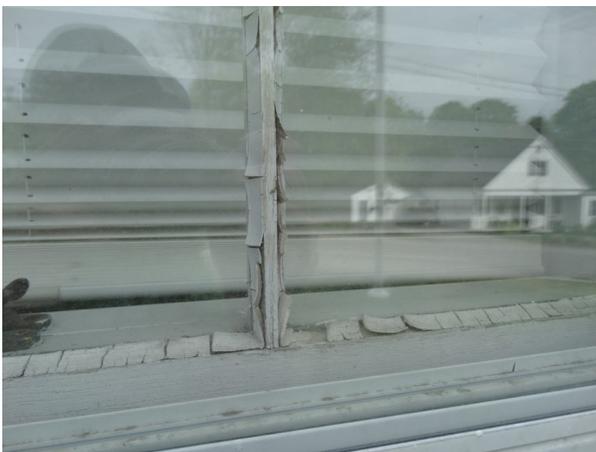
Figure 73: Detail of typical window glazing failure.

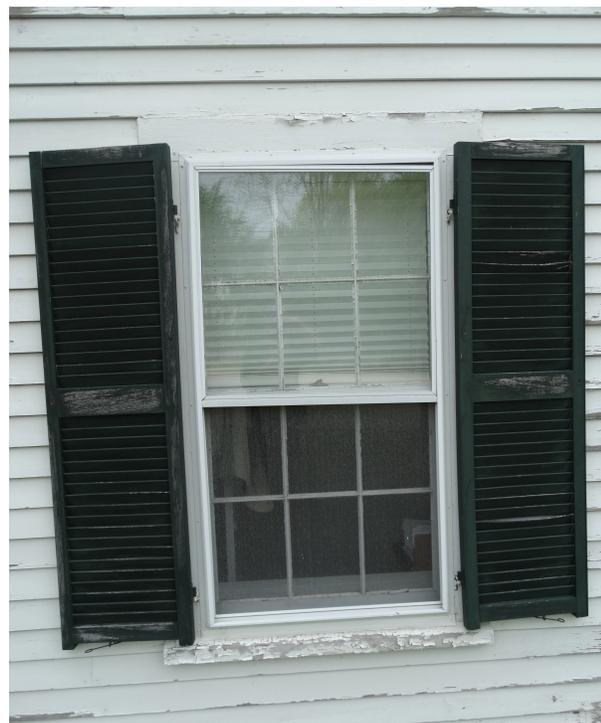
Figure 74: Detail of typical modern replacement shutters, which exhibit warping and minor deterioration.

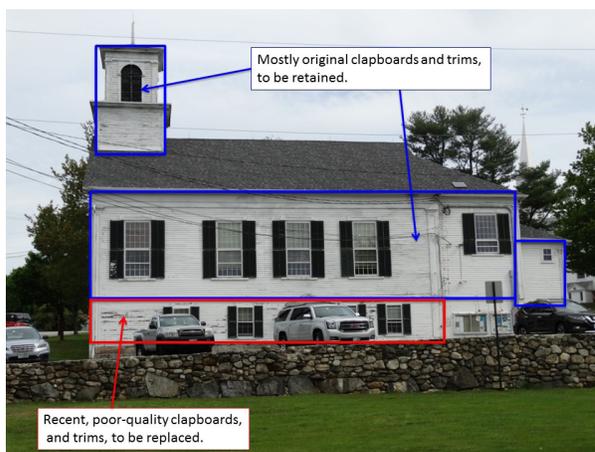
There are at least two generations of clapboards on the south elevation. Original courses from 1873 survive mainly between and above the windows at the second-floor level. Most of the lower courses appear to be from the last decades of the twentieth century. The former are made of native white pine, and exhibit minor cracks and significant paint failure but are in otherwise sound condition. The latter appear to be low-grade cedar or pine, and exhibit warping, extensive paint failure, and patched-in repairs. (Figure 75)

Figure 75: View of south elevation looking north, showing areas of predominantly original siding to preserve (blue) and modern, poor-quality clapboards to be replaced (red).

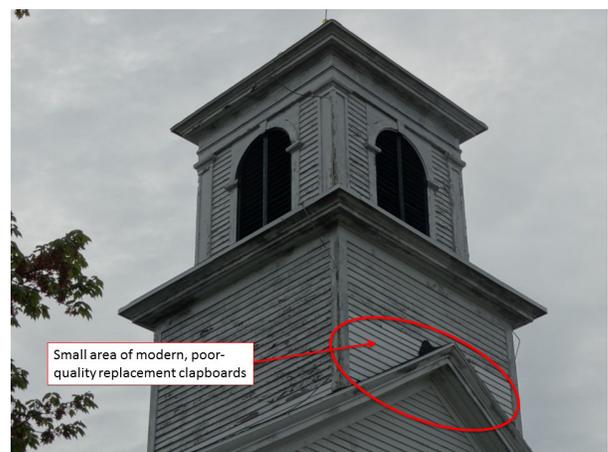
Figure 76: View of tower looking southeast, showing predominantly original clapboards and trims, with some later, low-quality replacements (indicated in red).

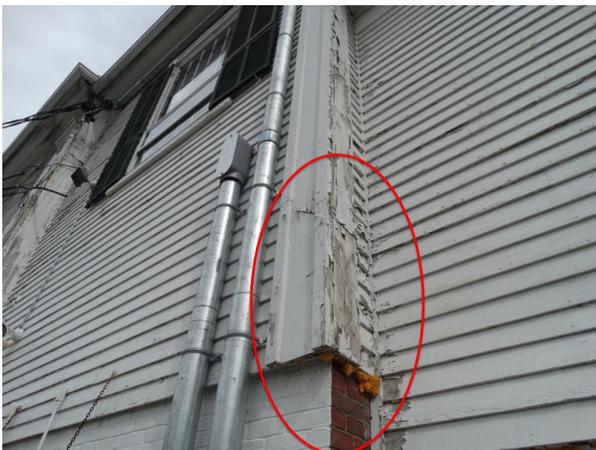
Figure 77: Detail of corner pilaster base, east end of main building south elevation, showing poor past repairs and spray-foam insulation.

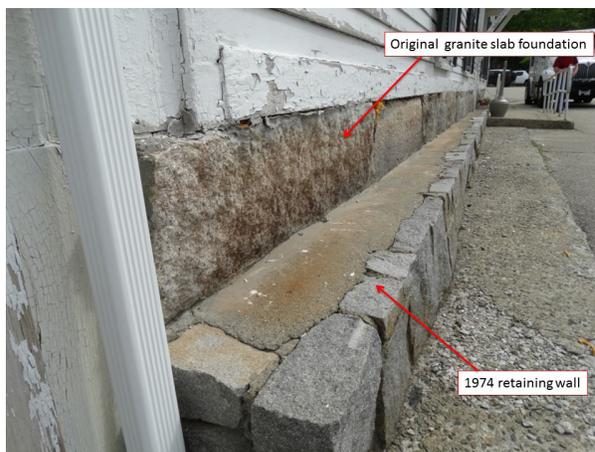
The brick portion of the foundation, east of the main entrance is in overall very good condition. Minor mortar loss has occurred due to weathering and erosion. It should be replaced with a soft lime pointing

Figure 78: Detail of south elevation foundation looking east, showing original foundation and later retaining wall with recent mortar repointing.

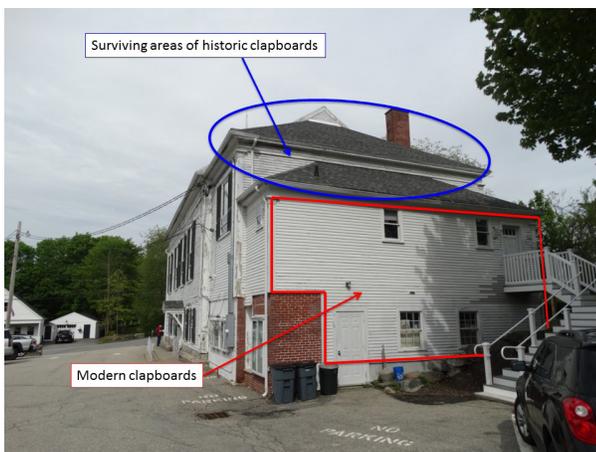
Figure 80: View of east elevation looking northwest, showing areas of original clapboards and trims (blue), and modern replacements (red).

Whether or not they are painted in the near term, we recommend that the upper levels of original clapboards be retained or repaired, where necessary, in-kind with high-quality materials according to specifications provided by a qualified architectural conservator. We recommend that the lower courses ultimately be replaced with high-quality, sustainable material such as vertical-grain western yellow

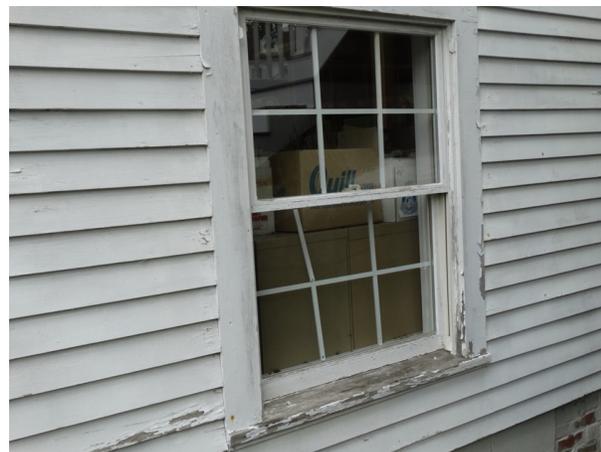
The windows on the east elevation are modern replacement windows, probably from the 1970s. They are in sound condition, but in some cases the snap-in faux muntin grids are broken and require simple repair. (Figure 81)

Figure 81: Detail of modern window, east elevation, ground floor, showing broken false muntins.

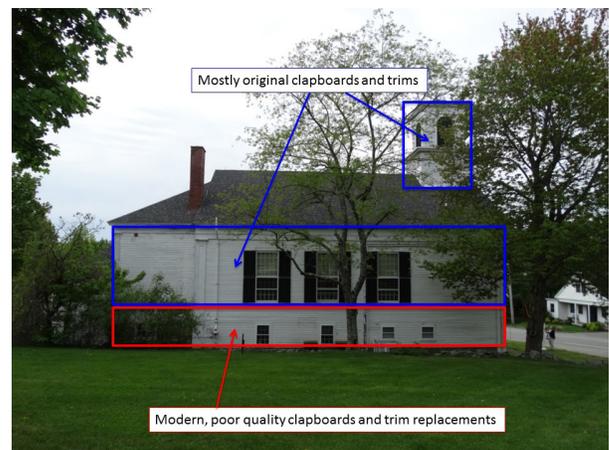
Figure 83: View of north elevation looking south, showing predominantly original clapboards (blue) and poor-quality modern replacements (red).

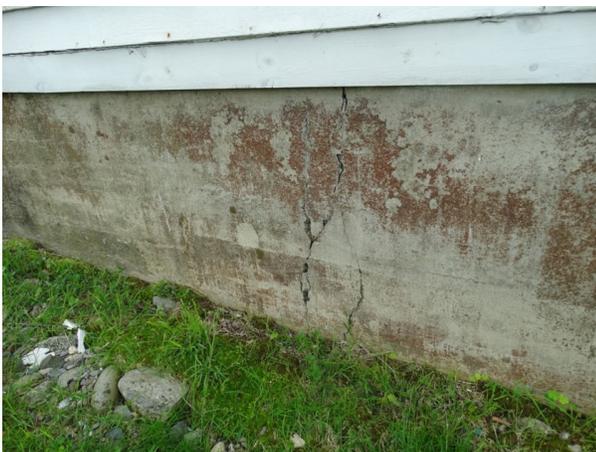
The foundation on this elevation consists of poured concrete. This likely replaced an earlier stone foundation in the early 1900s. It exhibits minor cracking from long-term, small differential movement on the structure above over time, but these cracks are not a structural concern. There are no signs in the building above that the building is inadequately footed. (Figure 84)

Figure 84: Detail of concrete foundation, north elevation, showing typical cracks, non-structural.

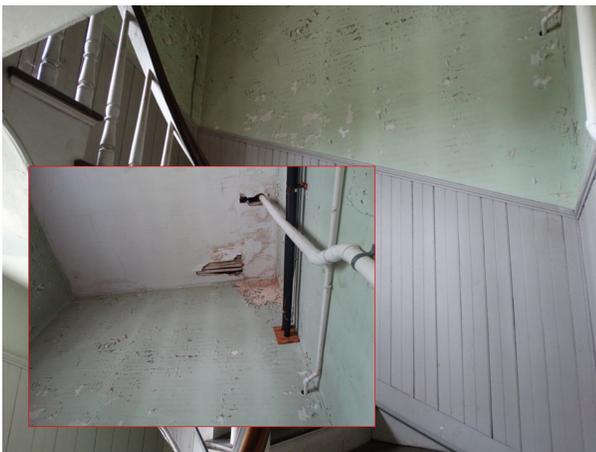
Figure 85: View of north staircase wall (Room 202) looking north, showing deteriorating paint and original plaster. Inset: View of ceiling above (Room 302) showing failing plaster, to be conserved and repaired.

The original plaster surfaces in these spaces are important character-defining features. We recommend removal of the drywall in room 302 and consolidation, reattachment and repair of all remaining original

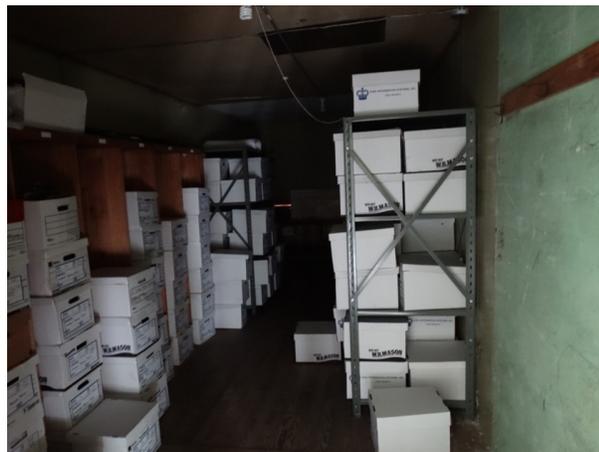
Figure 86: View of Room 302 looking south. Wall plaster is intact and requires stabilization. Most of the ceiling plaster has been reinforced with modern drywall.

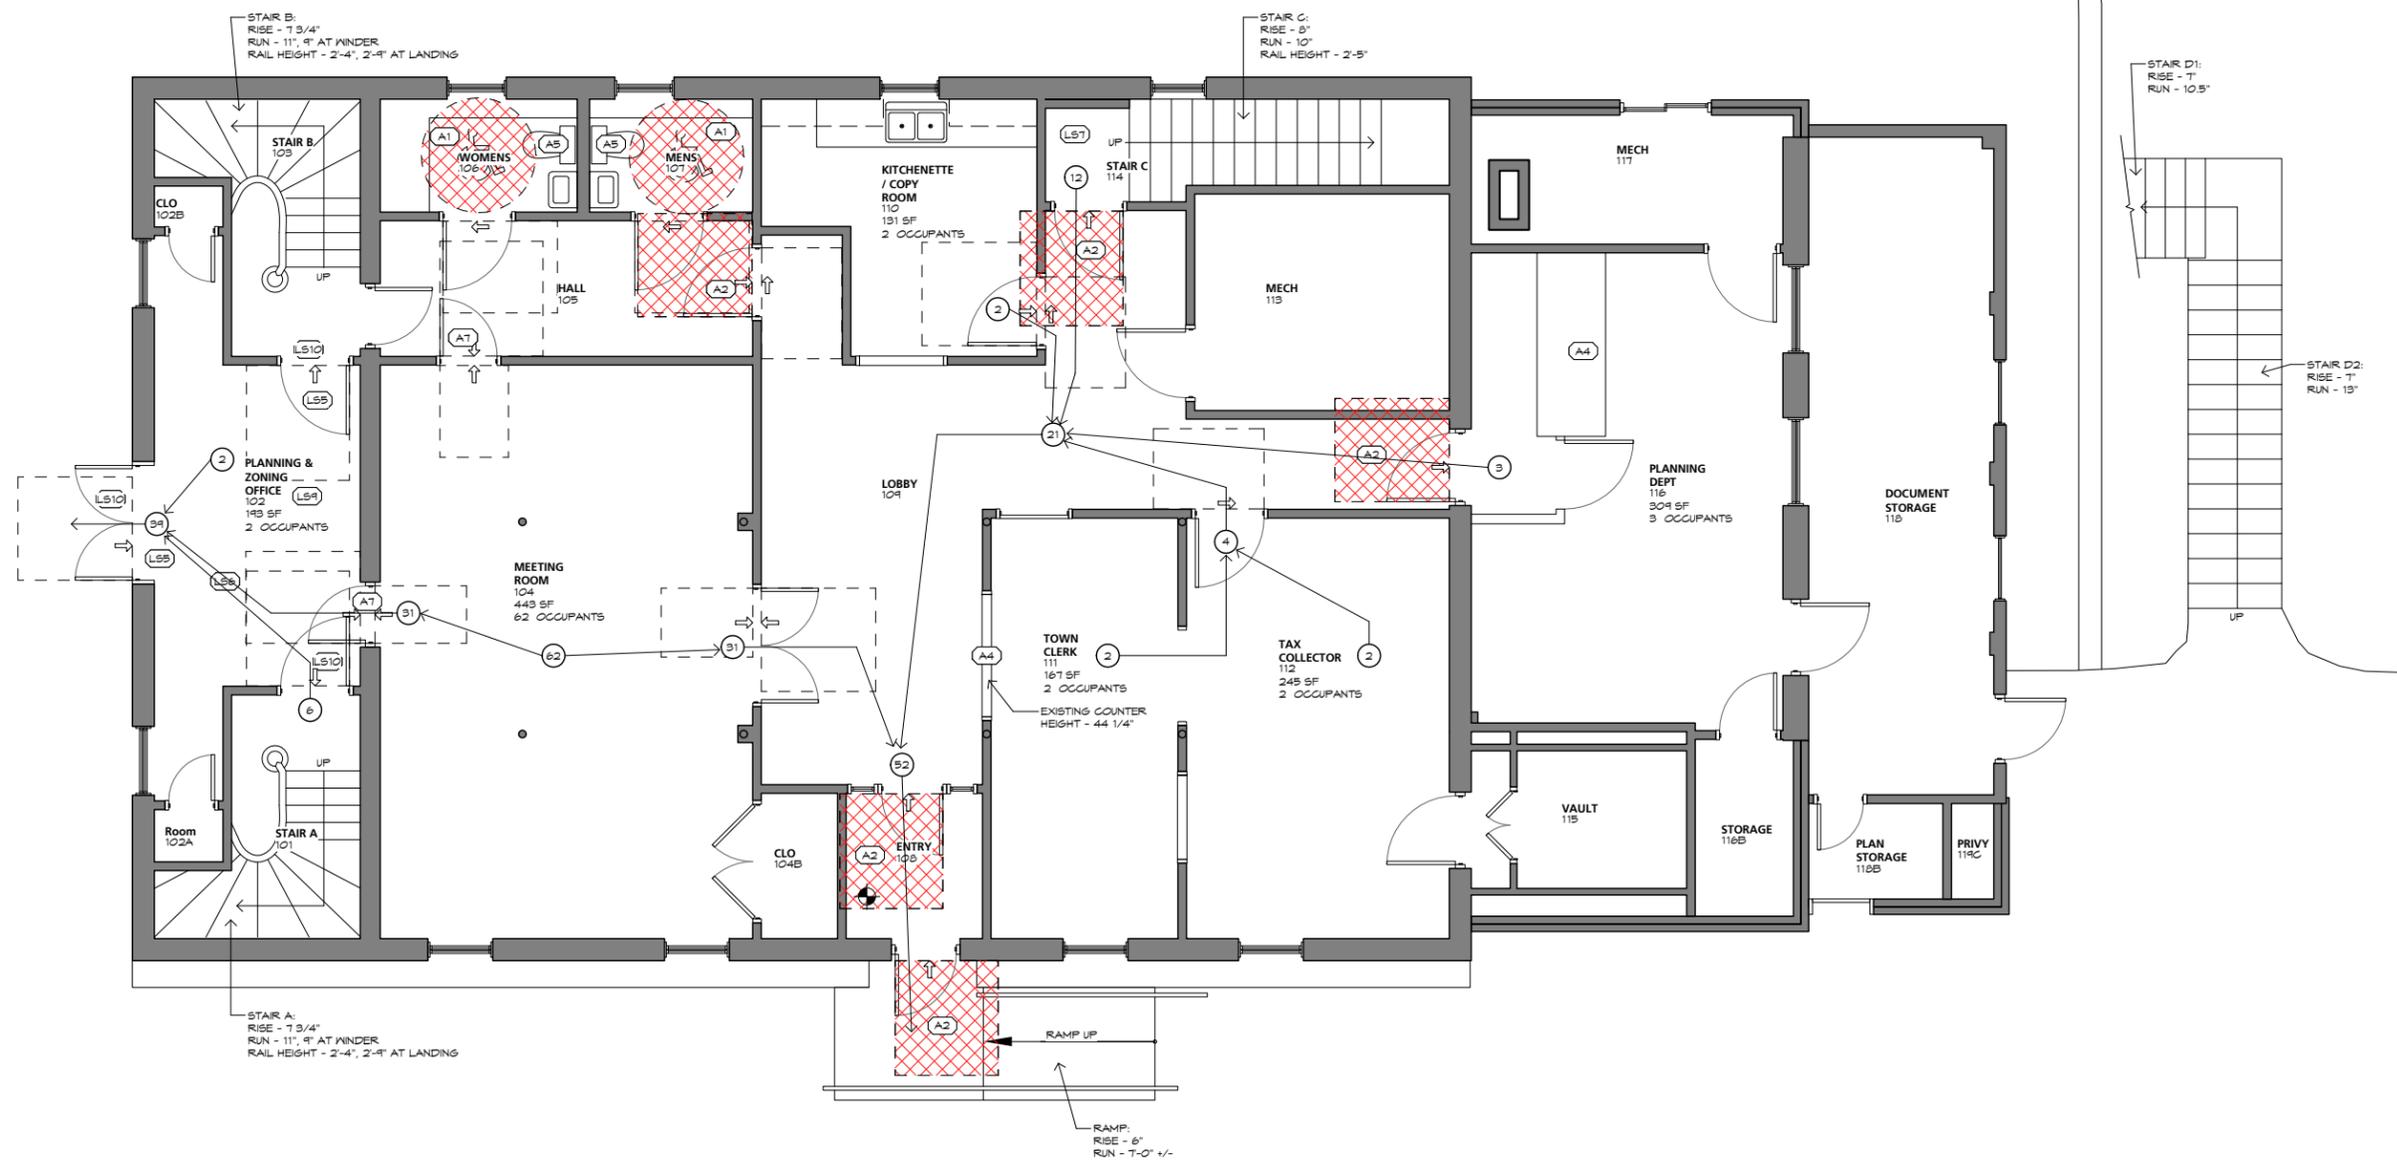
1 FIRST FLOOR CODE DIAGRAM
 ADA.1 1/4" = 1'-0"

ADA KEY NOTES		
A1	DOES NOT MEET ADA TURNING RADIUS CLEARANCES	ADA 2010: 304.3
A2	FULL SIDE OF DOOR DOES NOT MEET ADA MANEUVERING CLEARANCES	ADA 2010: FIGURE 404.2.4.1
A3	PUSH SIDE OF DOOR DOES NOT MEET ADA MANEUVERING CLEARANCES	ADA 2010: FIGURE 404.2.4.1
A4	DOES NOT MEET ADA COUNTER HEIGHT	ADA 2010: 902.3
A5	DOES NOT HAVE ADA GRAB BARS	ADA 2010: 604.5
A6	FLOOR LEVEL HAS NO ADA ACCESS	ADA 2010: 306.404
A7	CLEAR WIDTH OF DOOR DOES NOT MEET ADA CLEARANCES	ADA 2010: 404.2.3
