# Parsons Creek Watershed Based Plan

May 2011

**Prepared by:**  
FB Environmental Associates, Inc.  
97A Exchange St., Suite 305  
Portland, ME 04101

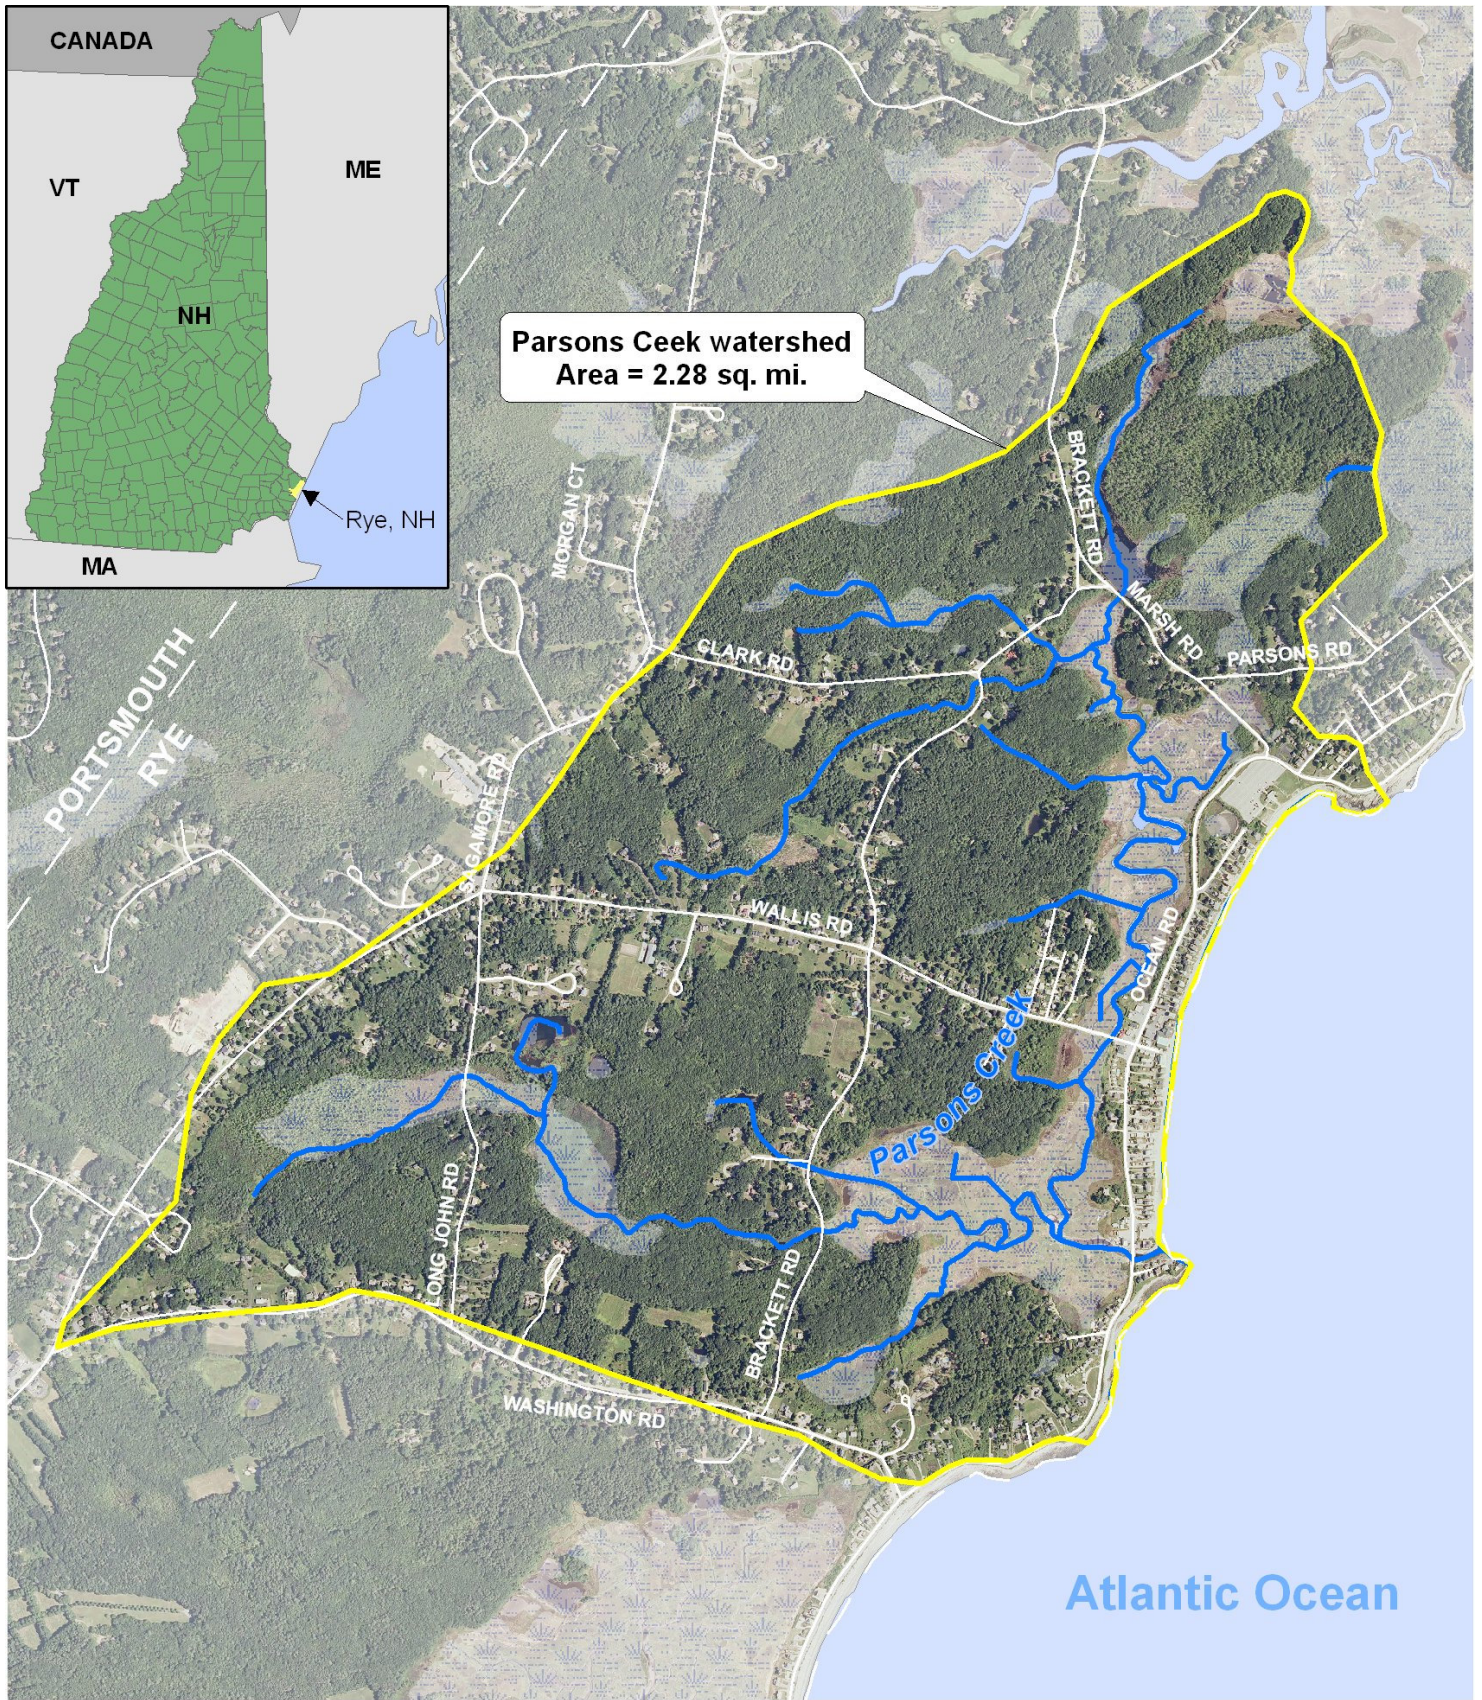
## Parsons Creek Watershed, Rye, NH

Watershed Boundary (2.3 sq. mi.)

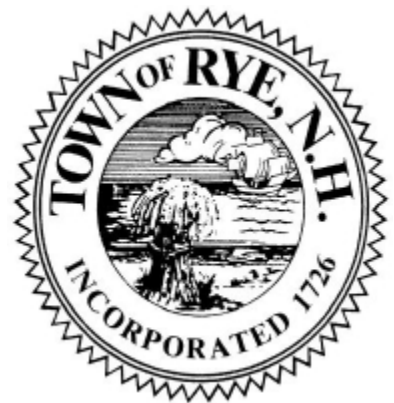
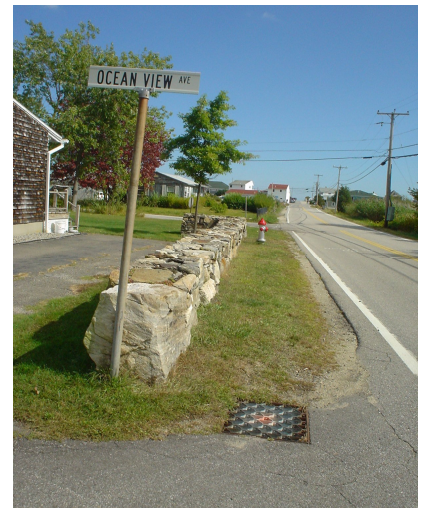
**Catch basins collect stormwater that carries pollutants to Parsons Creek.**

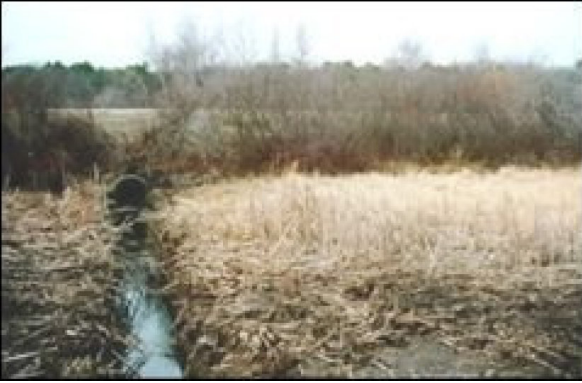
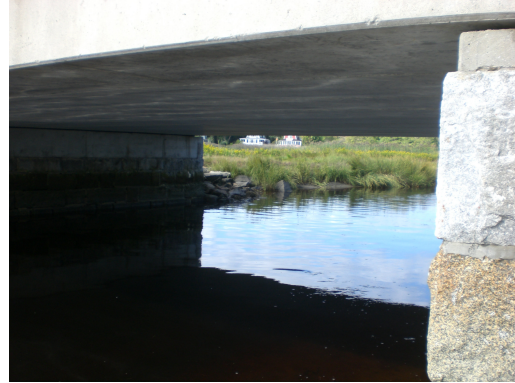
**The mouth of Parsons Creek before (left) and after (right) the 1997-1999 tidal restriction removal project.**

In 1999, the town completed a tidal restriction/invasive species removal project in the main salt marsh of Parsons Creek. This project, in partnership with the NH Coastal Program, removed and replaced three tidal restrictions throughout the main marsh area. Most importantly, the culvert under Route 1A was replaced with a bridge which reestablished the mouth of Parsons Creek. The bridge significantly increased tidal flow and reduced flooding of properties next to the marsh. Routine post-project monitoring has shown that natural vegetation is returning to the marsh due to the increased tidal flow and the marsh is regaining stability.

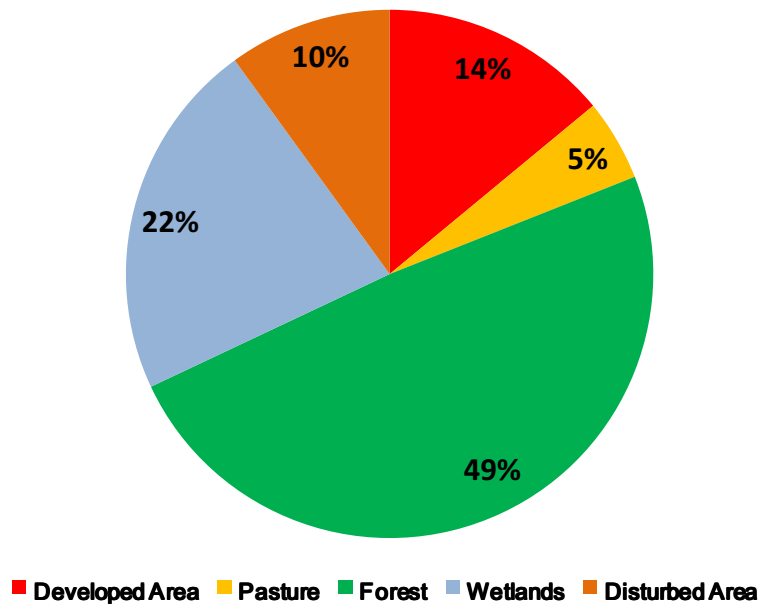
Figure 2.2 Pie Chart of Land Uses in Parsons Creek Watershed

Analysis using the 2001 New Hampshire Land Cover layer provided by New Hampshire's Statewide Geographic Information System (GIS) Clearinghouse (GRANIT) shows that land uses in the Parsons Creek watershed are predominantly woods and wetlands (Figure 2.2). Forested lands, made up of mixed forest types including oak, beech, pine, and hardwoods, accounts for 49% of land use area. Tidal wetlands dominate the coastal areas and account for 9% of the total 22% of wetlands in the watershed. The remaining 29% of watershed area is comprised of other land covers types, such as developed area, disturbed area, and hay/pasture.

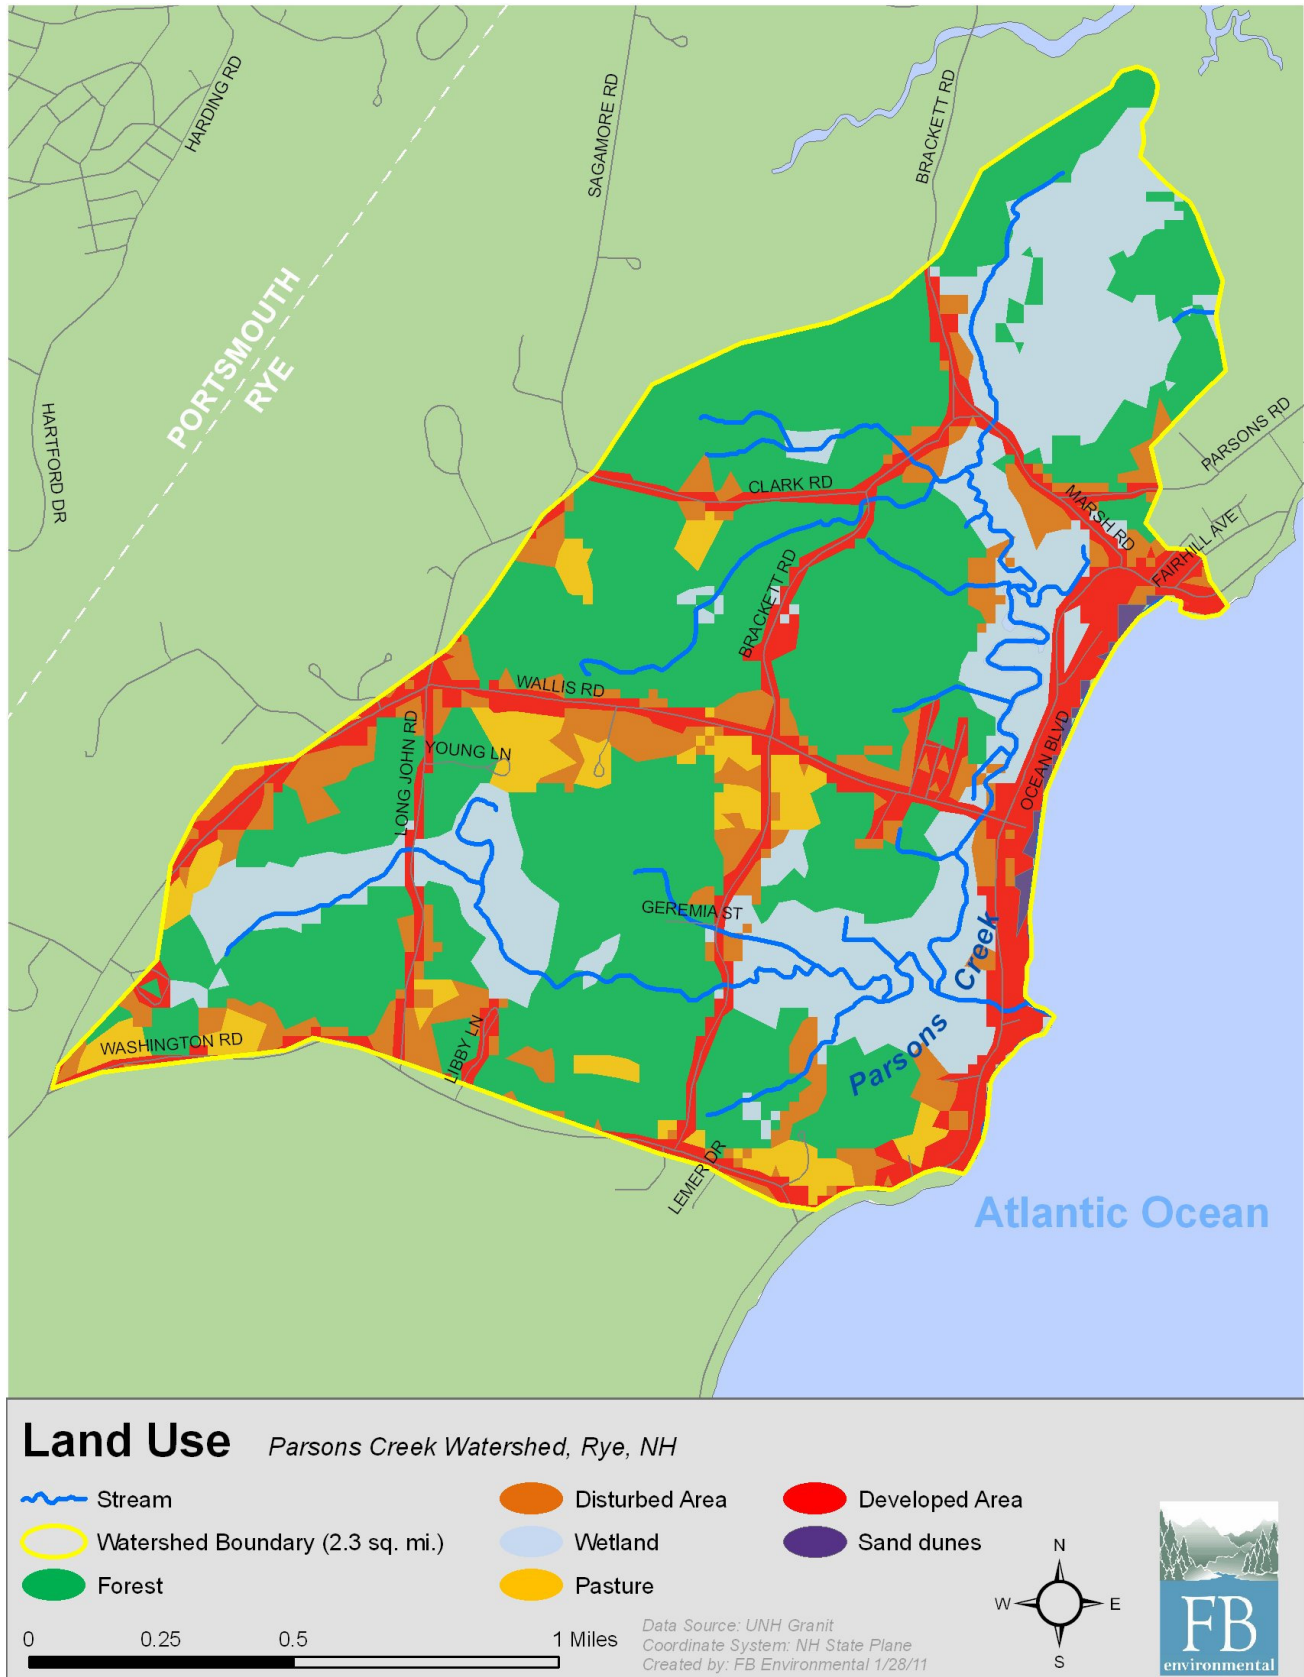
Figure 2.3. Map of Land Use in the Parsons Creek Watershed

The forest land is located in large habitat blocks inland from the coast and is separated only by roads and minimal development (Figure 2.3). Wetland areas wind through the forests following the course of Parsons Creek. The northern branch headwaters, above Brackett and Marsh Roads, make up the largest area of wetlands in the watershed. Development is concentrated near the coastline and Route 1A as well as other major roads. Agriculture is scattered throughout the southern half of the watershed along Wallis and Washington roads. Most agriculture in the watershed consists of cropland and pasture.

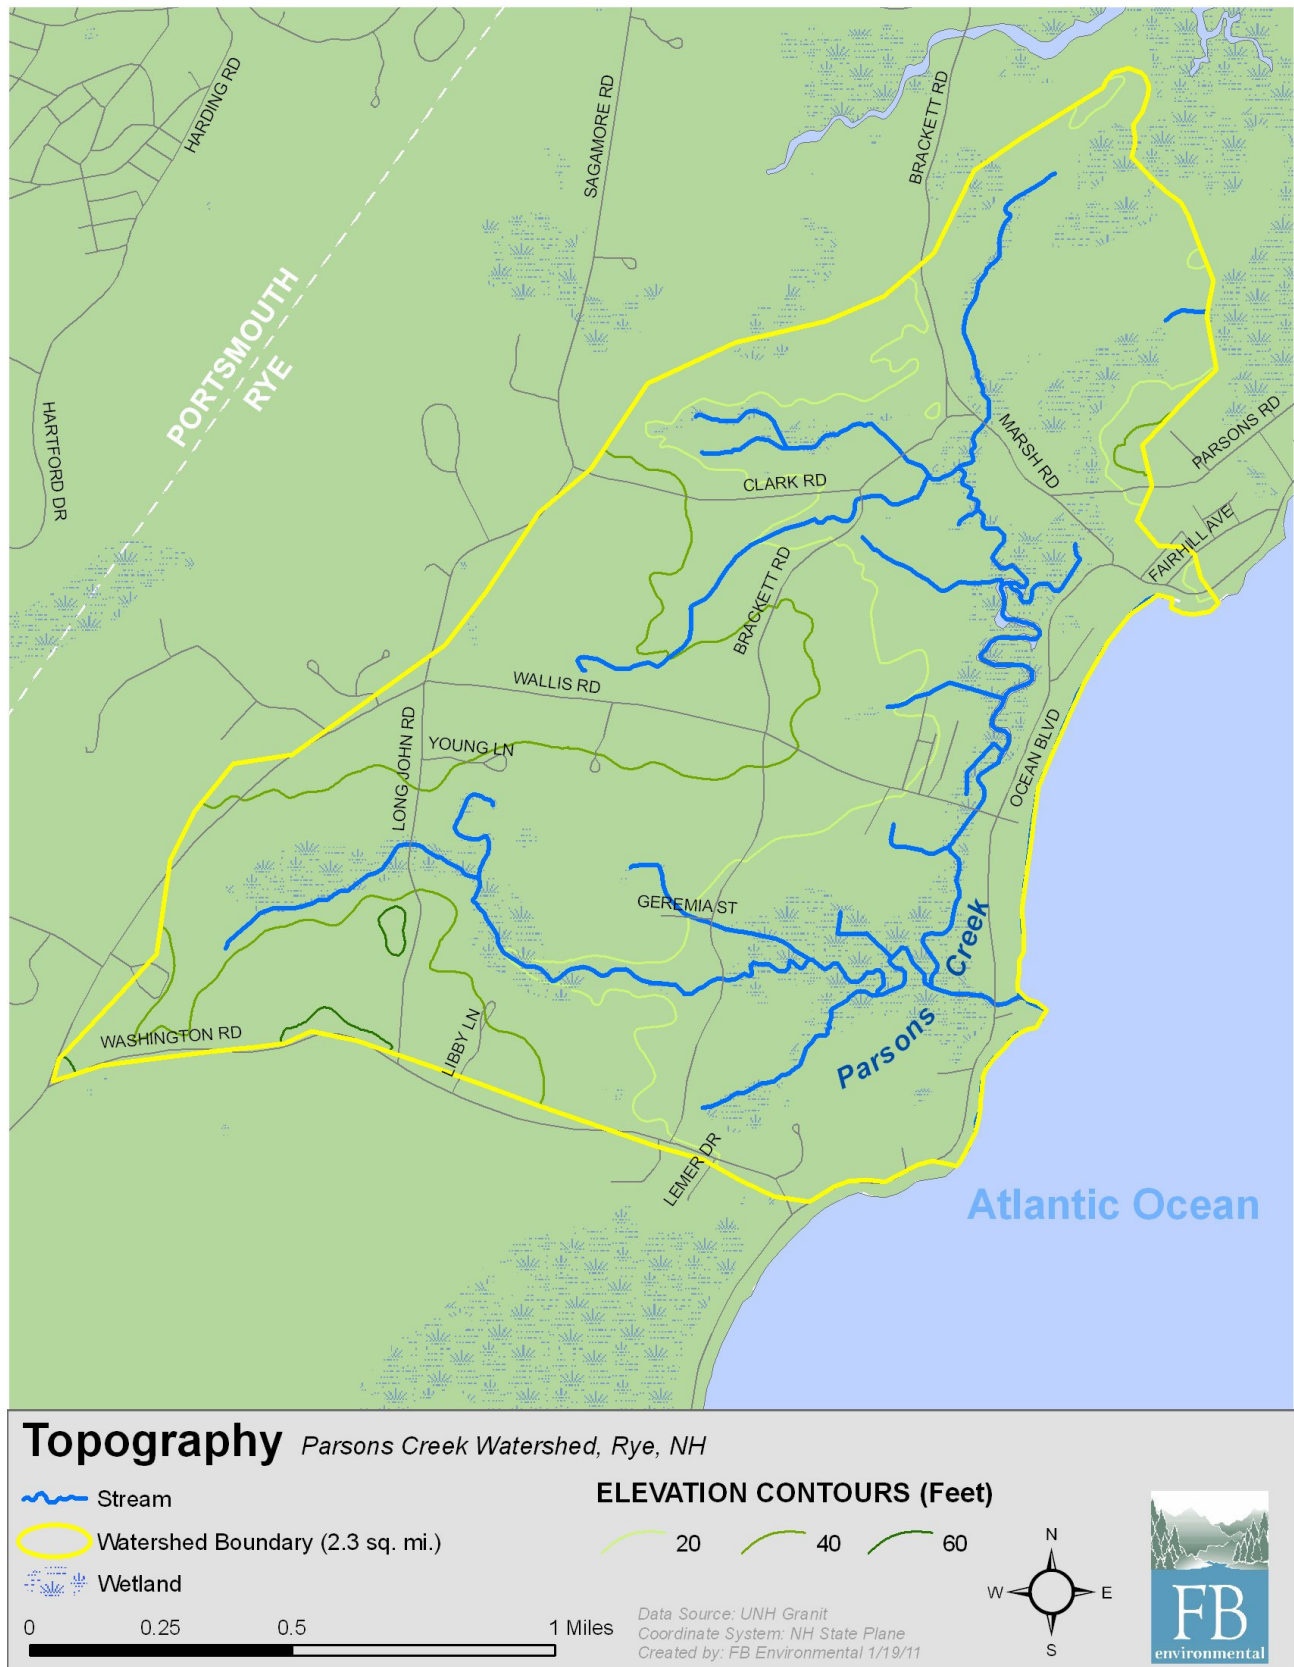
Figure 2.4. Map of Topography in the Parsons Creek Watershed

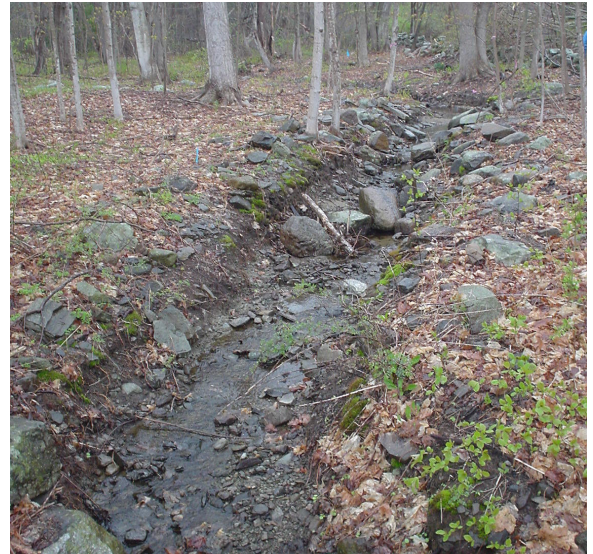
**Parsons Creek tributary , as seen from BCH15 on Brackett Rd.**

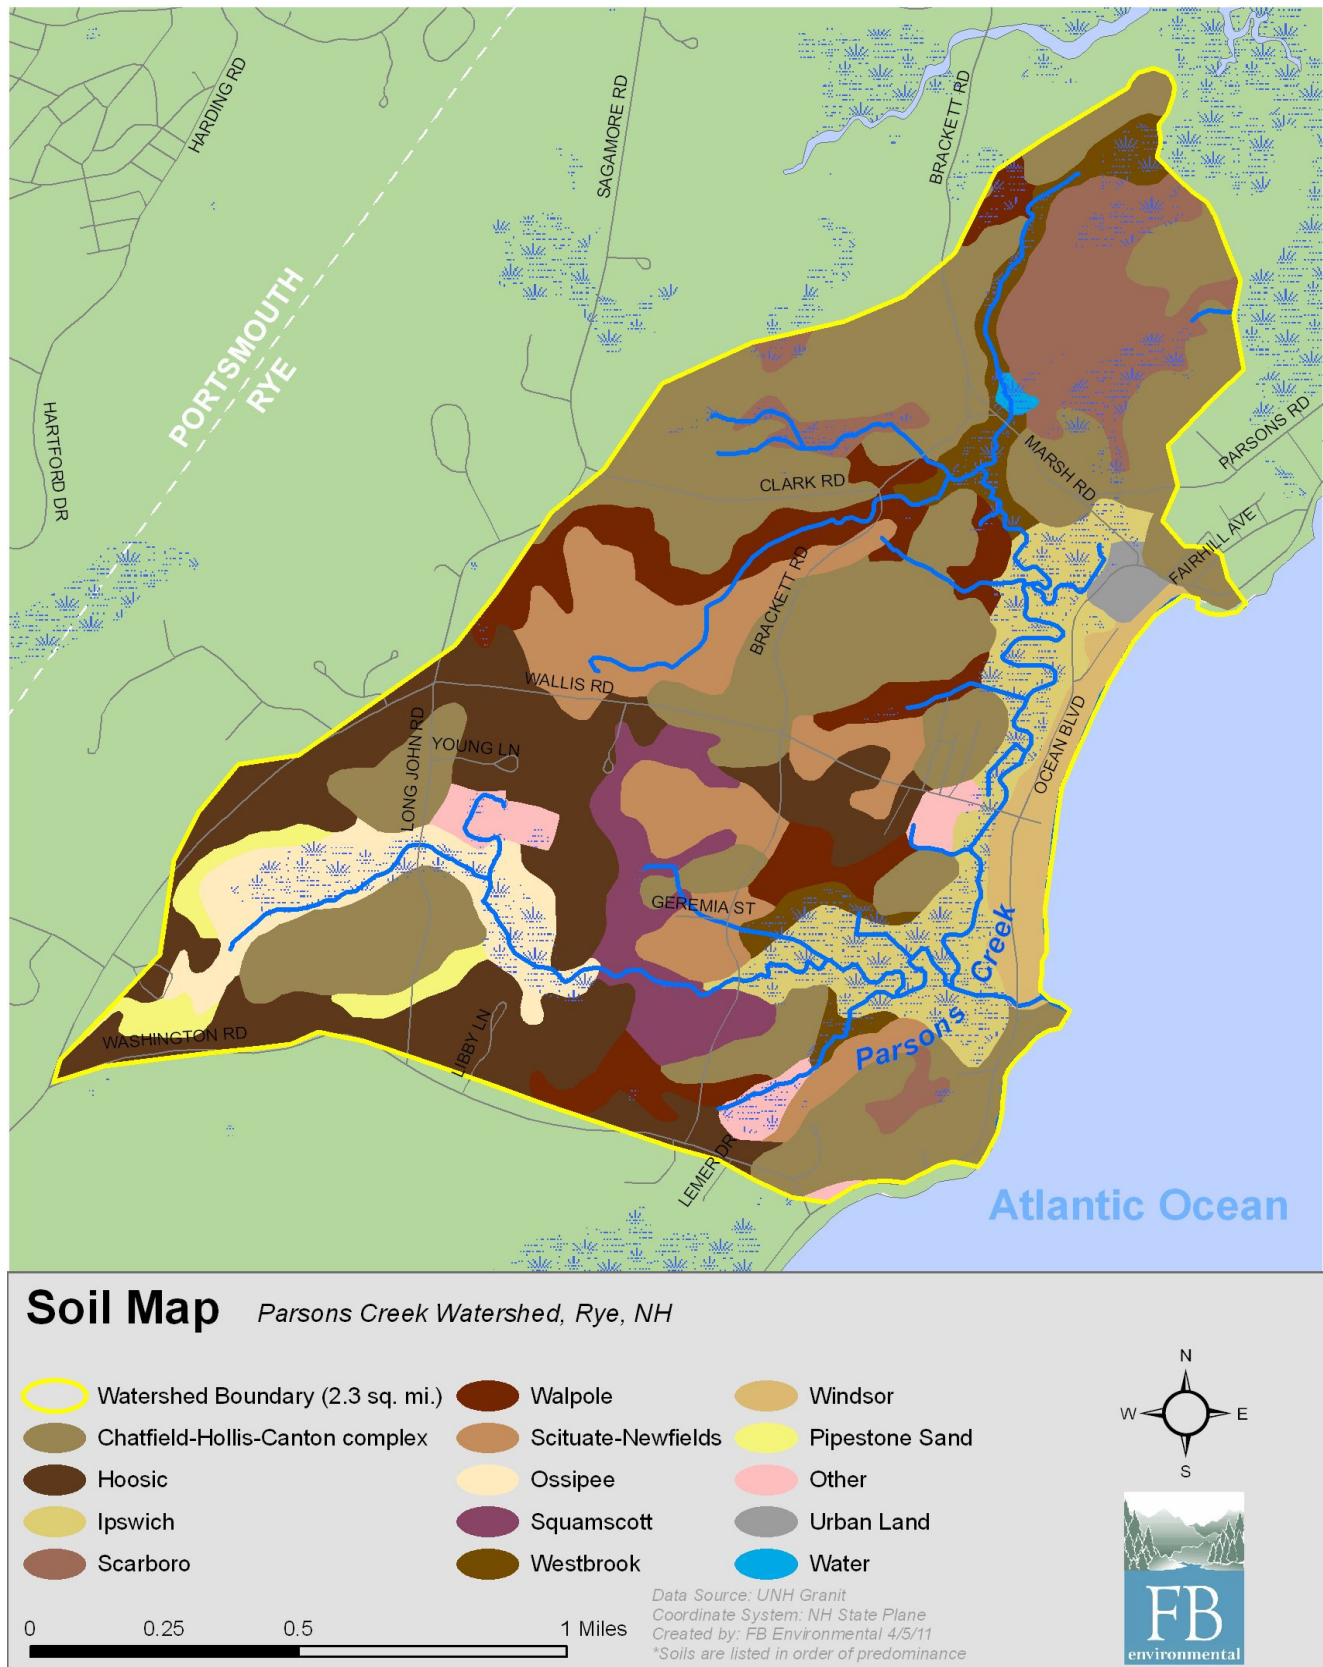
Figure 2.5. Map of Soils in the Parsons Creek Watershed

Most soils in the watershed are mapped as fine sandy loam or muck. Wetland areas in the tidal marsh are primarily Ipswich mucky peat, a poorly drained salt grass habitat that is rich in organic matter deposits and salt (Figure 2.5). Along the northern branch of Parsons Creek, soils transition to Westbrook mucky peat which gives way to Scarboro muck in the headwaters above Marsh Rd. Scarboro muck is created by glacial deposits and decaying organic matter in shallow depressions where the water table is at or near the surface. Ossipee mucky peat is found beneath the headwaters of the western branch and is created from plant and woody debris. This soil is also very poorly drained and characteristic of a wooded wetland (NRCS, 2010).

Non-wetland soils in the watershed transition from rocky, loamy soils in the north to fine sandy soils in the south. Chatfield-Hollis-Canton soils dominate the northern end of the watershed. They are well drained soils with a sandy loam texture and glacial till deposits. Most forested areas in the watershed are found on these soils. Woodlands are also found on Hoosic soils in the southern end of the watershed. Hoosic soils are found on gently sloped terrain and are composed of glacial outwash. Glacial outwash creates excessively dry, sandy soils with small gravel sized rocks. Areas with this soil are typically used as farmland but can host a wide variety of hardy trees such as sugar maple, oak, and hickory. Land uses on this soil in Parsons Creek watershed are primarily developed.

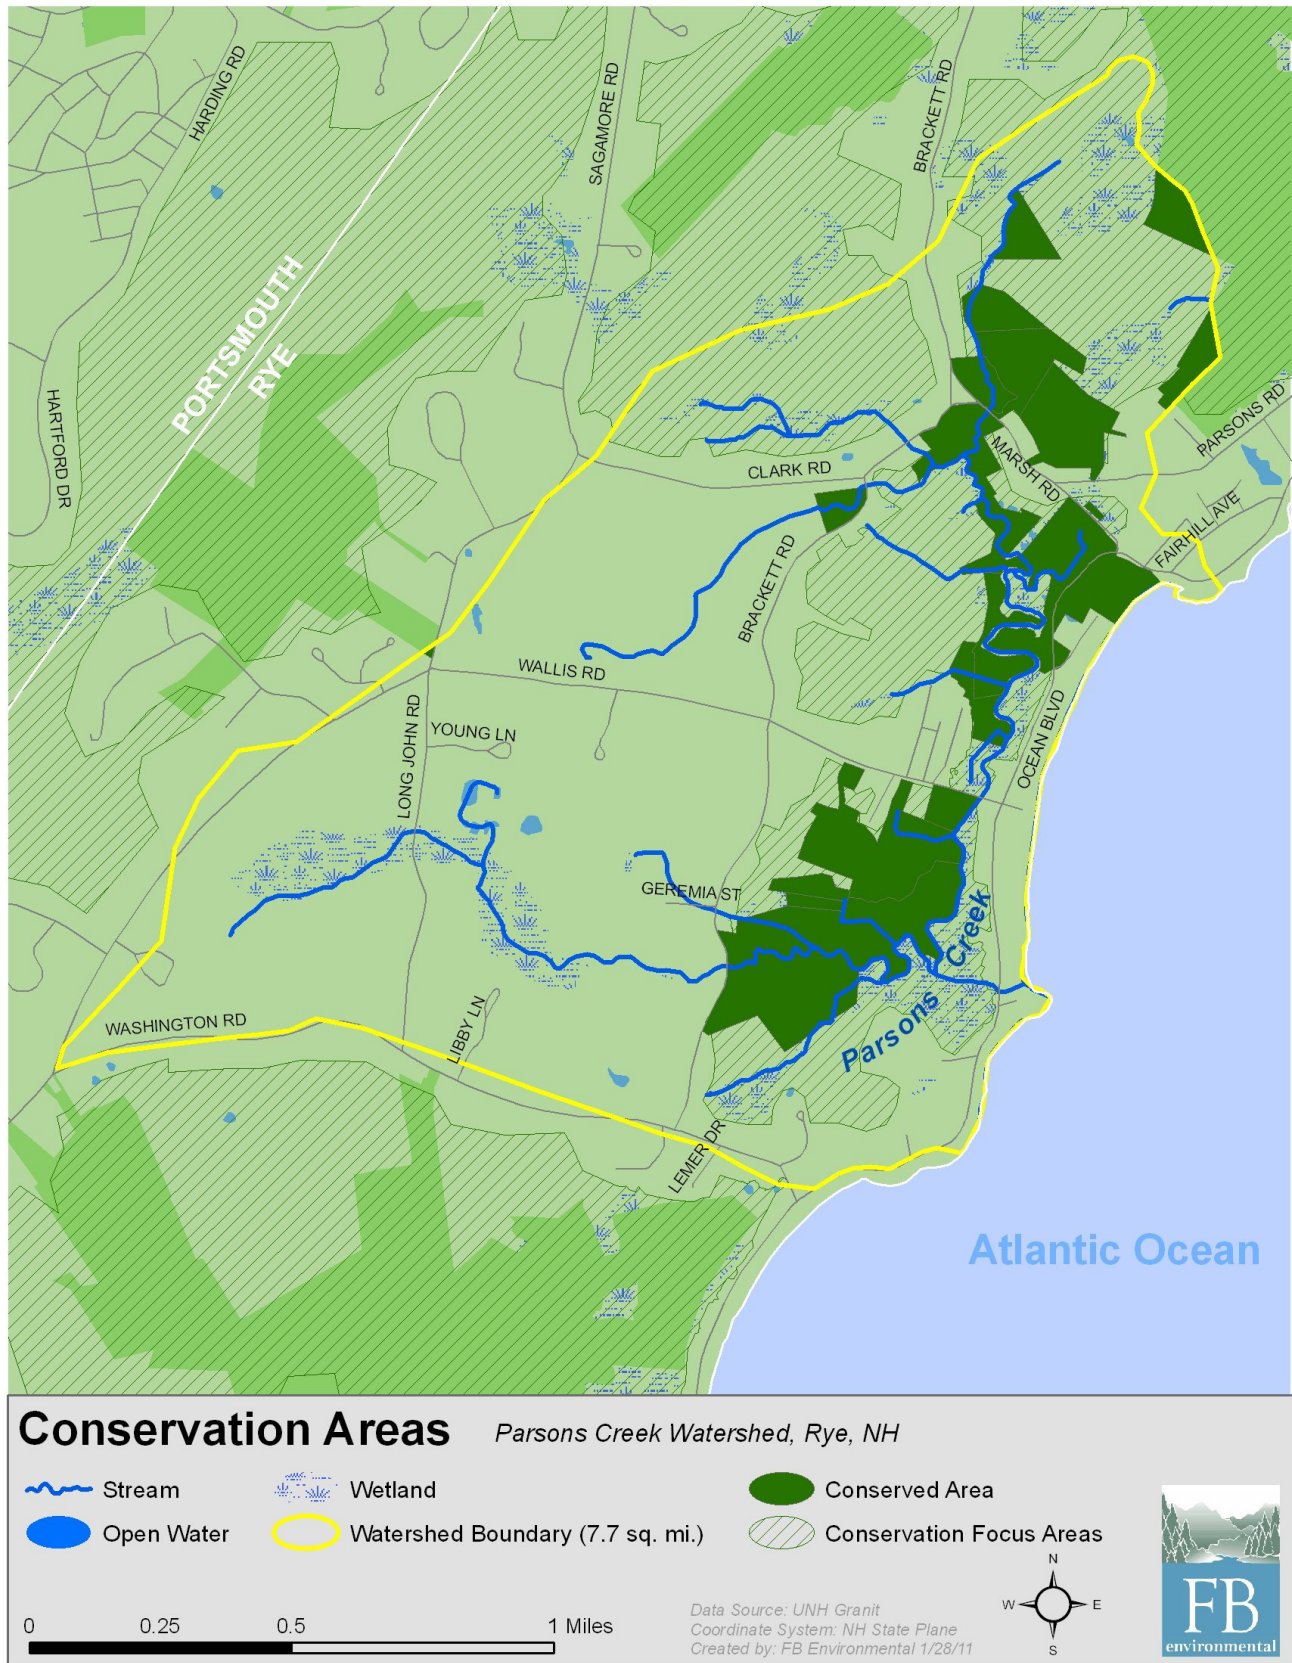
Figure 2.6. Map of Conservation Areas in Parsons Creek Watershed

- Wallis Marsh: salt grass habitat on both sides of Wallis Rd (~311 acres)
- Seavey Creek/Fairhill Swamp: marsh area above Marsh Rd, headwaters of the northern branch of Parsons Creek (~637 acres, most area is outside of the watershed)
- Lower Berry's Brook: land north of Brackett and Clark Roads (~270 acres, most area is outside of the watershed)

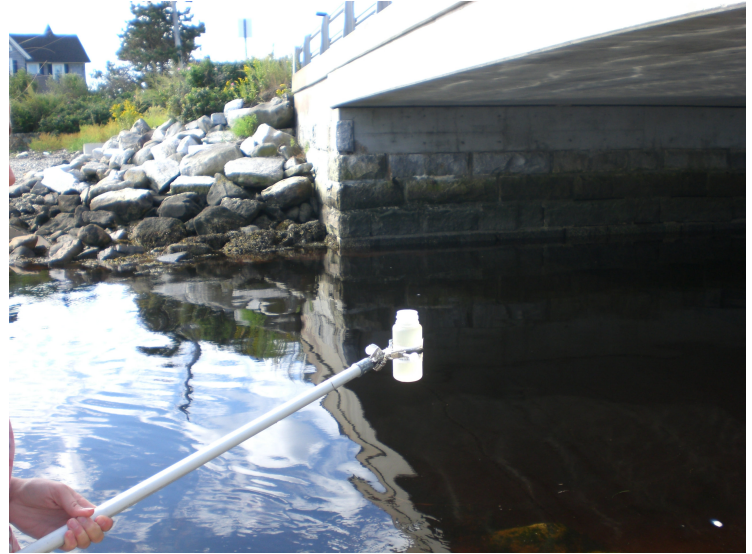
**Sampling the mouth of Parsons Creek .**

The mouth of Parsons Creek (station BCHPICRYEPAR), which is tidal and is held to the same standards as all NH beaches, is consistently above the state Enterococci standards of 104 and 35 counts/100 mL. Consistent violations at this site have led DES to list Parsons Creek as impaired due to bacteria concentrations which affect primary and secondary recreation uses.

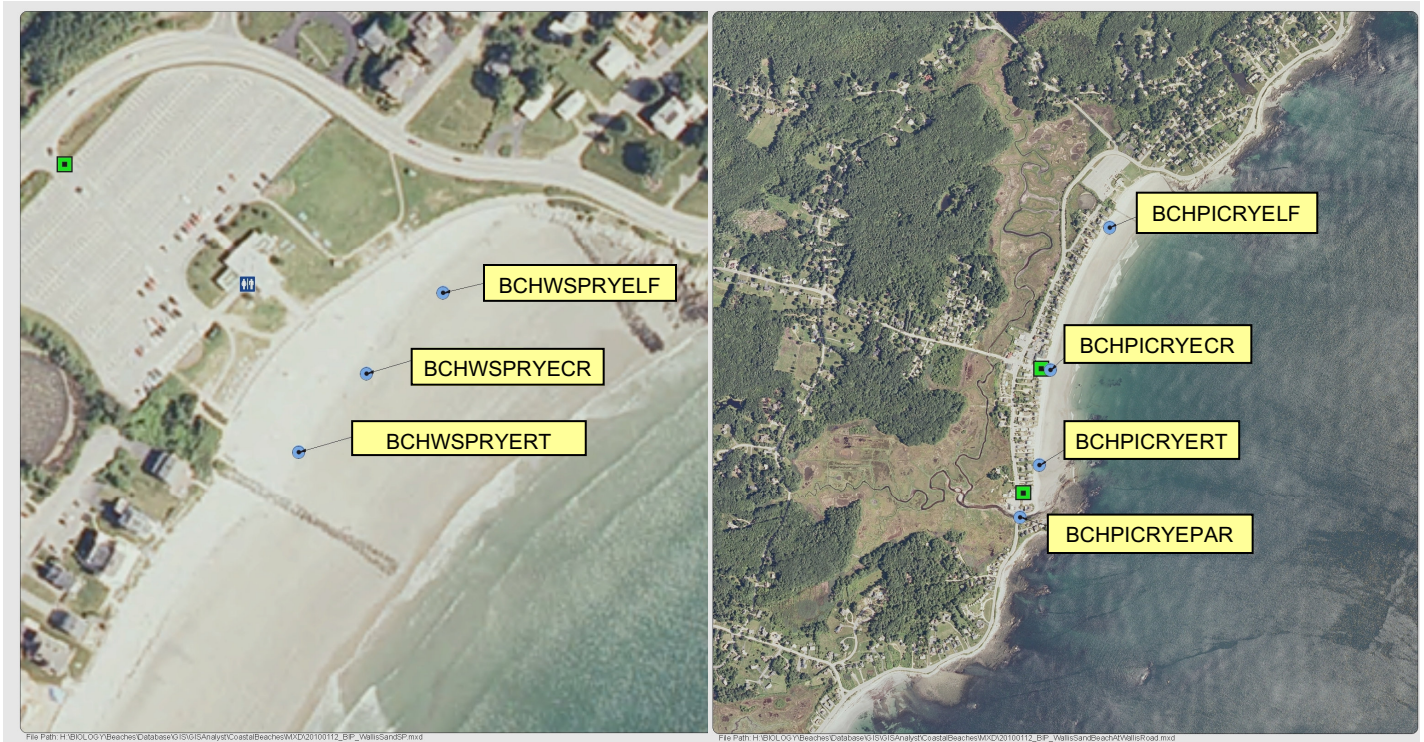
**Figure 3.1. Sampling Station Locations on Wallis Sands State Park Beach (left) and Wallis Sands Beach at Wallis Rd (right)**

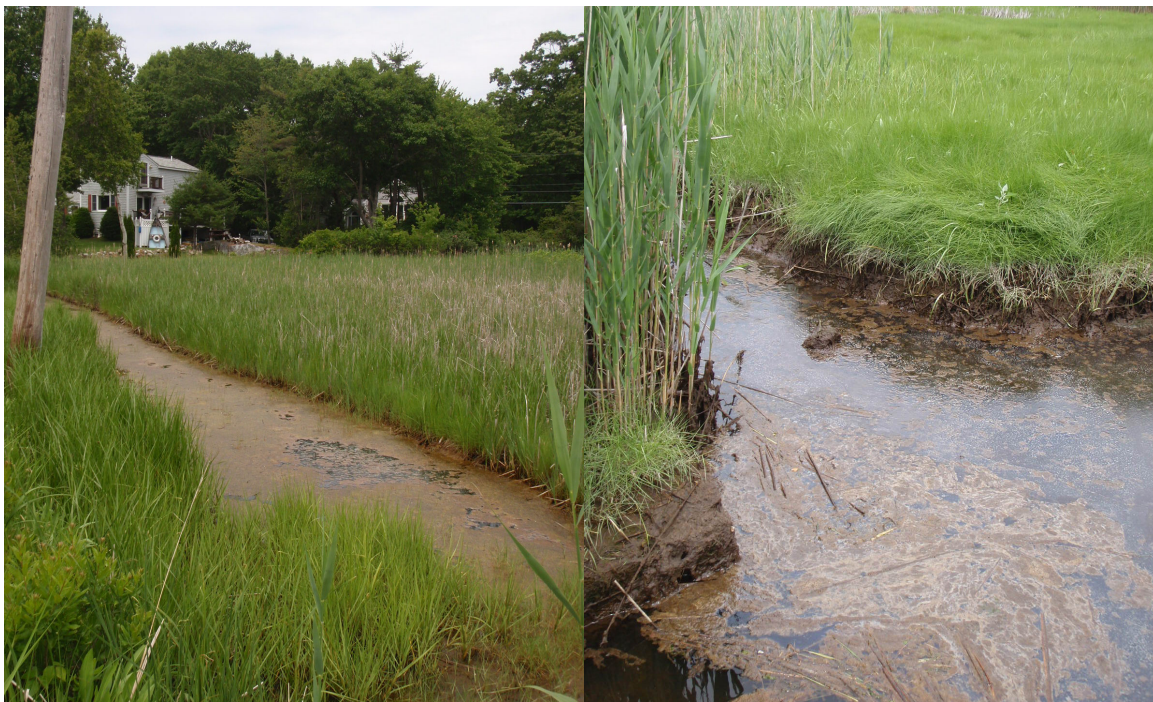
Both photos above show sample site BCH 11 during routine sampling on June 16, 2010. BCH 11 was above EPA water quality criteria during all sampling events. (photo: Megan Cook, NH DES )

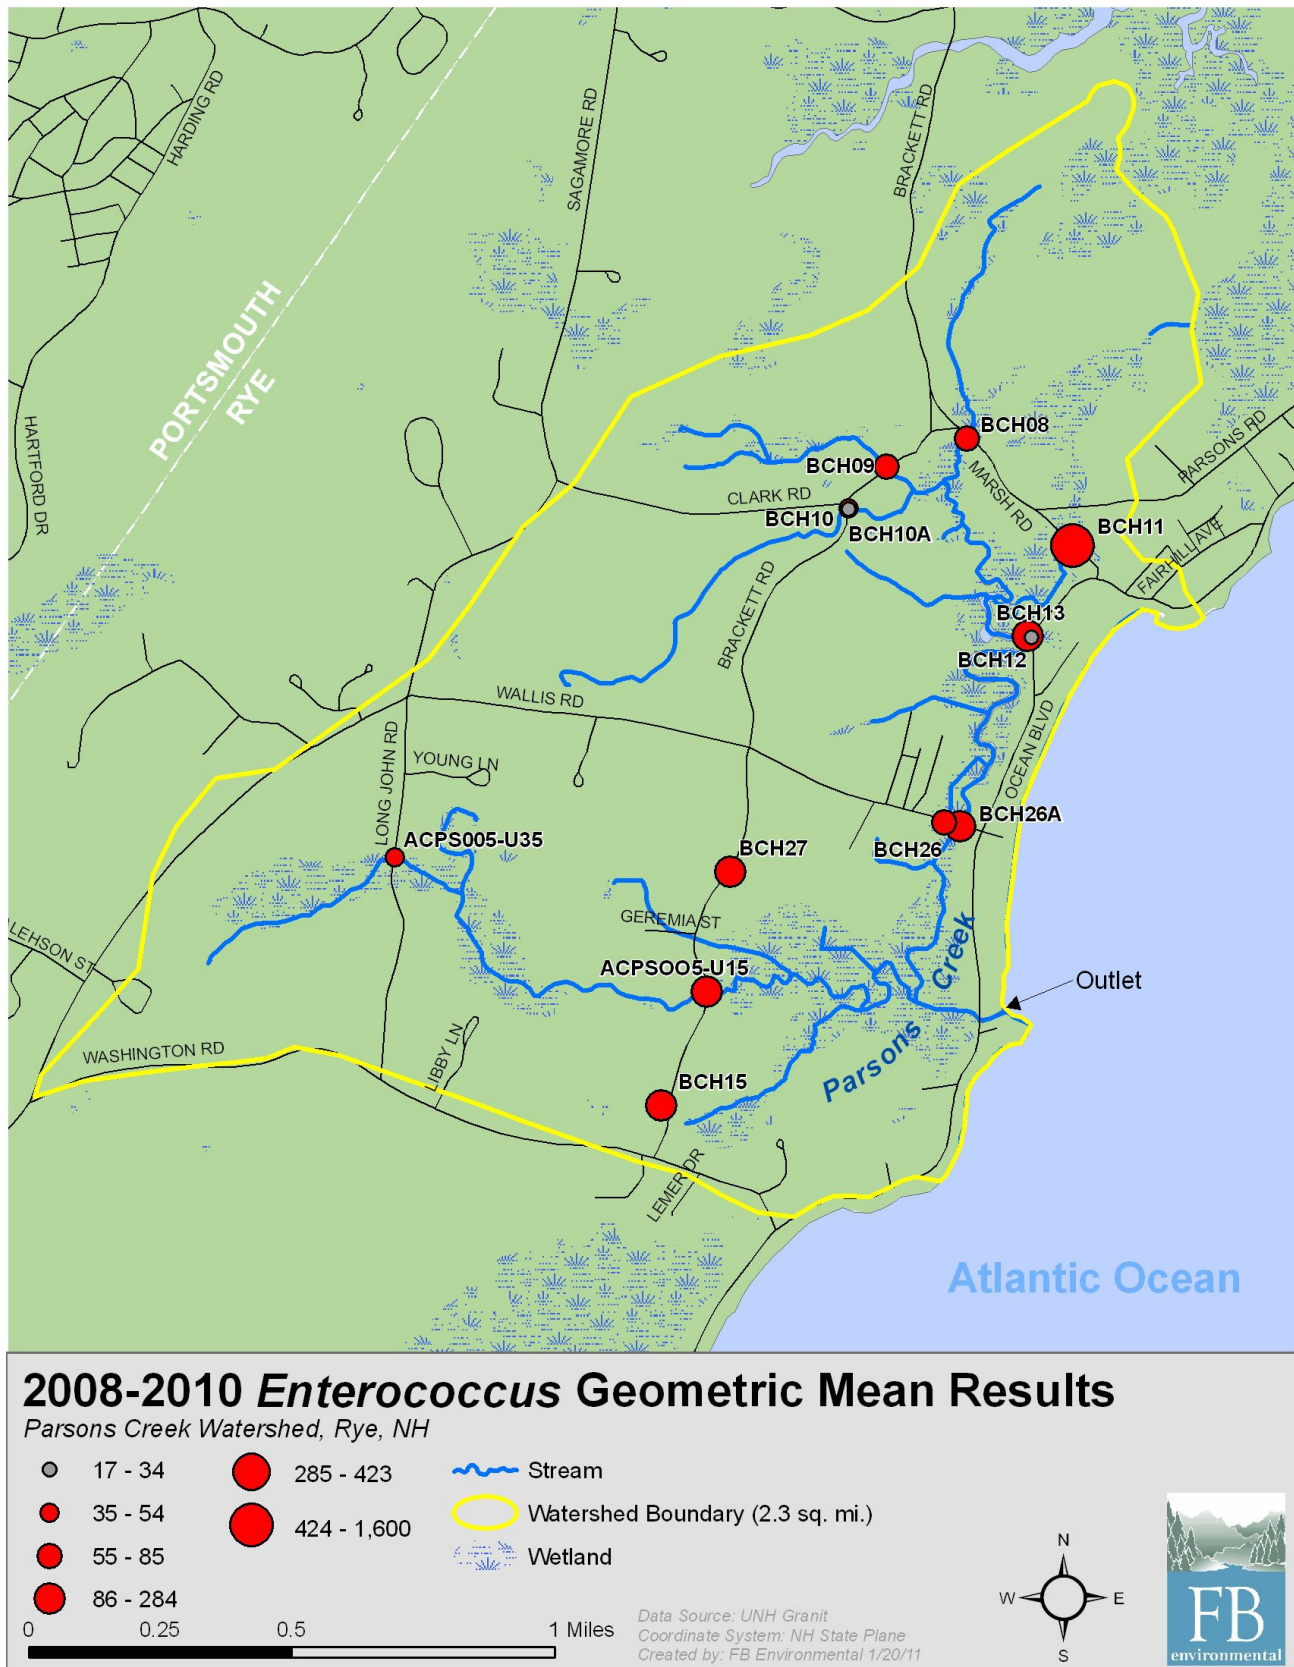
Figure 3.2. Map of Enterococci Sampling Locations and Geometric Means

Bacteria levels in Parsons Creek range from <9 to 19,700 colonies/100 mL (Table 3.3). Of the 15 sites sampled since 2009, all have at least one sample that exceeds 104 col/100mL, the most strict state instantaneous standard for Enterococci involving primary human contact. BCH 11, the headwaters of Parsons Creek's northern branch, far exceeded State standard in all sampling events regardless of weather conditions and had the largest single sample result of 19,700 col/100 mL.

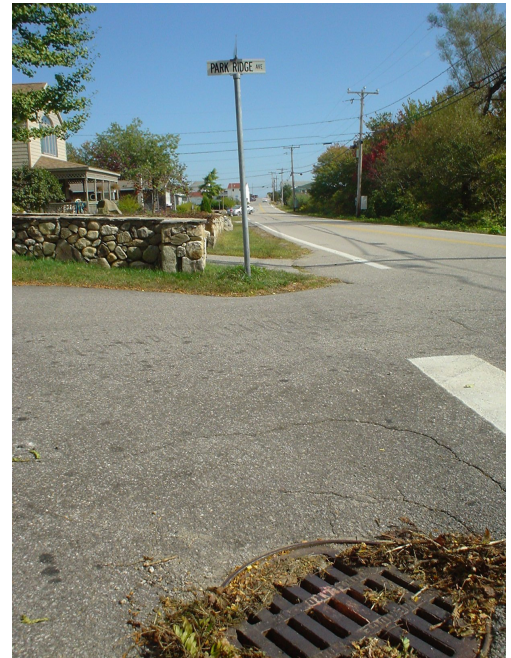
**Catch basin with debris at the corner of Park Ridge Rd**

The September 29 survey focused on the storm drain network and followed the Town of Rye's MS4 map of stormwater infrastructure. During the survey, a few catch basins were observed to be plugged with sediment or organic matter, but most allowed water to drain freely.

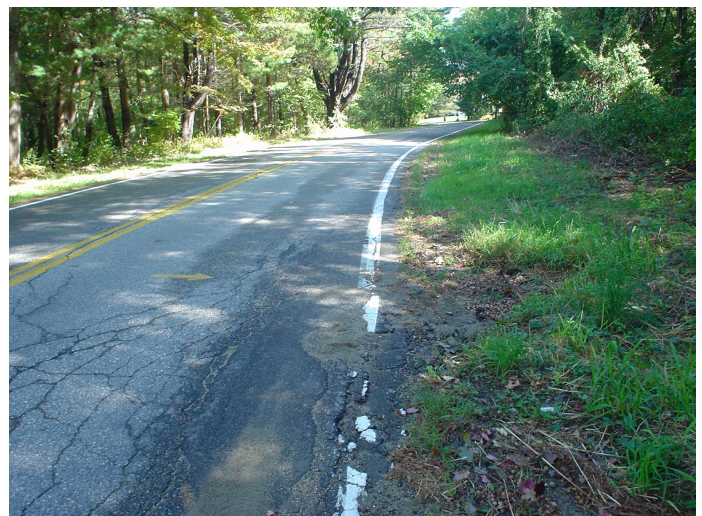
**Sediment along a road side near a catch basin, indicated by a yellow arrow. Sediment is a carrier of both bacteria and nutrients.**

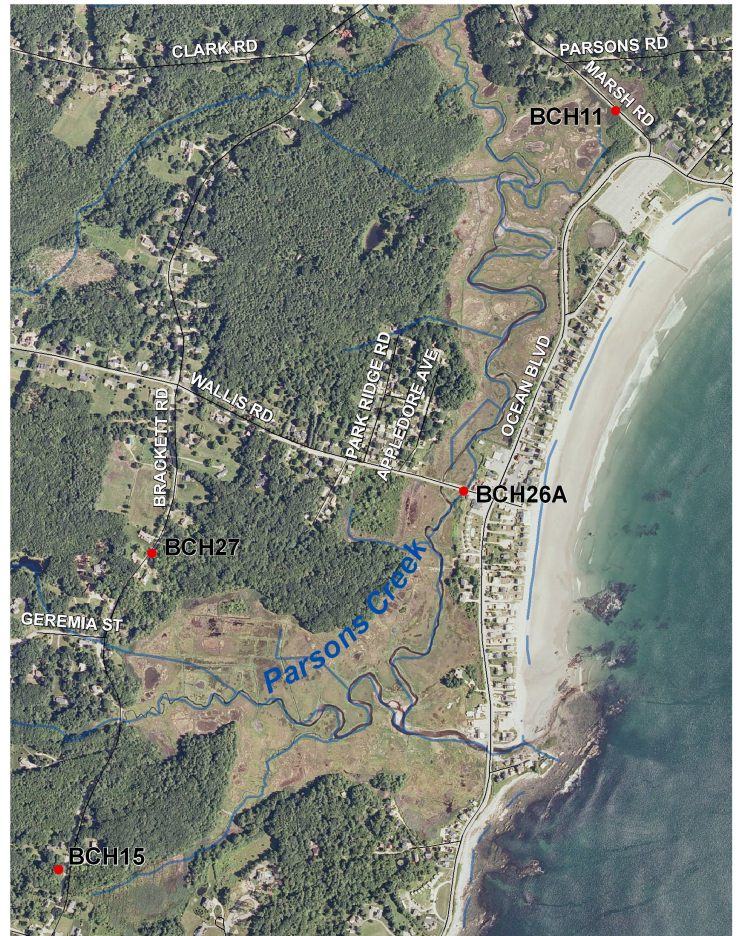
**Figure 4.1. Map of hotspots explored in the Parsons Creek watershed during the November 16, 2009 watershed survey.**

bacteria counts had been observed in a late October, 2009, sampling event by NH DES staff. Order-of-magnitude exceedances of the Enterococci bacteria standard (104 Enterococci counts/100mL) were observed at 4 locations in the Parsons Creek watershed: site BCH11, site BCH15, site BCH26A, and site BCH27. The results from that sampling event were used to target these specific areas during the survey. A summary of observations obtained upstream of each of the four high bacteria sample sites (Figure 4.1) is provided below.

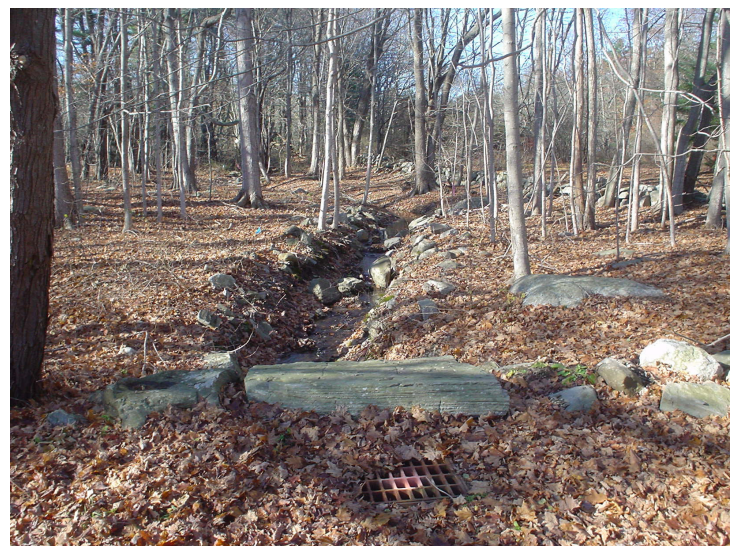
**Storm drain seen beside a wooded tributary to Parsons Creek at BCH15.**

- A bacteria measurement of 6,200 counts/100mL was collected at site BCH15, the southernmost sample site on Brackett Rd.
- The entire stream corridor from the pond to Wallis Road is thickly wooded.
- There were no clear signs of human-sources of bacteria-related contamination. Wildlife is a possible source.

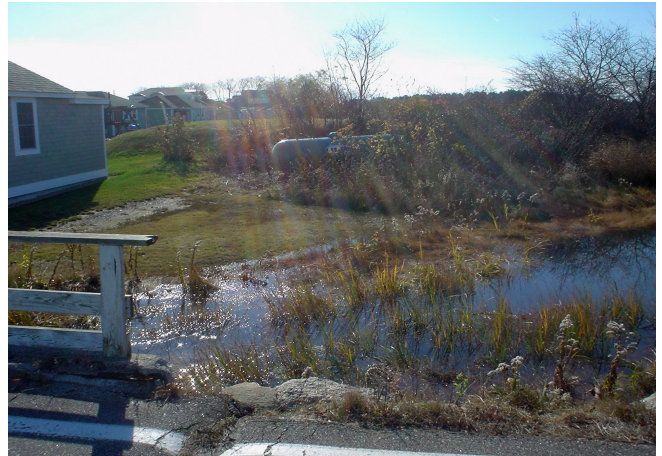
**Proximity of development, including septic disposal fields, to Parsons Creek at BCH26A**

- Enterococci levels of 5,100 counts/100mL were measured during wet weather survey of late October, 2009, at Site BCH26A.
- A portable toilet was observed directly adjacent to the stream channel just upstream of the bridge. The portable toilet is a potential bacteria source itself, but may also indicate an inadequate or malfunctioning wastewater system at one of the nearby buildings.
- In the same parking lot, a dumpster was observed situated about 15 m from the tidal channel representing another potential pollutant source.
- Given the close proximity of some buildings to the marsh in this area, their poor condition, and the indication of septic systems behind them, these properties may be considered a possible source of bacteria to Parsons Creek.

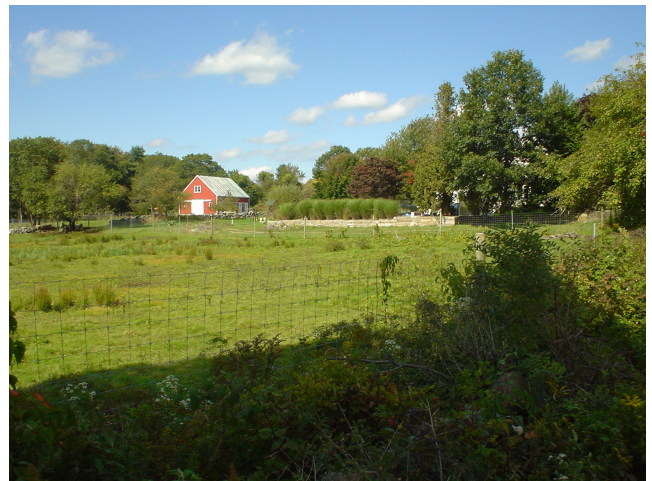
**An active buffalo pasture in the Parsons Creek watershed**

- A bacteria measurement of 1,700 counts/100mL Enterococci was collected during the early May 2010 wet weather survey at Site BCH27.
- This site was selected for sampling because one of the stormdrains accepts drainage from an active buffalo pasture.
- For this reason, *E. coli* (another freshwater indicator bacteria) was also tested, with a result of 3,700 counts/100mL.
- Drainage to this sample site consists of runoff from other areas in addition to the pasture.

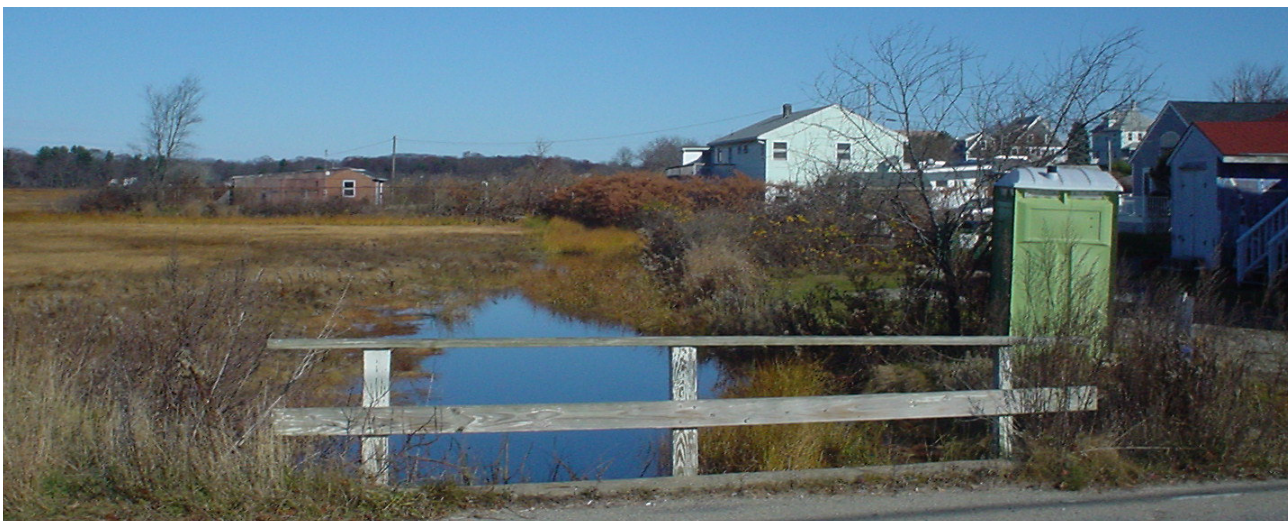
**Buildings and a portable toilet immediately adjacent to Parsons Creek at BCH26A.**

- Abandoned pet waste observed near site BCH11.
- Lack of vegetated buffer surrounding the marsh at BCH11 between lawn and tidal waters.
- Commercial buildings without vegetative buffer next to BCH26A.
- Storm drains piped directly to surface waters from neighborhood northwest of BCH26.
- Lack of vegetated buffer surrounding the marsh at BCH26 between lawn and tidal waters.
- Storm drains piped directly to surface waters from Brackett Road near BCH10 and 10A.
- Residential neighborhood with storm drains piped to streams at BCH27.
- Portable toilet and dumpster within 20 feet of tidal waters adjacent to BCH26A.
