# Parsons Creek Watershed Based Plan

May 2011

**Prepared by:**  
FB Environmental Associates, Inc.  
97A Exchange St., Suite 305  
Portland, ME 04101

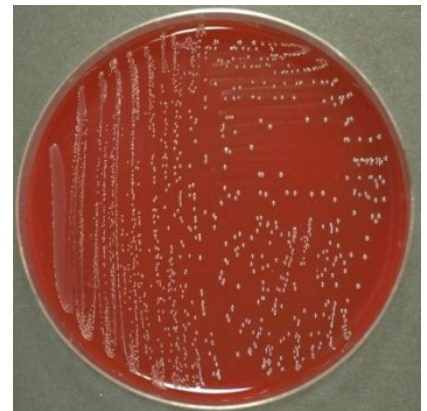
**Enterococci bacteria on an agar plate**

A combination of literature, scientific models, and on-the-ground observations were used to estimate bacteria loads. The NH DES Beach Program samples for Enterococci at the Parsons Creek stations which is used to indicate the current fecal coliform load in the stream. The indicator bacteria used for the annual estimates is fecal coliform (FC). There are other indicator bacteria as well. For example, *E. coli* is a specific constituent of the fecal coliform group and is commonly used in freshwater. Enterococci is an alternative indicator bacteria group used for salt water. Despite the differences between these groups, all are considered indicators of fecal-borne pathogens (EPA 1997). Fecal coliform was modeled in this study because it has the greatest amount of available research and data to support current and future load estimation. Bacteria load estimates are provided on an annual basis (i.e., counts/year) to allow uniform comparison across source types. The method of bacteria load estimation was deterministic, meaning that potential sources were identified,

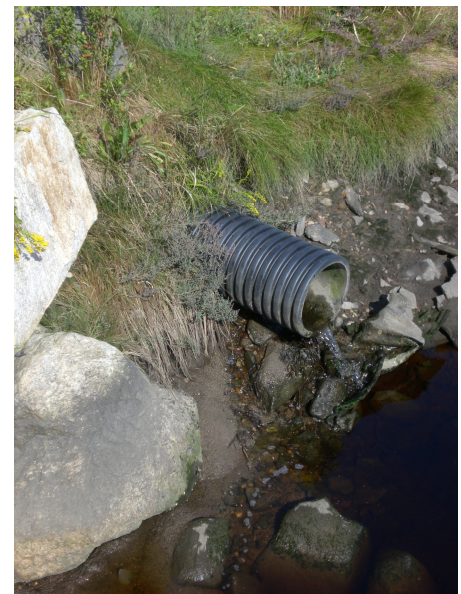
**Stormwater outfalls can carry pollutants to Parsons Creek**

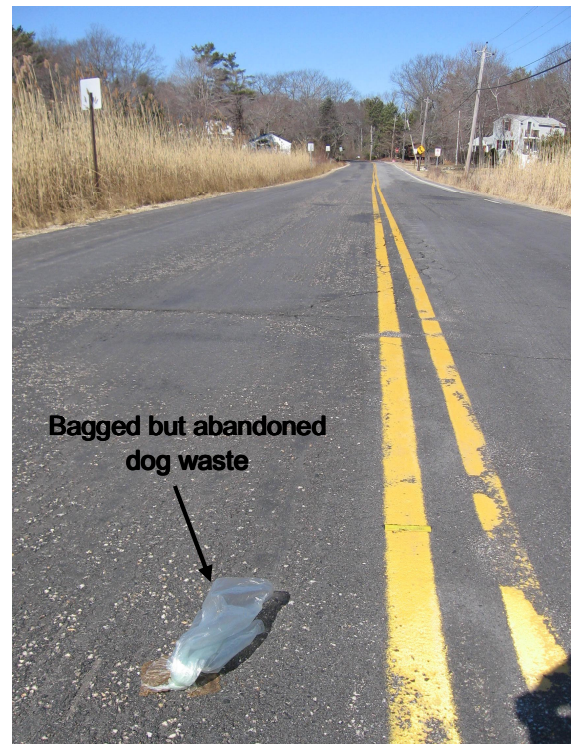
**Developed area runoff can wash bacteria into Parsons Creek. The presence of bagged but abandoned waste near site BCH11 suggests current management measures are only partially successful.**

- Abandoned pet waste observed near site BCH11.
- Lack of vegetated buffer surrounding the marsh at BCH11 between lawn and tidal waters.
- Commercial buildings without vegetative buffer next to BCH26A.
- Storm drains piped directly to surface waters from neighborhood northwest of BCH26.
- Lack of vegetated buffer surrounding the marsh at BCH26 between lawn and tidal waters.
- Storm drains piped directly to surface waters from Brackett Road near BCH10 and 10A.
- Residential neighborhood with storm drains piped to streams at BCH27.
- Portable toilet and dumpster within 20 feet of tidal waters adjacent to BCH26A.

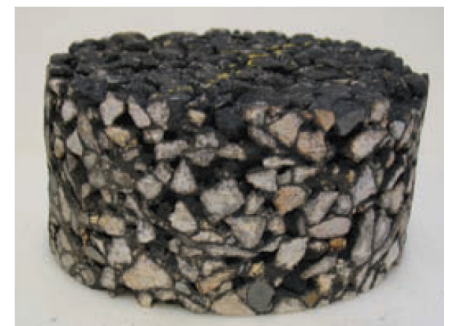
**Pervious pavement allows water infiltration and reduction in winter road sand and salt necessary to keep roads clear.**

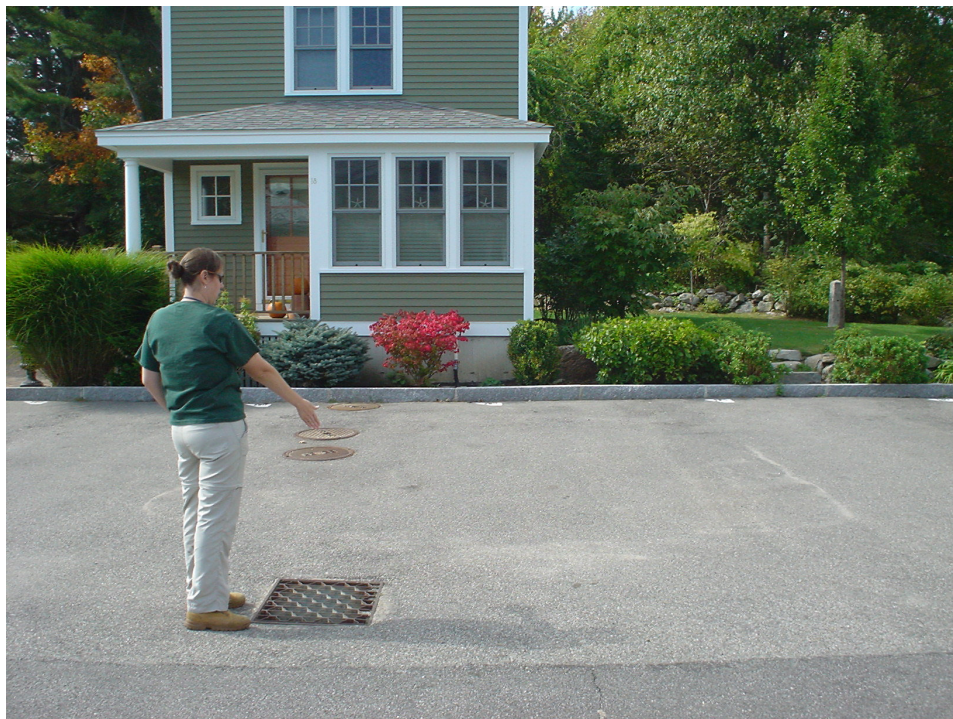
**Storm drain in the parking area of a residential development that catches untreated area runoff.**

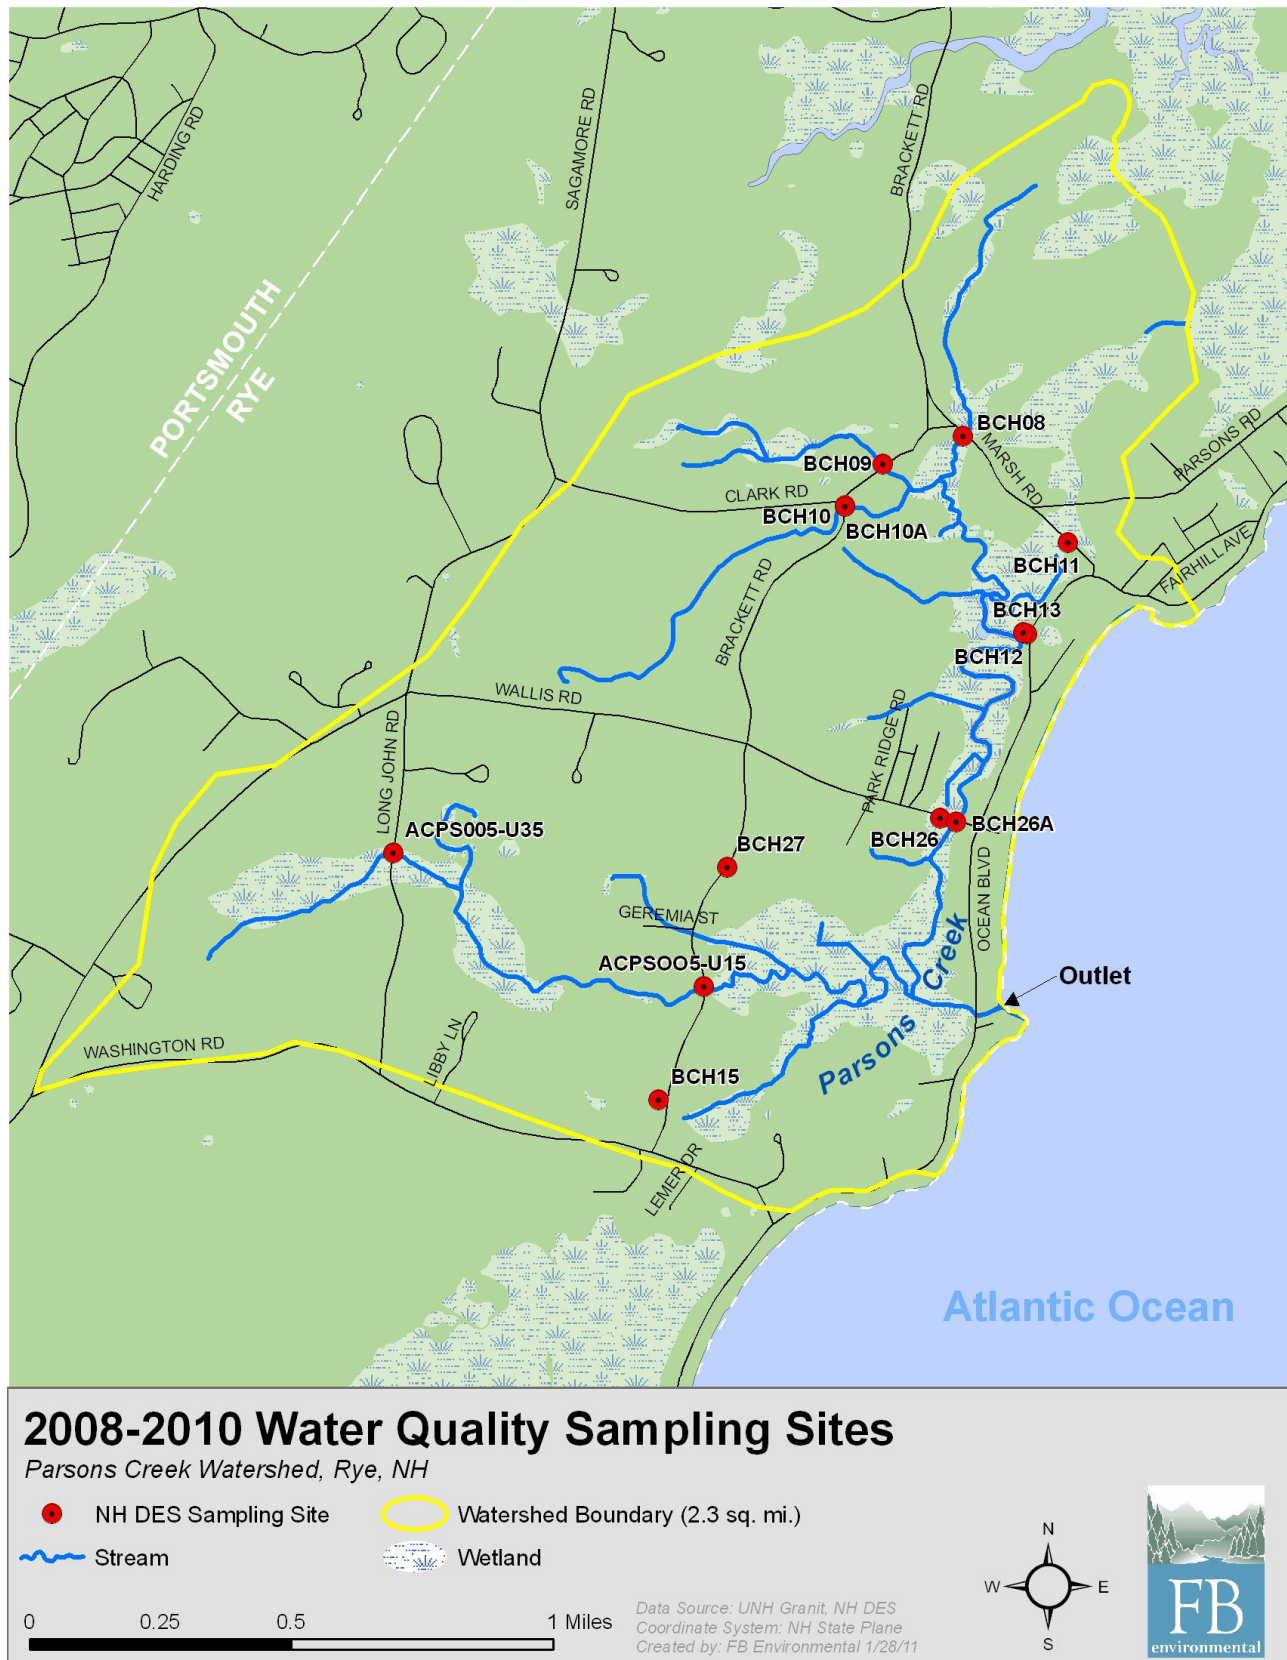
Figure 7.1. Map of Sampling Locations in Parsons Creek Watershed

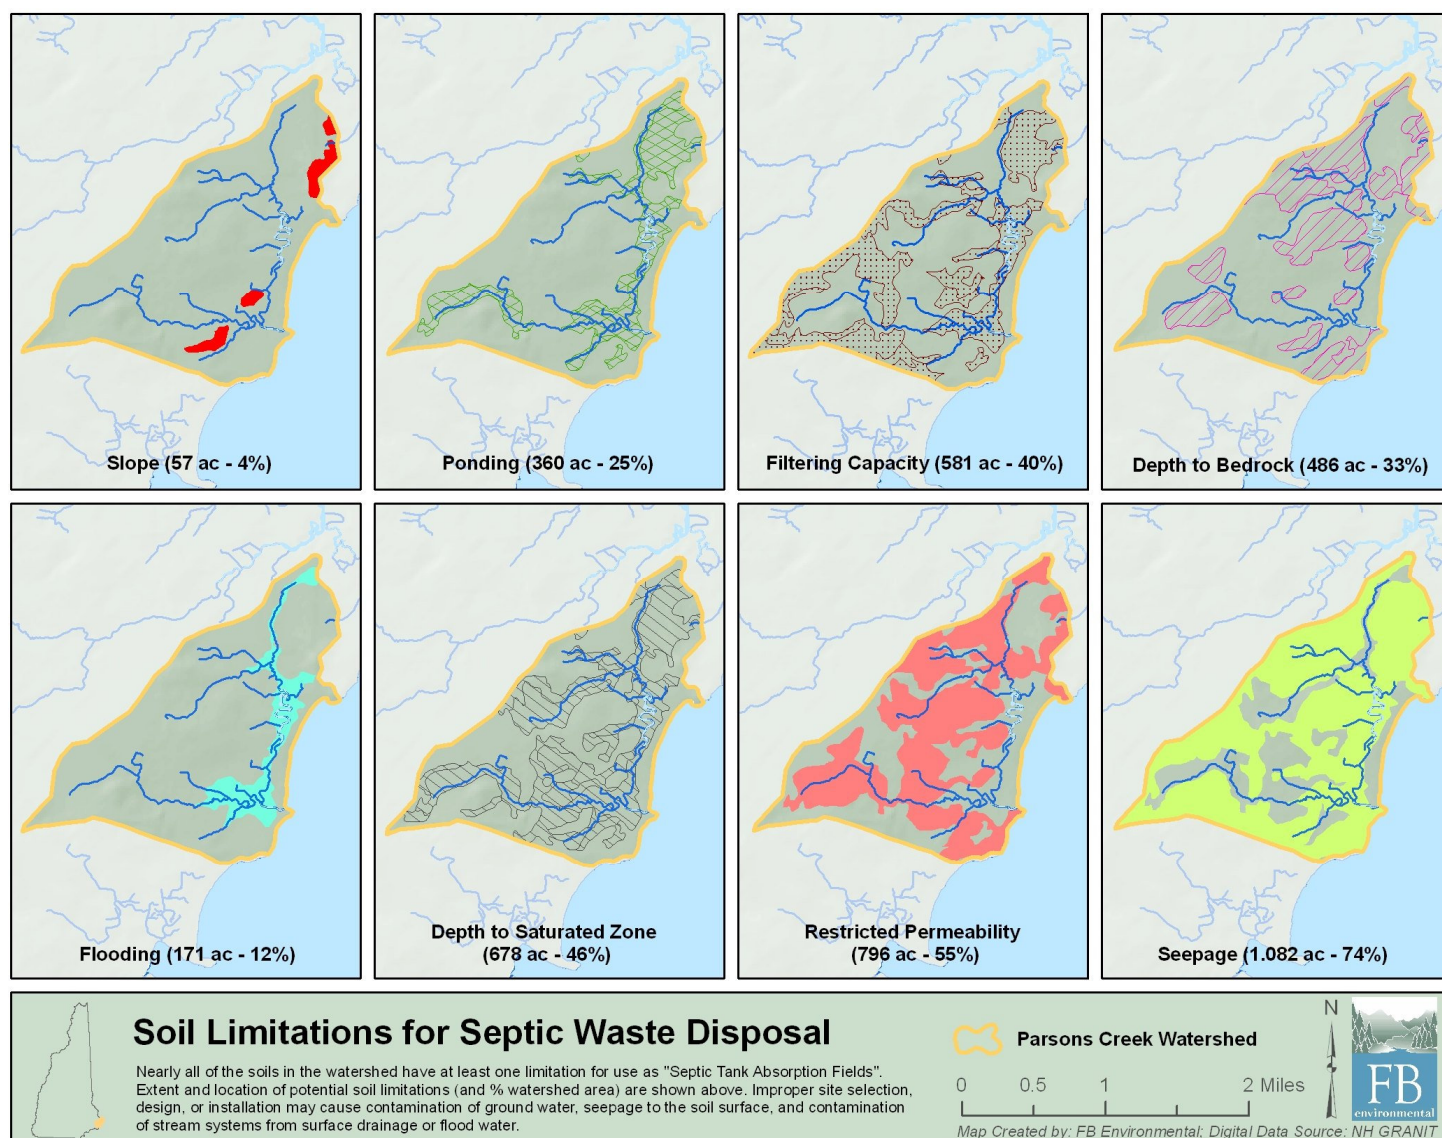
Figure 1: Parsons Creek watershed soil limitations for septic system, as indicated by the Natural Resource Conservation Service.

Where soils are underlain by loose sand and gravel or fractured bedrock at a depth of less than 4 feet below the distribution lines, the absorption field may not adequately filter the effluent, particularly when a system is new; consequently, ground water supplies may be contaminated.

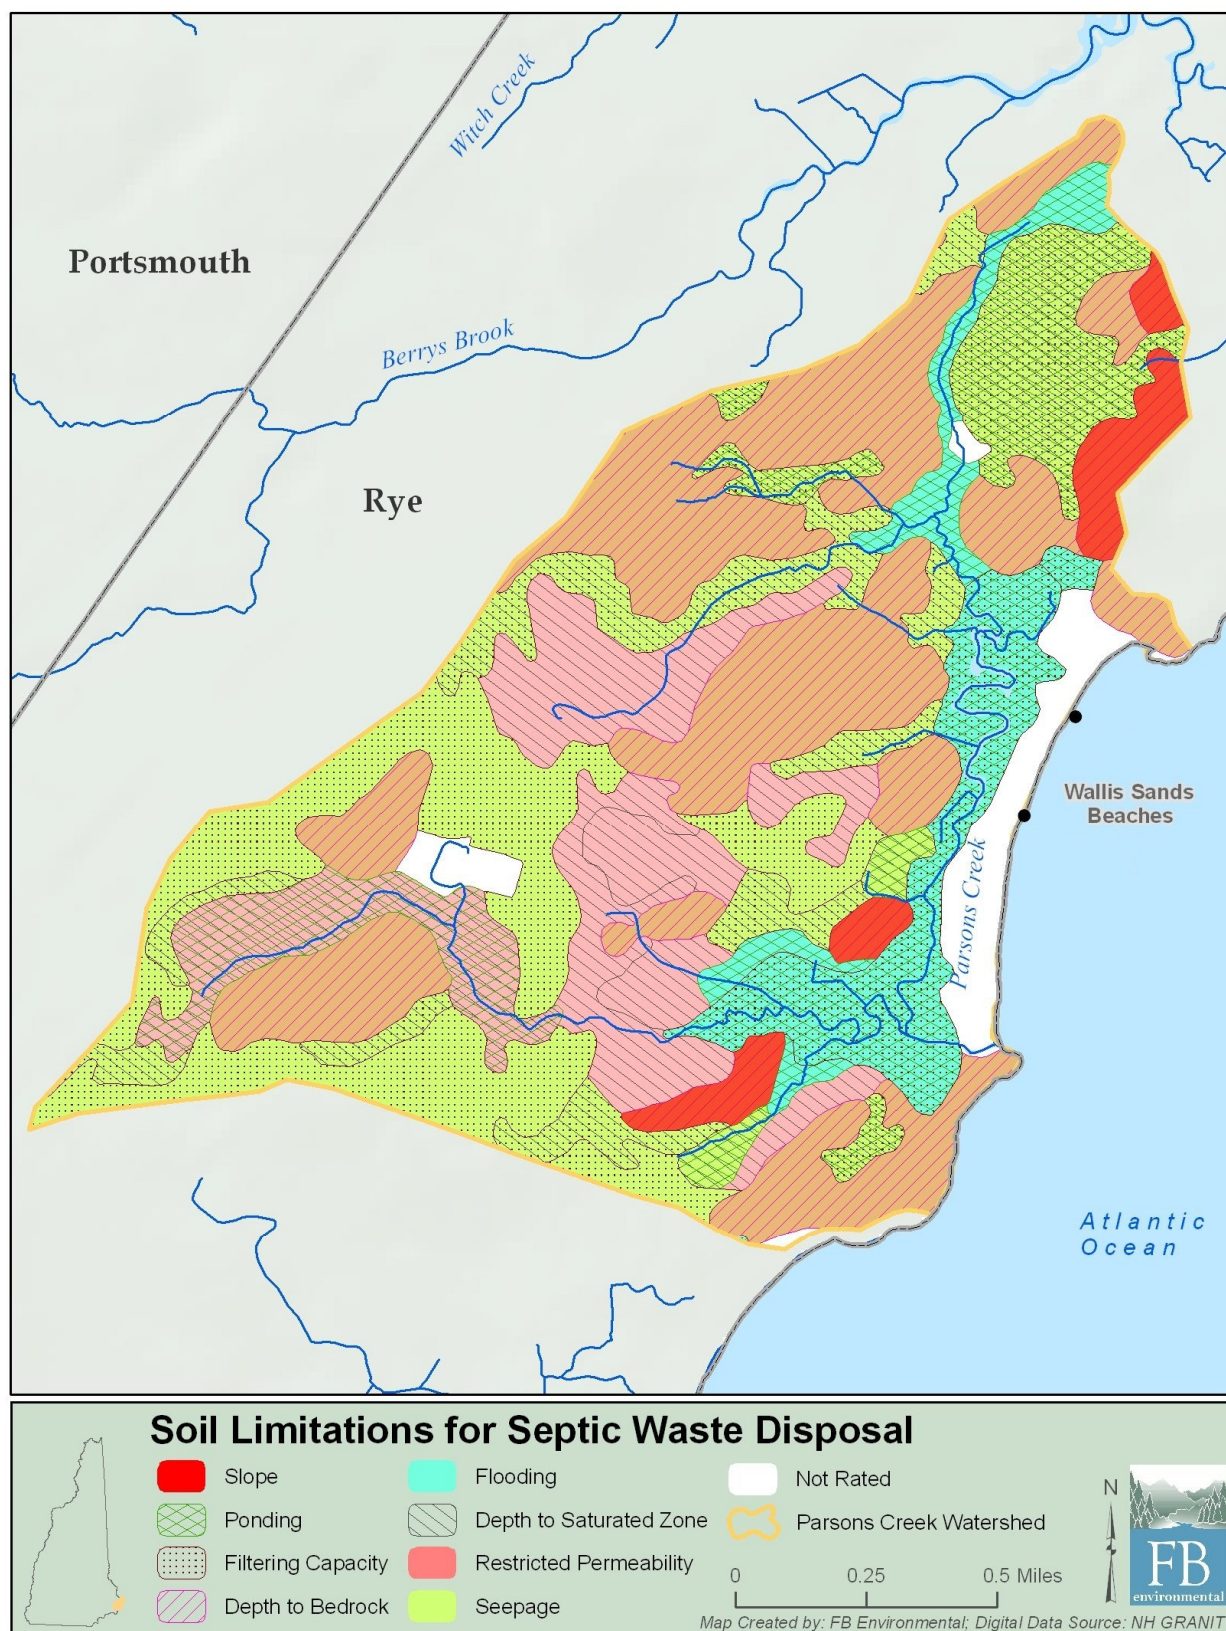
Figure 3: Parsons Creek septic disposal soil limitations, note the overlapping limitations in many areas.

**8. Restricted permeability:** The soil horizon with the minimum K<sub>Sat</sub> governs the rate of water movement through the whole soil. When this rate is low, transmission of fluids into and through the soil is impeded and runoff, infiltration, and percolation of pollutants may result in environmental, health, and performance concerns. This limitation is present for 57% of the Little River soils and 55% of the Parsons Creek soils.

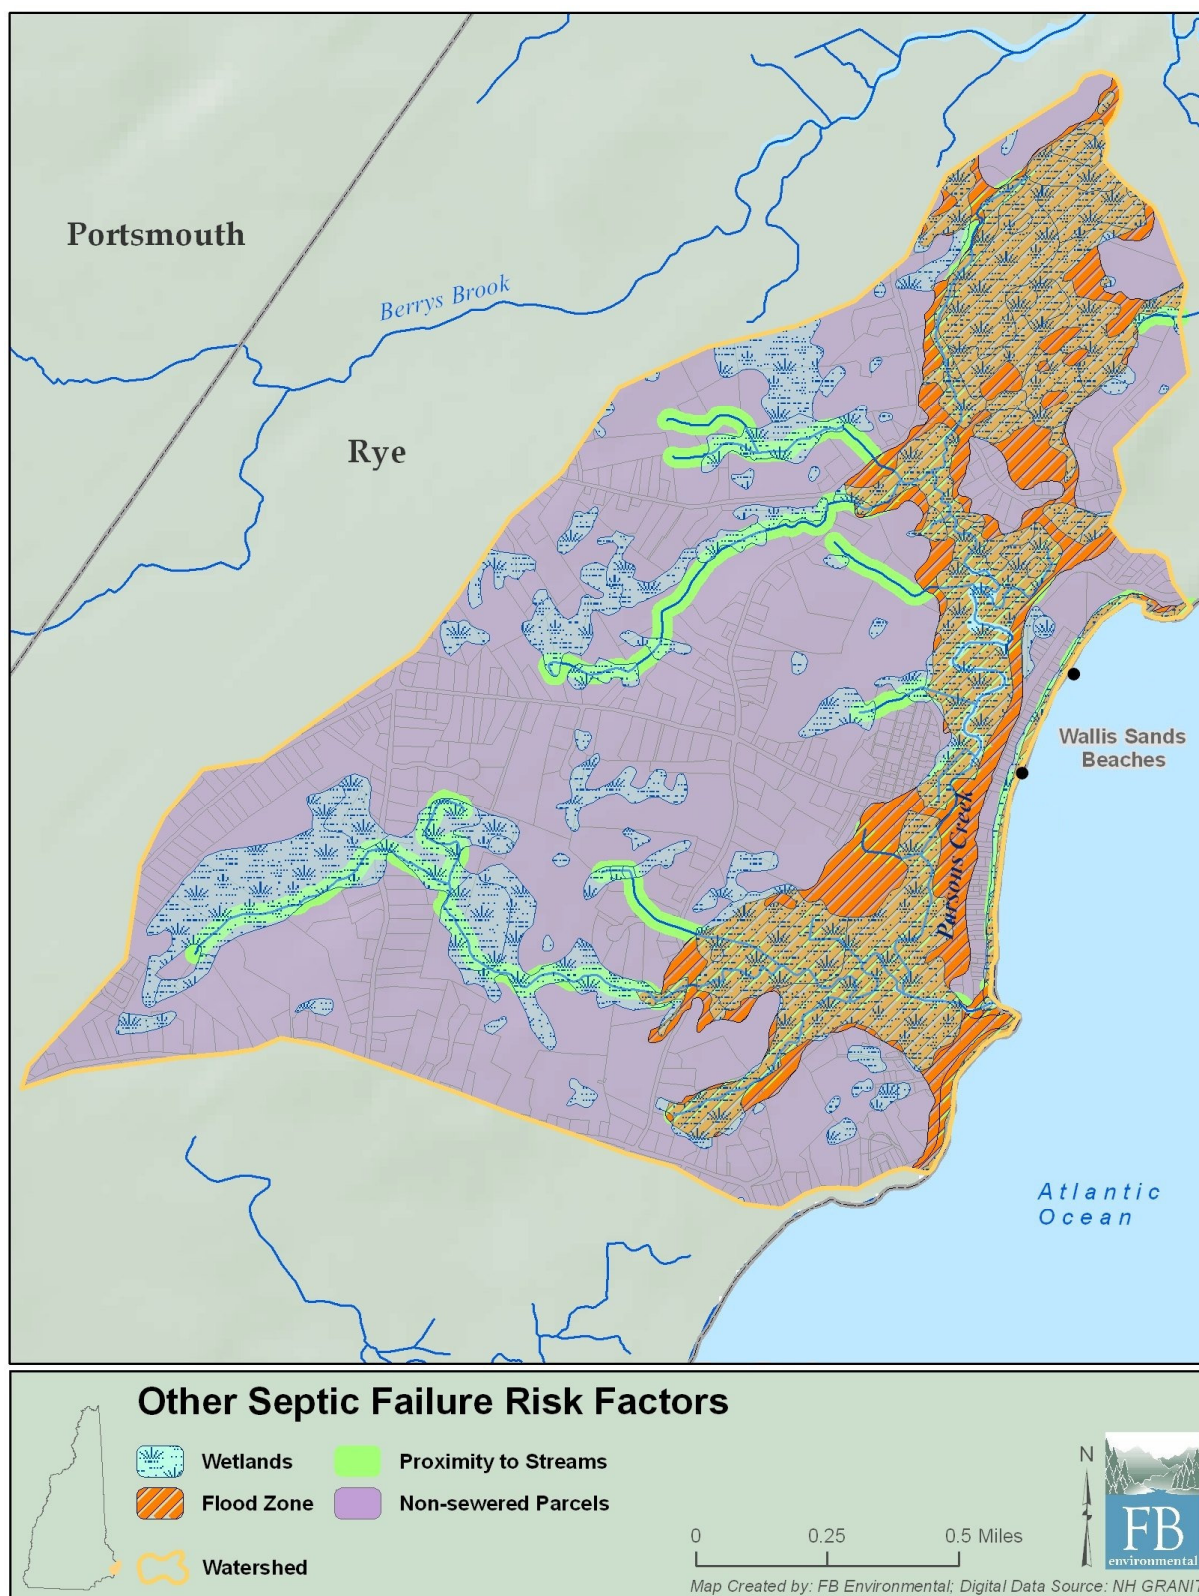
Figure 5: Parsons Creek watershed factors (beyond soils) contributing to risk of water quality contamination from malfunctioning septic systems.

- **Proximity to Streams:** All streams in the watersheds were buffered by 100 feet, the average setback distance required in New Hampshire. Within these areas, there is increased potential for bacterial contamination from septic failure due to stormwater runoff and astronomically high tides.

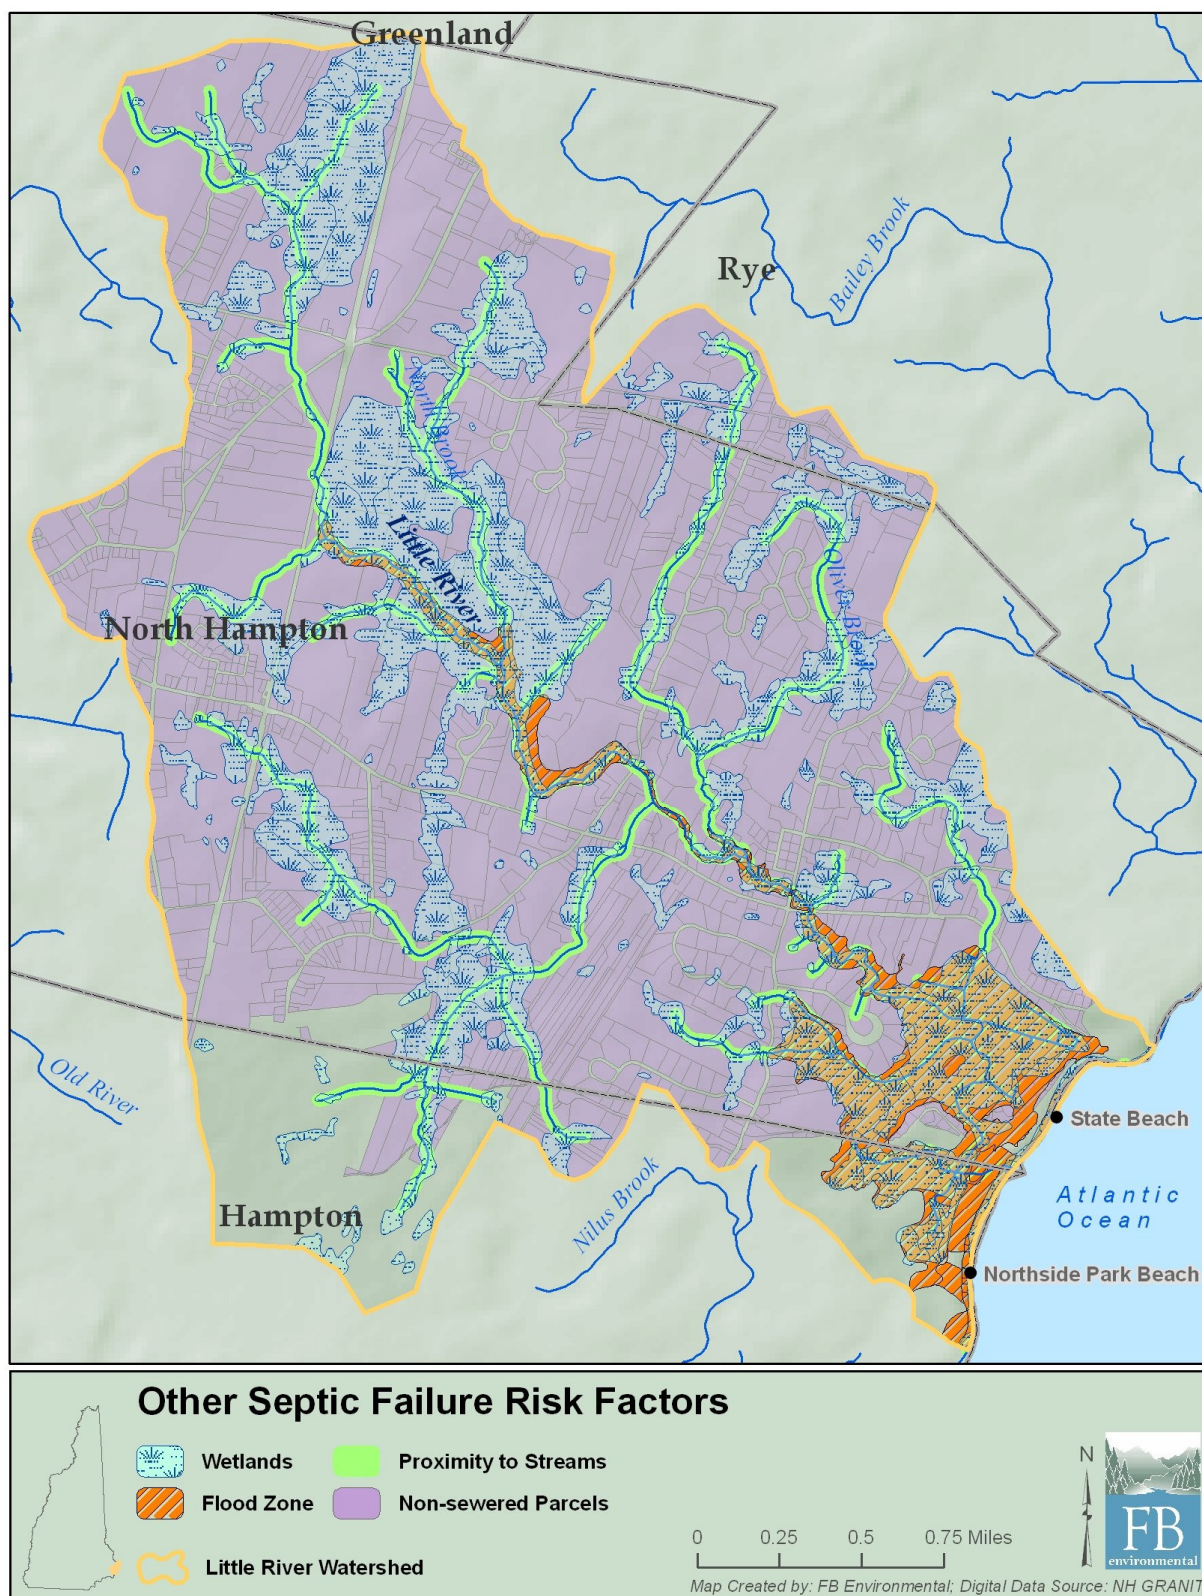
Figure 6: Little River watershed factors (beyond soils) contributing to risk of water quality contamination from malfunctioning septic systems.

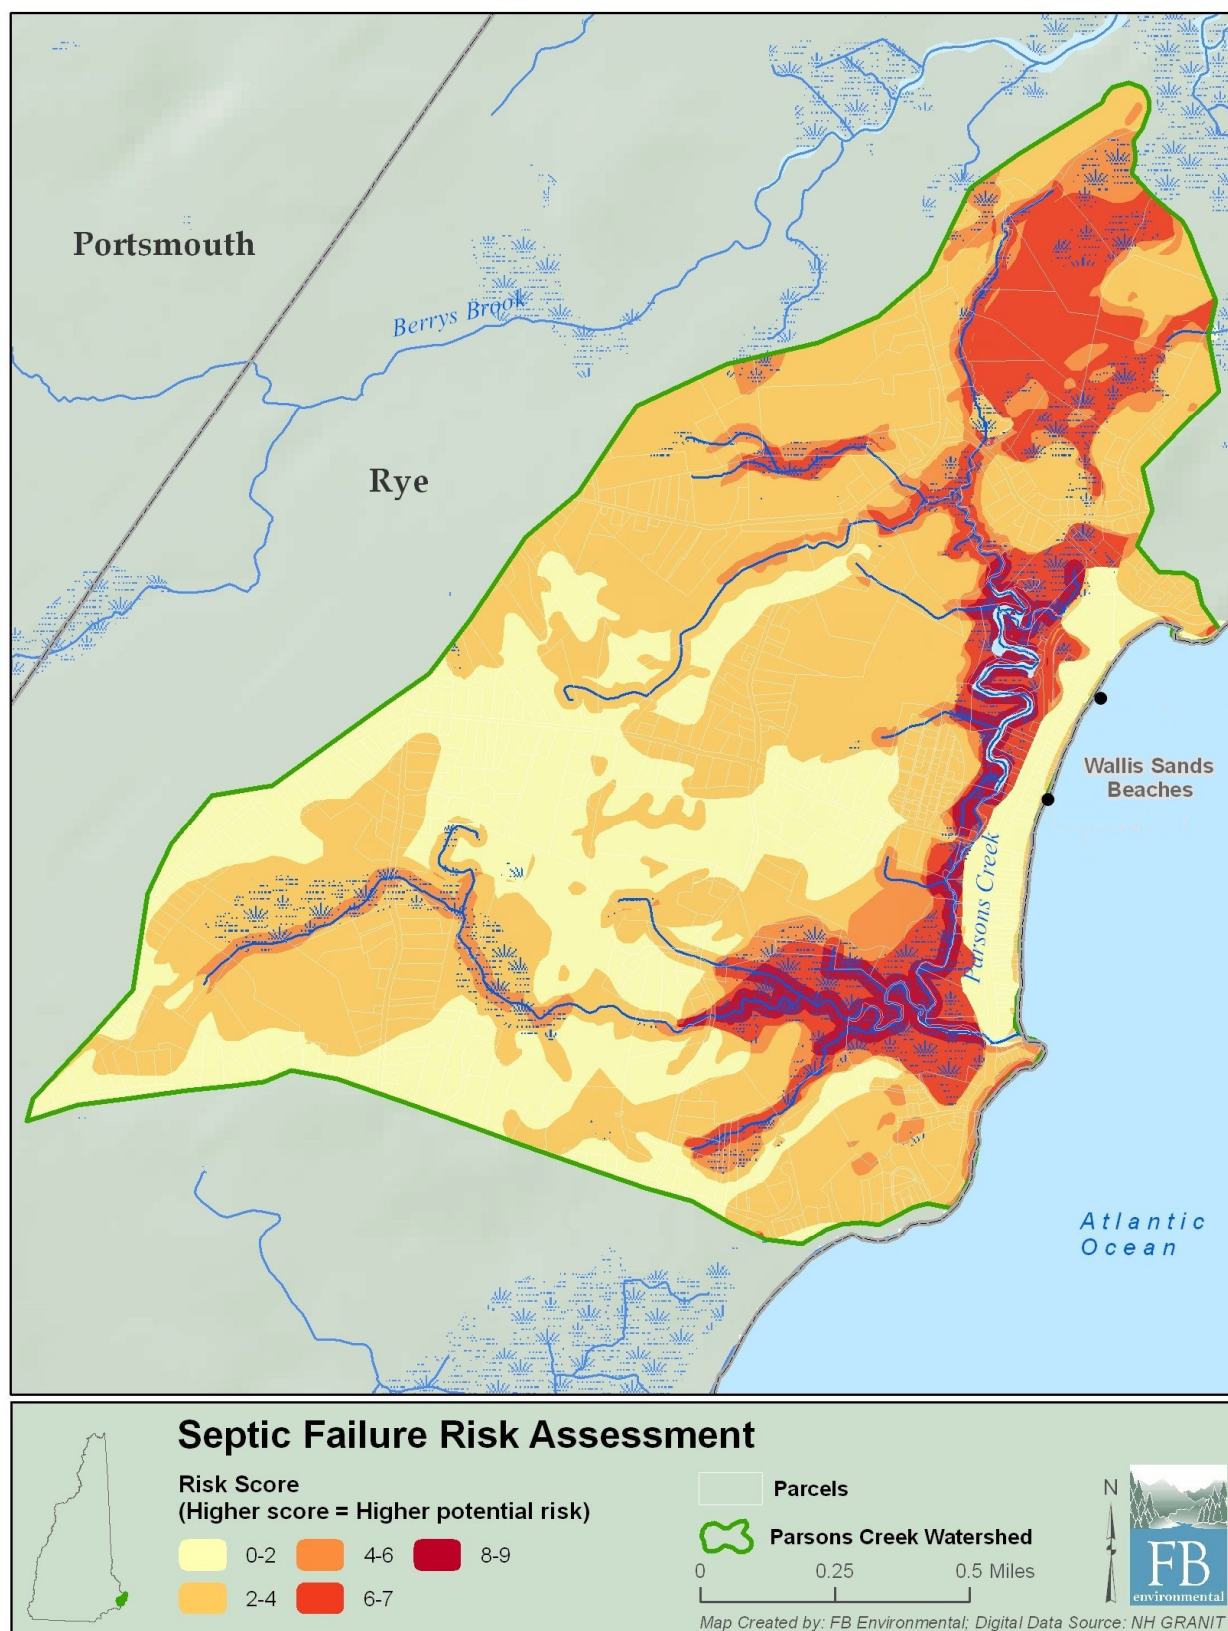
Figure 7: Parsons Creek watershed overall septic systems risk assessment.

After assigning risk scores, all data layers were overlaid to create a composite risk map. Risk scores for overlapping criteria were summed to create a single risk factor for each area of intersection. Final risk factors ranged from 0 to 9, with 9 representing the greatest potential risk. Since the majority of soils in the watersheds are not well suited for septic systems, the primary determinant in identifying the greatest risk potential from bacterial contamination from septic failure risk was proximity to freshwater streams, estuaries, wetlands and flood hazard areas.

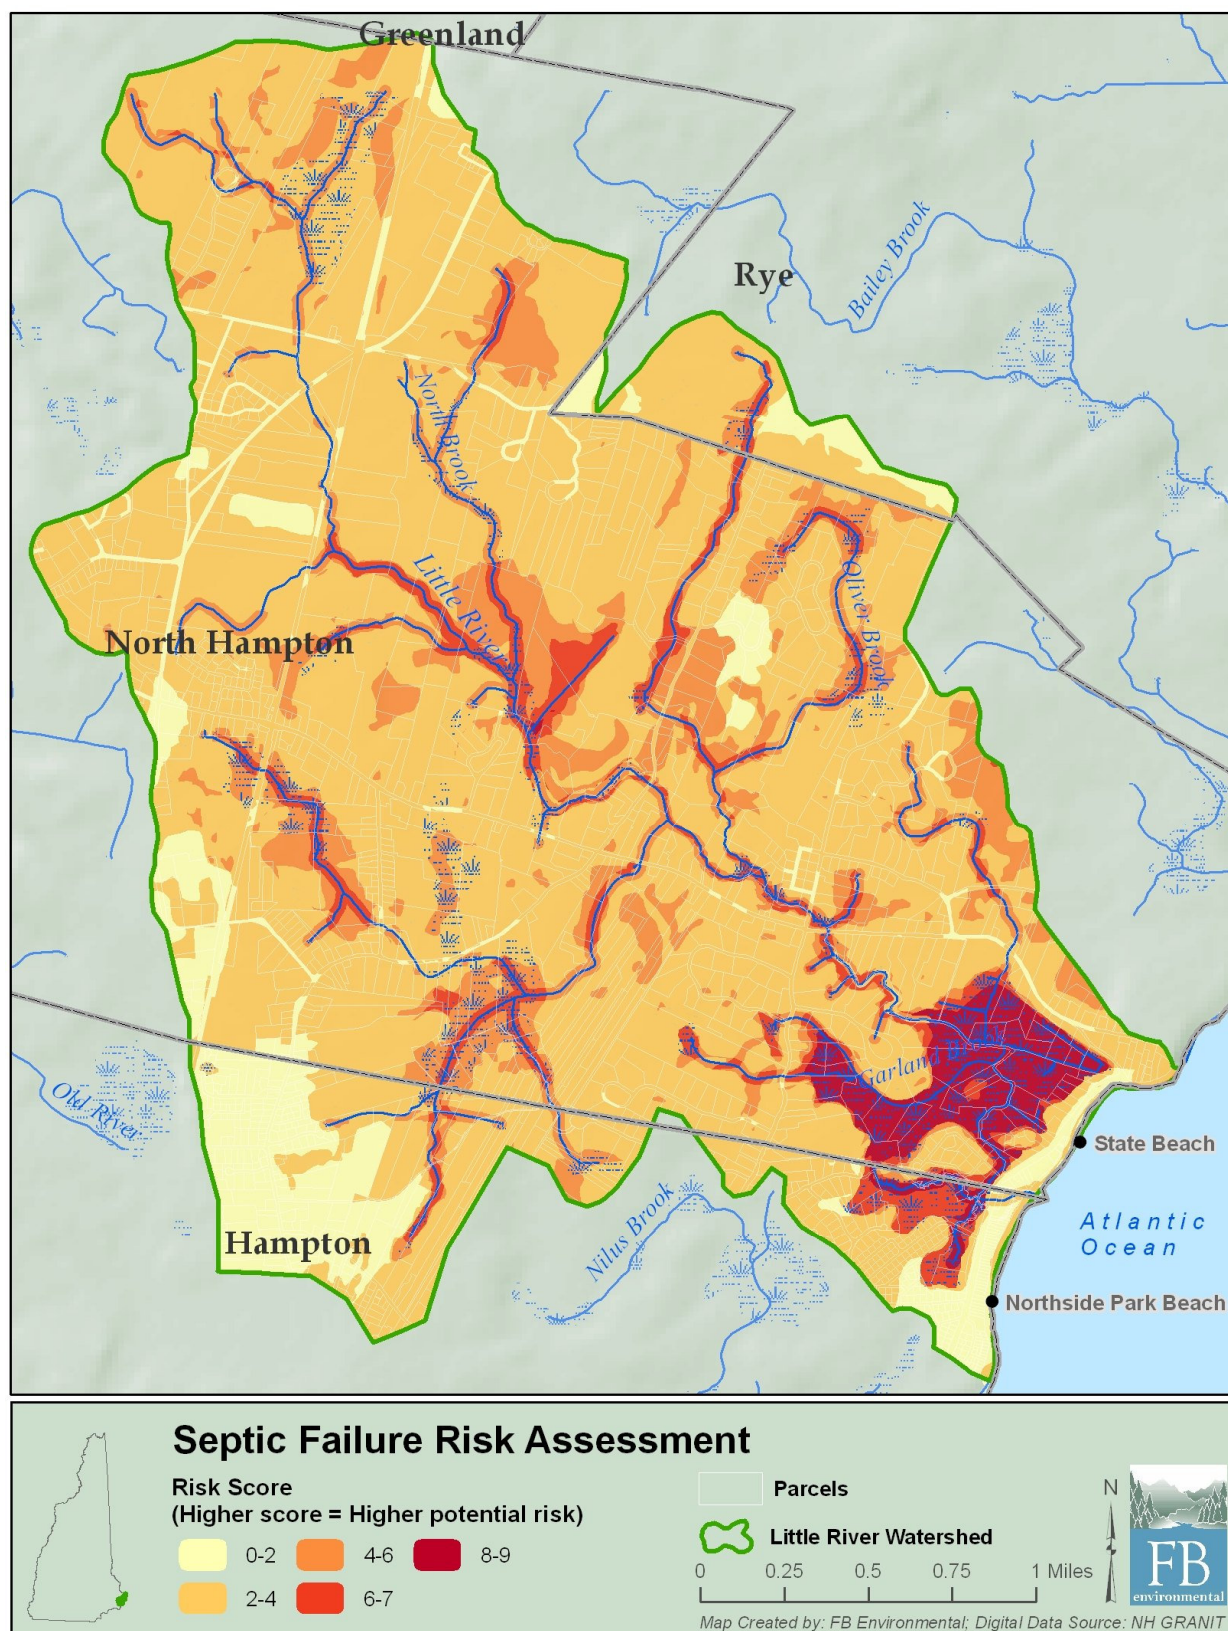
Figure 8: Little River watershed overall septic systems risk assessment.

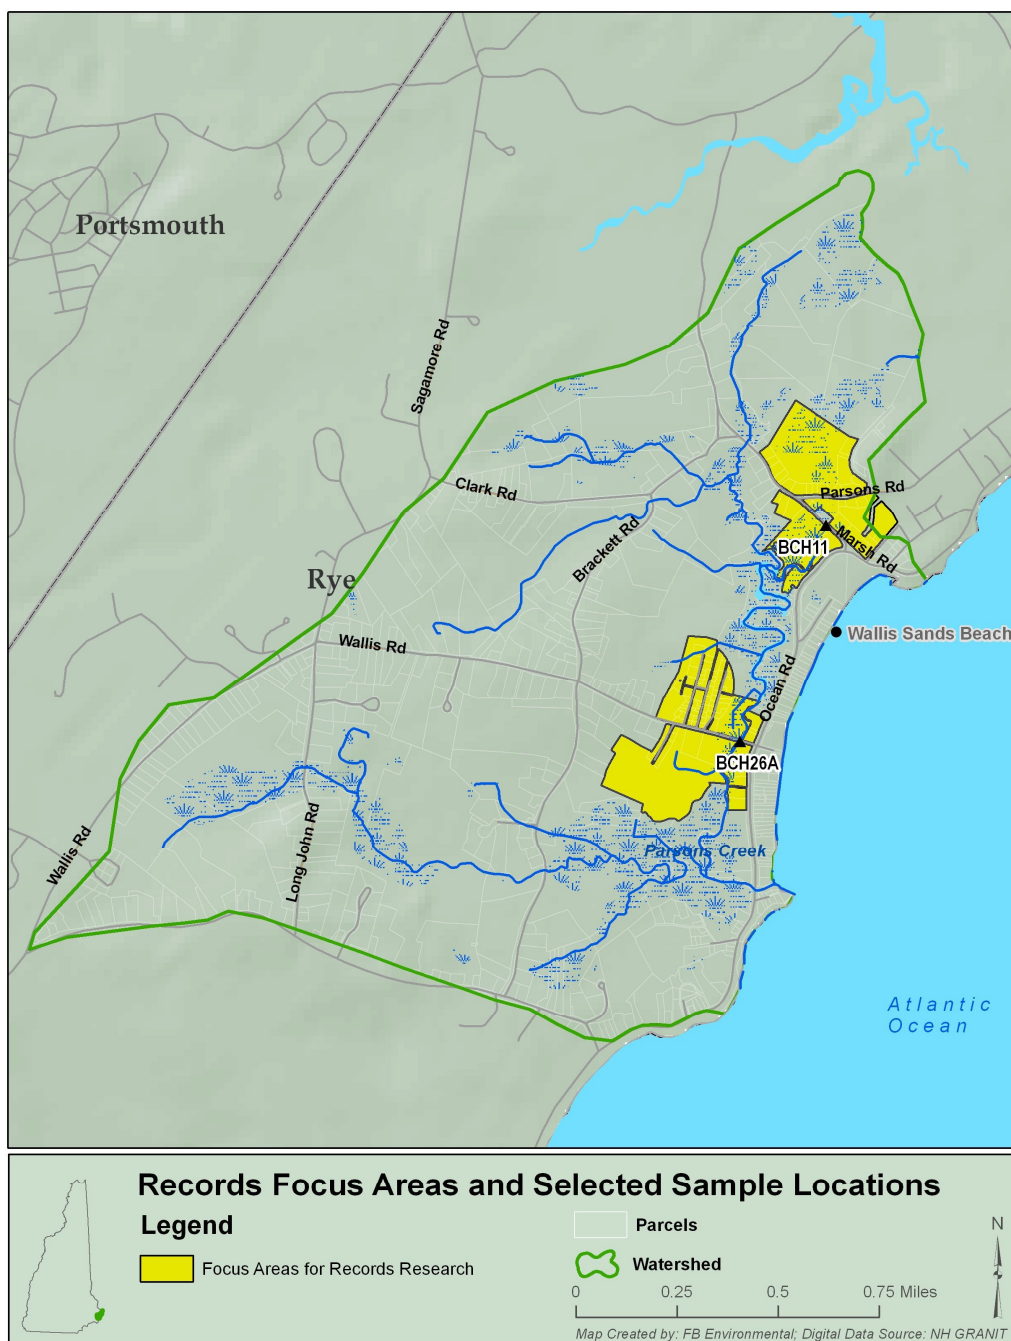
Figure 9: Focus areas for records research in Parsons Creek watershed.

- BCH11, along Marsh Rd in Rye.
- BCH26 and BCH26A, at the intersection of Wallis Rd and Ocean Rd in Rye, including the neighborhood just west of this intersection.
- BCH25, Appledore Ave in North Hampton.
- BCH18 and BCH19, along Lafayette Rd / US Route 1 in North Hampton.

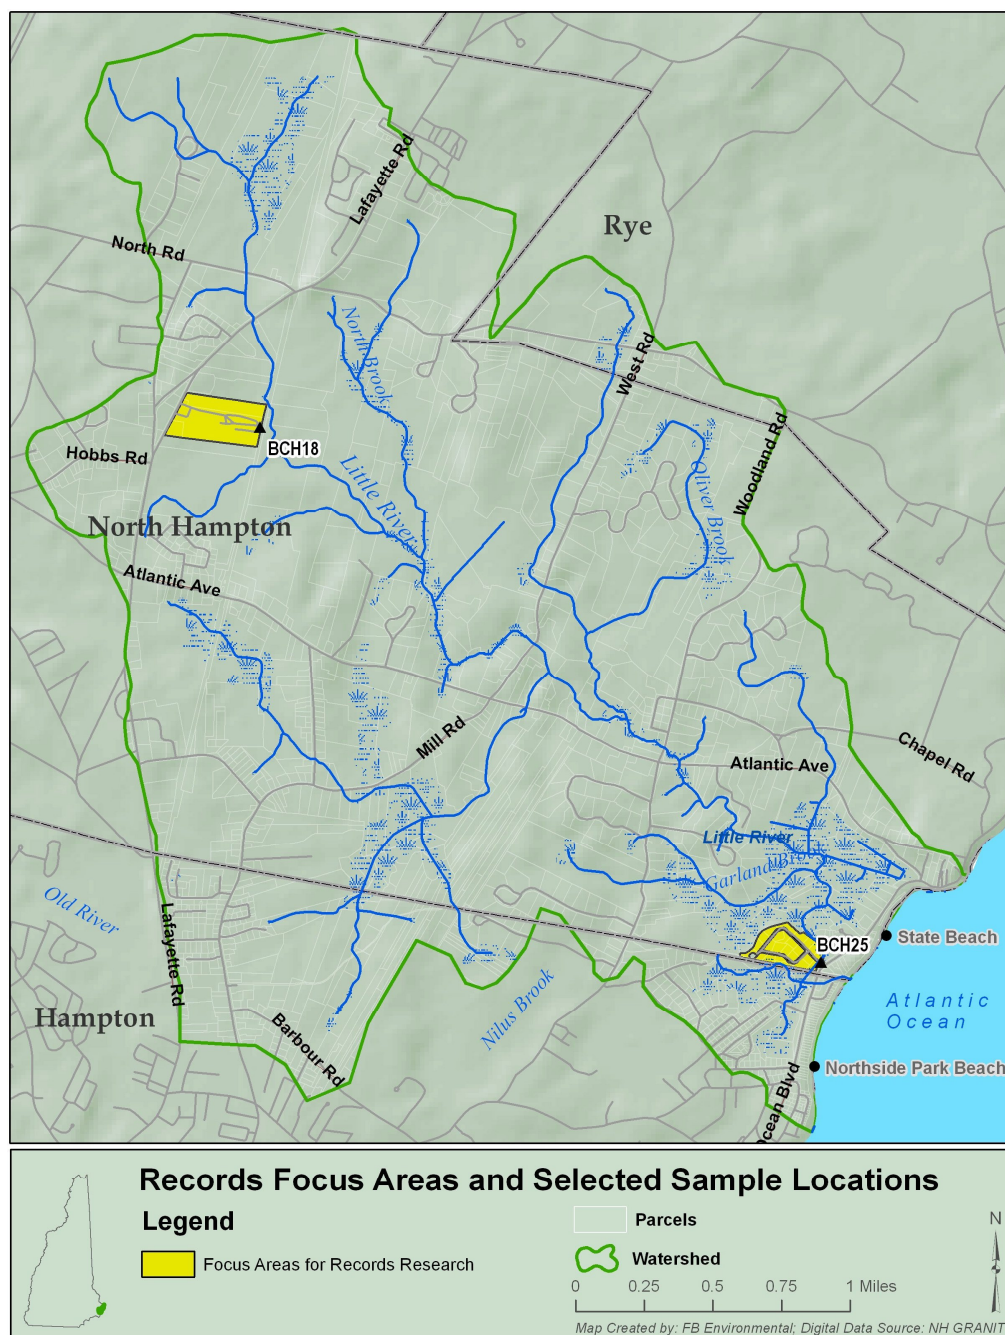
Figure 10: Focus areas for records research in Little River watershed.

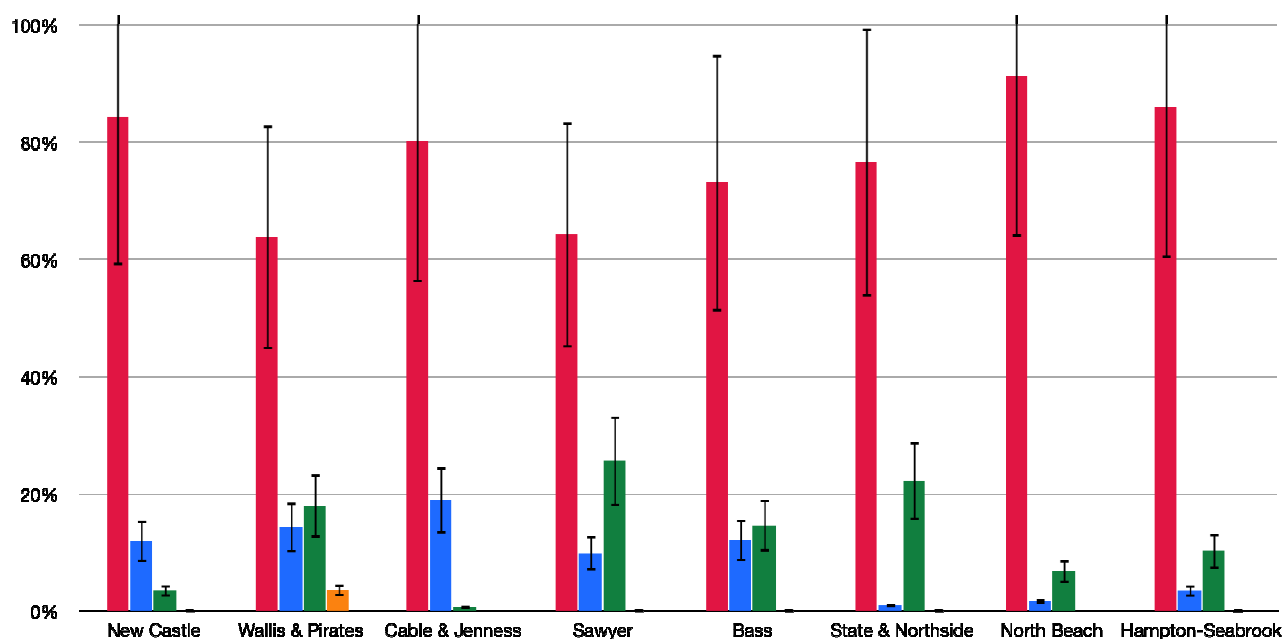
**Figure 11: Estimated Bacteria Loads: Percentage of Each Type by Watershed.**

Figure 16 provides estimated percentages of each type of bacteria load for each watershed. Developed area runoff is estimated to be the largest bacteria source in all of the study area watersheds (as shown in red below) ranging from 64% to 91%. Developed area runoff contributions originate in roadways, in yards, with pets, in illicit storm drains, and from other sources. Failing septic systems (blue) and wildlife (green) are also estimated to be significant in most watersheds. Failing septic systems are estimated to range from 1% to 19%, with larger estimated loads in unsewered communities. Farm animals are estimated to be significant only in the Wallis & Pirates Cove watershed with a 4% estimated contribution.
