HISTORIC STRUCTURE REPORT

Rye Town Hall

10 Central Road
Rye, NH 03870

September 14, 2018

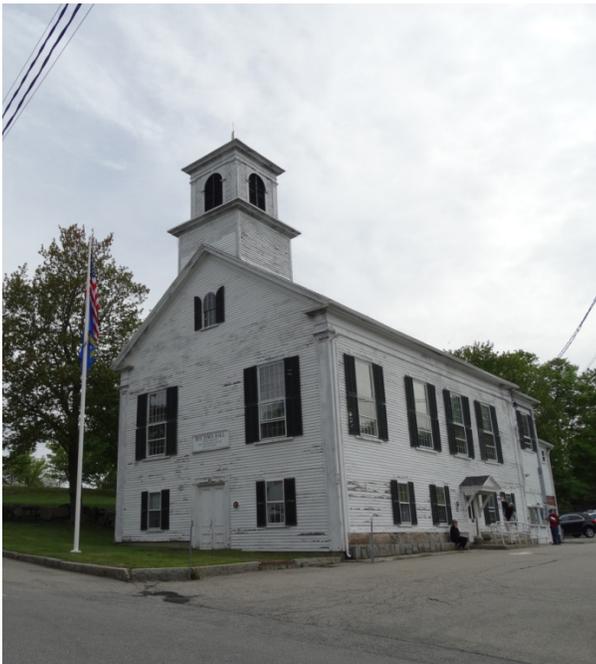
Figure 1: View of Rye Town Hall looking northeast, showing overall form and massing.

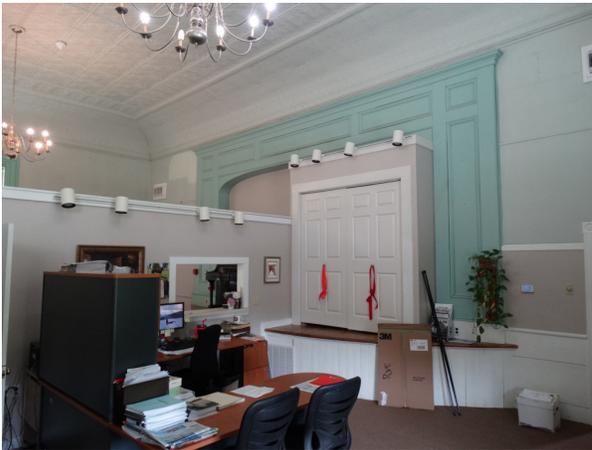
Figure 2: Interior view of main floor looking northeast, showing main original sanctuary space now divided by modern first-floor partitions. The 1900 stage and proscenium are visible.

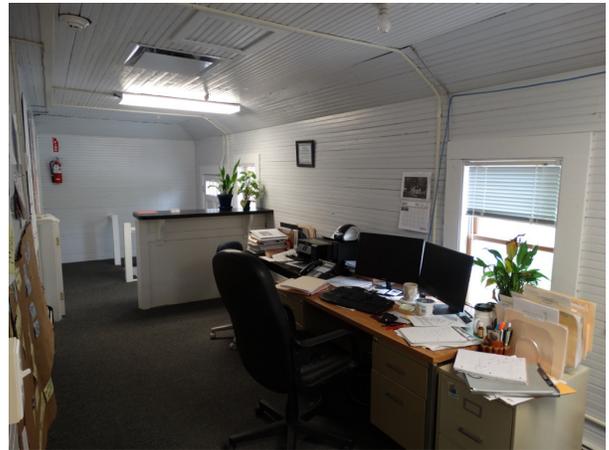
Figure 3: View of 1911 east porch, later enclosed as office space, looking northeast.

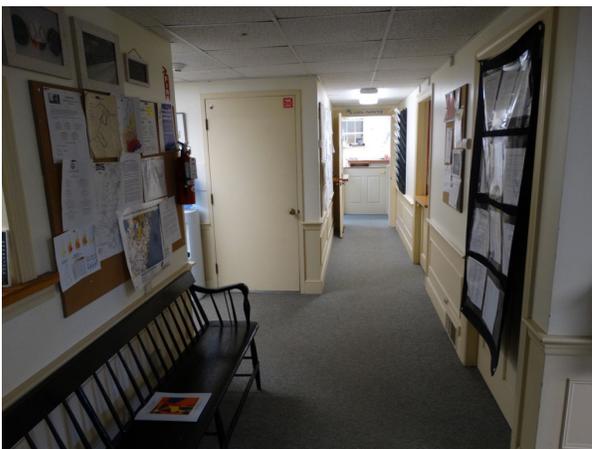
Figure 4: Lobby, Room 109, looking east, showing modern office partitions

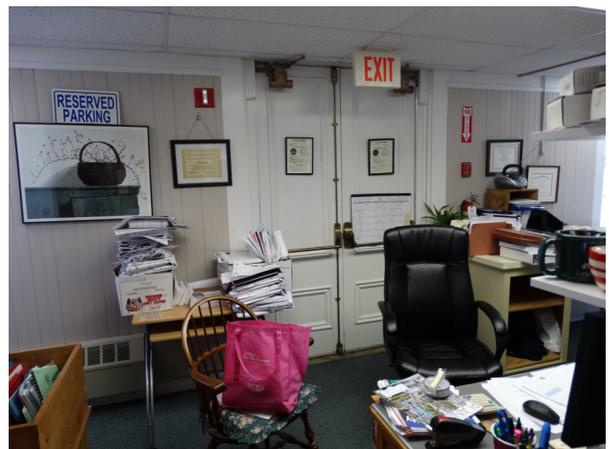
Figure 5: Room 104 looking west, showing original doors and wainscot elements within a modern office space.

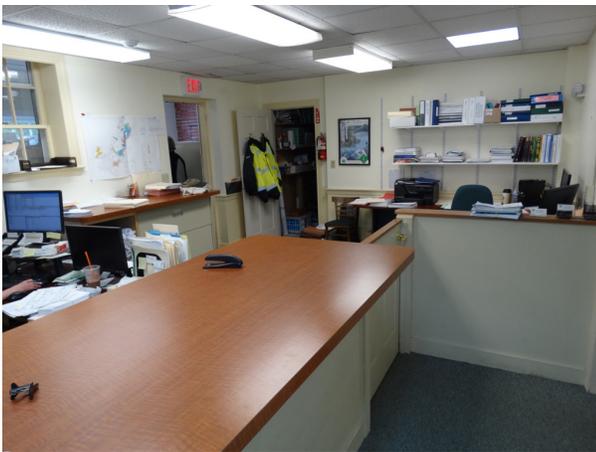
Figure 6: View of Room 116 looking southeast. A modern space, it shows the door to Room 116b at the left, rear.

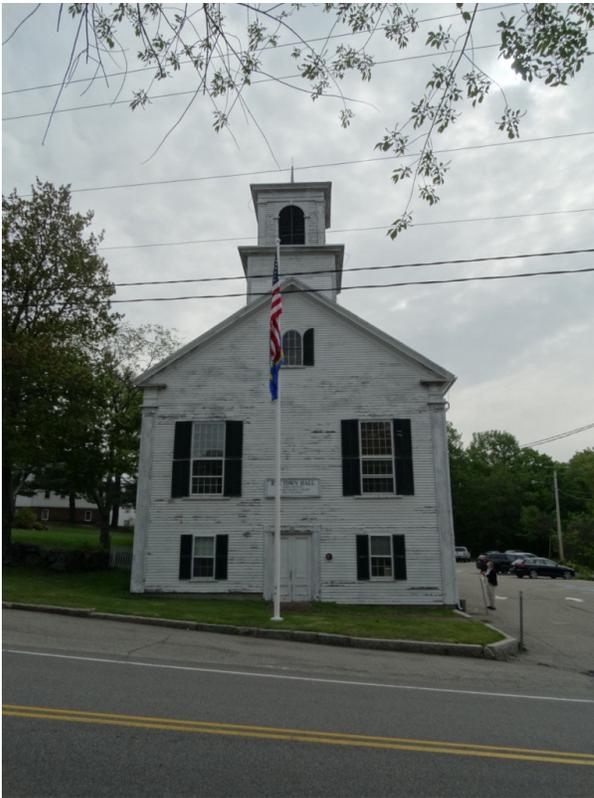
The foundation on the front elevation consists of poured concrete, probably from the 1890 renovations. It is exposed above grade by about 6 to 8 inches. The plane of the foundation steps down noticeably to the south of the front entrance doors. This probably accommodates grade conditions at the time the work was done.

Figure 8: West (front) elevation, looking east.

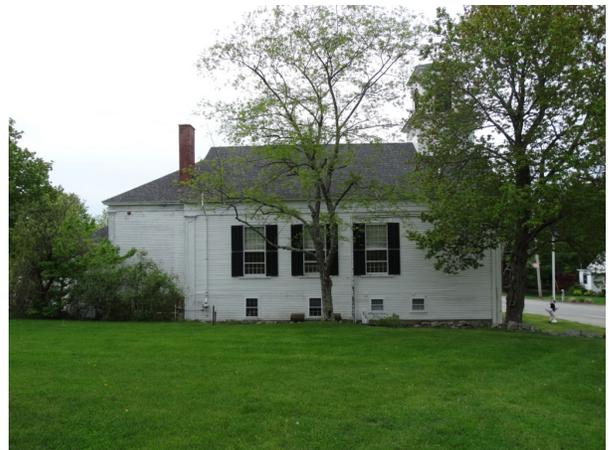
The foundation of the north elevation consists of poured concrete, probably dating to 1890. It is exposed above grade by about 24 inches.

Figure 11: North elevation looking south.

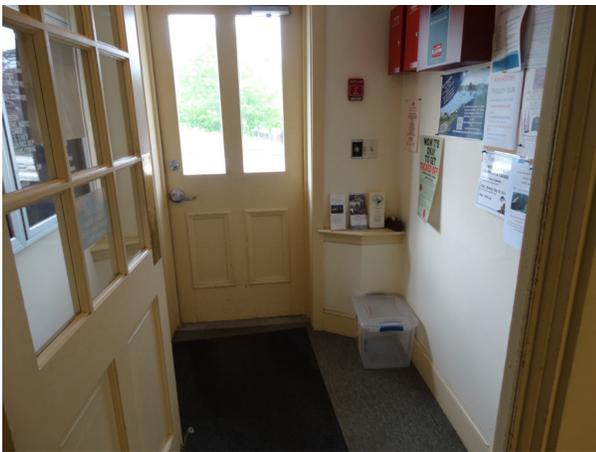
Figure 12: View of entrance, (Room 108) looking south.

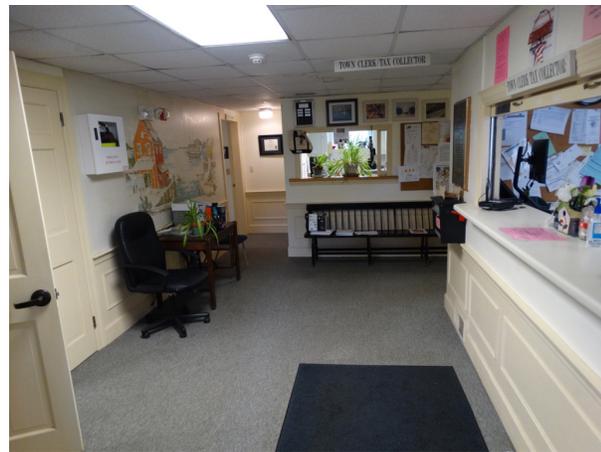
All visible architectural materials date to the late twentieth century. The walls are modern drywall. The ceiling is a hung ceiling system mounted with fluorescent light panels. The floor is covered with commercial-grade carpeting.

Figure 13: View of lobby (Room 109) looking east.

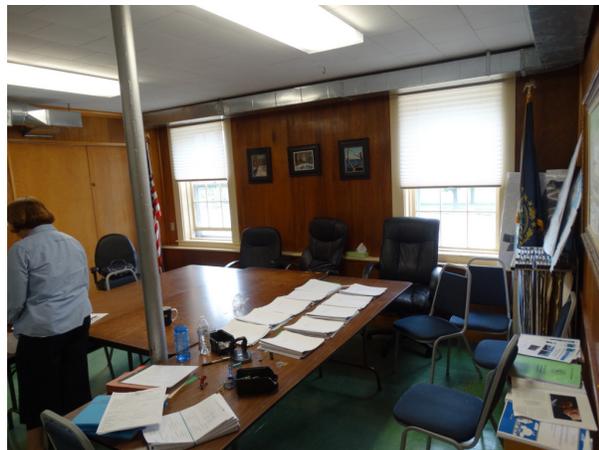
The Meeting Room, accessed from the west side of the main lobby via double-leaf doors, retains many mid-twentieth century finishes including the green linoleum tile floor and Luan-paneled wall coverings. The ceiling is finished with a hung ceiling system and mounted with fluorescent light panels. A single-leaf door on the west wall accesses the Planning and Zoning Office (Room 102). A pair of hollow-core Luan doors accesses a closet located at the south end of the east wall (Room 104B). The doors leading to the west hallway (Room 105) and the Planning and Zoning office are similar materials. The doors and windows are trimmed with plain knotty pine casings, highly varnished.

Figure 17: View of Room 104 looking south, showing closet in the east wall (Room 104b)

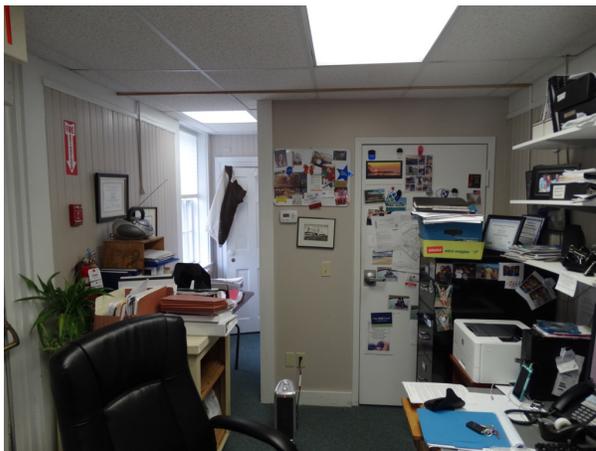
Figure 18: View of room 102 looking north, showing closet (Room102b) and fire-rated entrance to Stair A (Room 103).

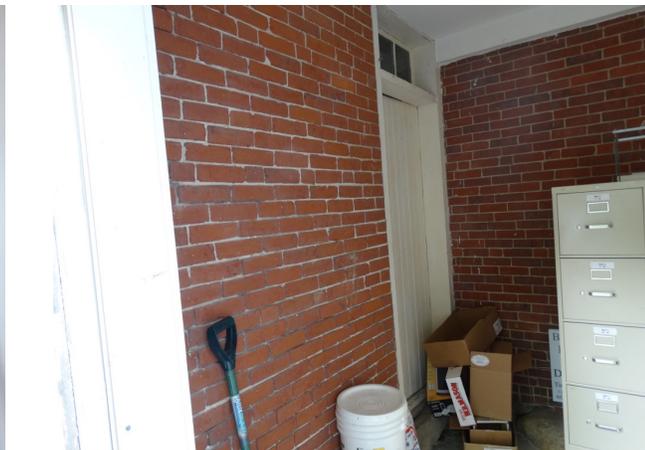
Figure 24: View of interior entrance to former privy (rooms 118B and 119c) looking southwest from Room 118.

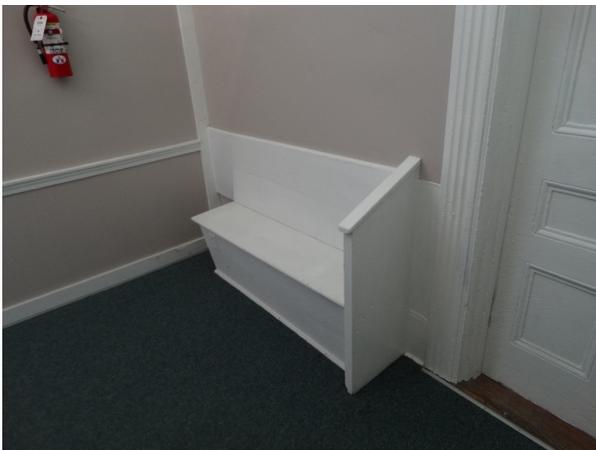
The whole space is circumscribed by original 1839 horizontal plank dadoes on the walls. Abandoned mortises that originally held the church pews, since filled with wooden plugs, can be seen at regular intervals and indicate the original configuration of the pews. A section of pews survives intact on the west wall, preserving original design and construction details.

Figure 25: View of 1839 church pew fragment, Room 205 looking south west, west wall.

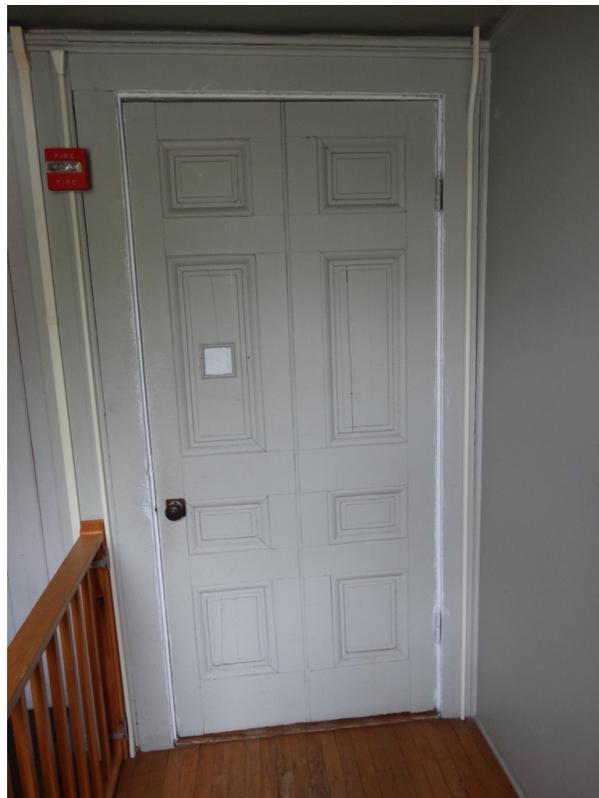
Figure 26: View of 1839 double-leaf exterior church doors looking west from Room 205.

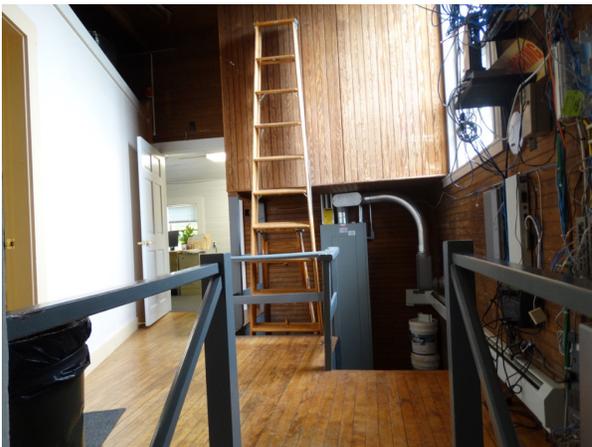
Figure 29: Room 212 looking east showing original back-stage elements and modern utilities.

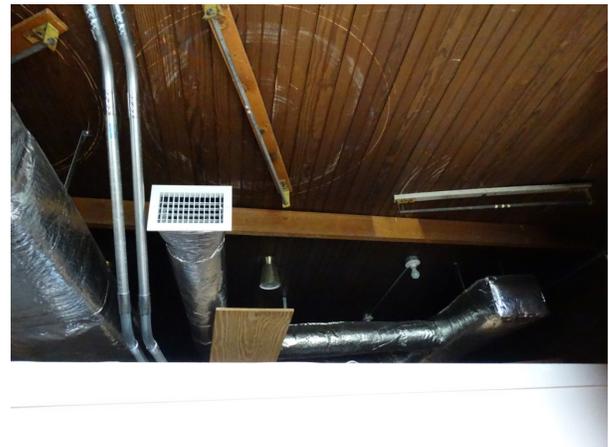
Figure 30: Room 214 looking up and to the west, showing modern utilities within a portion of the original backstage area, with original 1911 bead-board wainscoting intact.

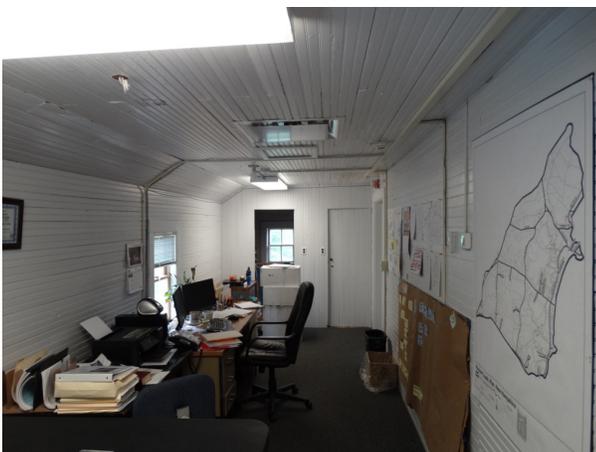
This space is essentially intact from the early twentieth century. It retains wooden bead-board wainscoting on all four walls as well as the ceiling, which is in a half-tray configuration due to the low pitch of the hipped roof. The floor is finished in modern commercial-grade carpeting. The south end of the space features two small spaces (rooms 215B and C). Currently used as storage, it is believed that these spaces may have been a second-floor privy, and that the women's privy was on the second floor and the men's on the first.

Figure 31: Room 215 looking south.

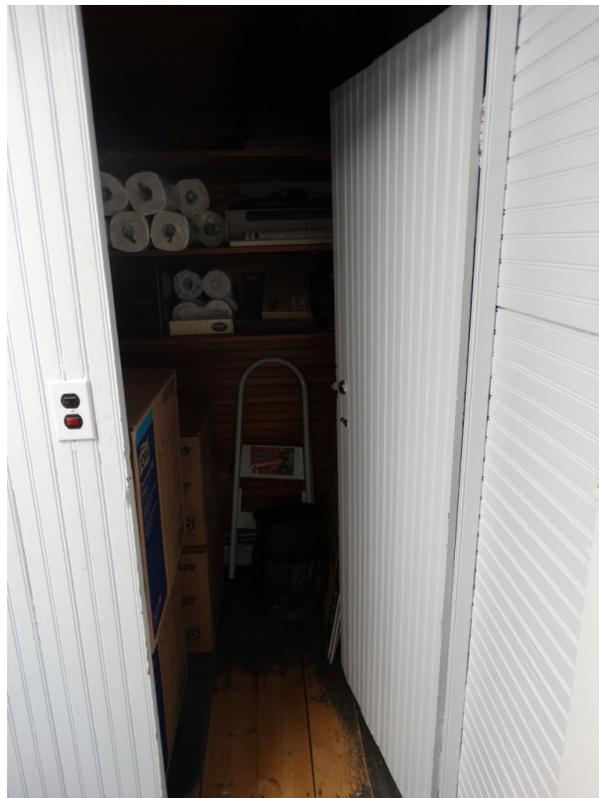
Figure 32: Room 215b, perhaps an original second-floor privy component, looking south.

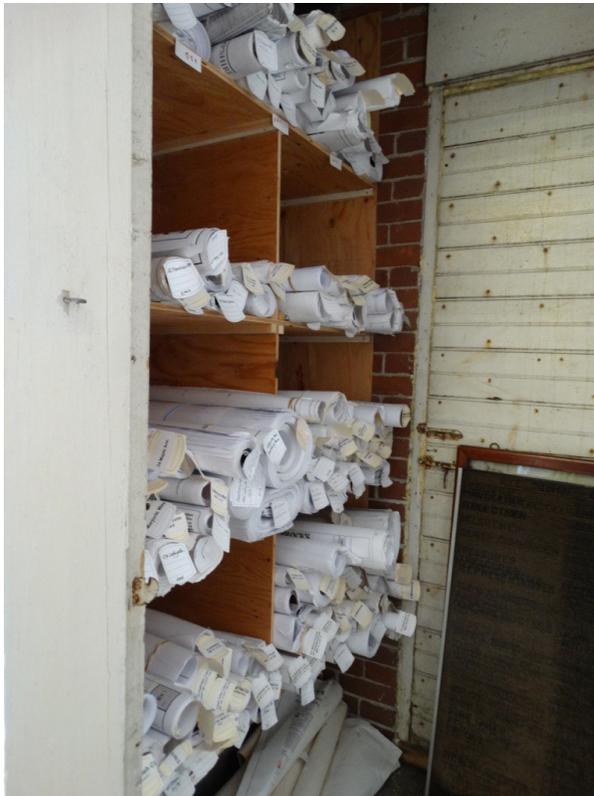
Figure 33: Room 118c looking south, possibly an original first-floor privy component.

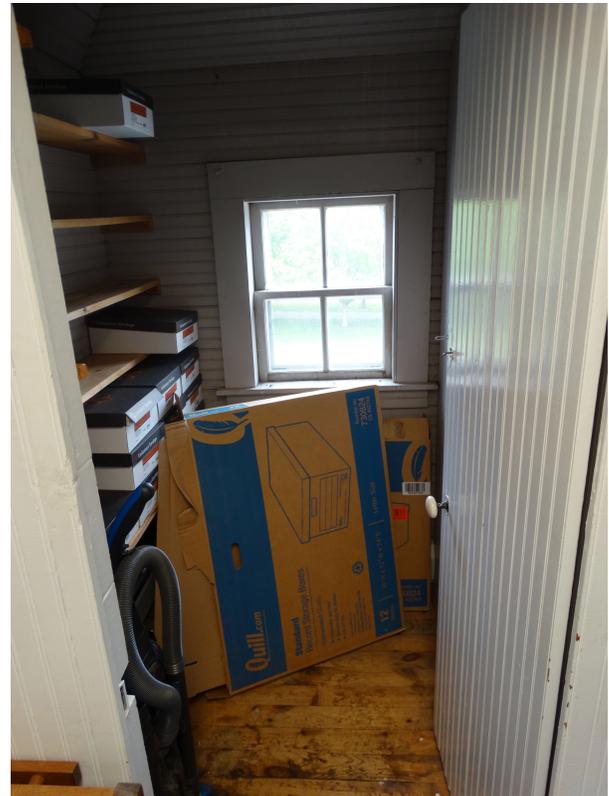
This small space, perhaps also part of a second floor privy in 1911, is mostly in its original state. It retains bead-board wainscoting walls and ceiling, and fir or spruce flooring with a glossy varnish finish.

Figure 34: Room 215c looking south, possibly an original second-floor privy component.

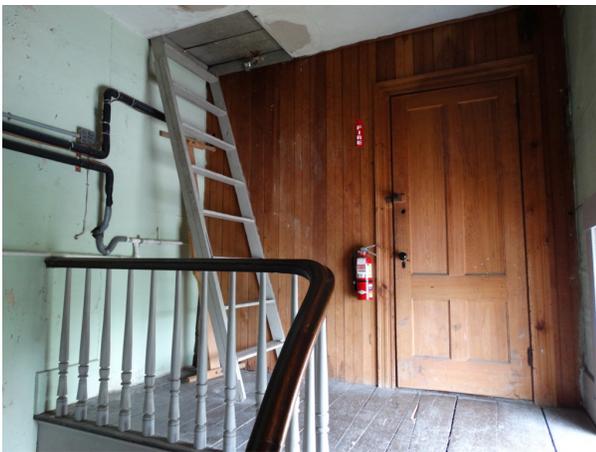
Figure 35: View of Room 303 looking south, showing the entrance to Room 302.

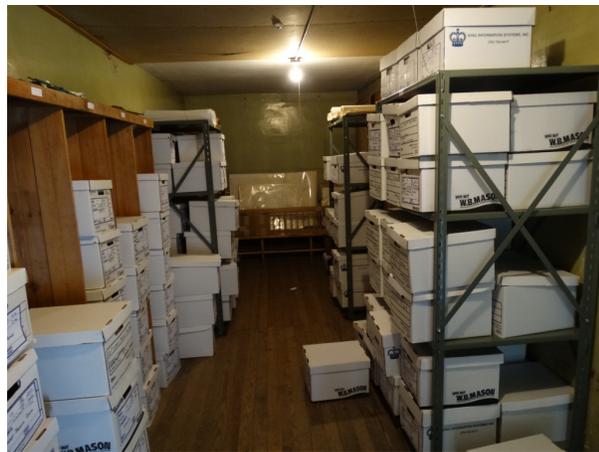
Figure 36: Room 302 looking south

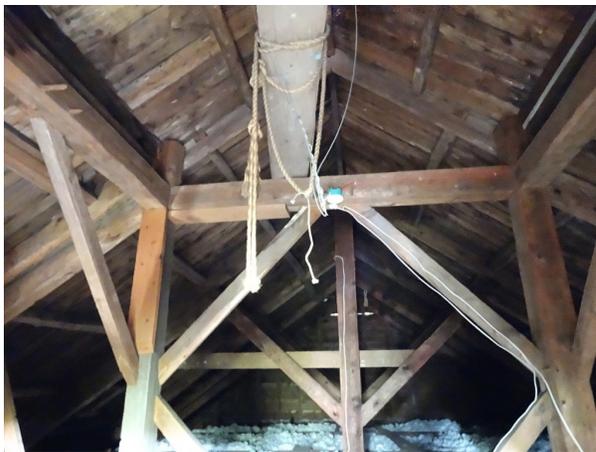
Figure 37: View of main attic looking east, showing cut-off trusses that supported the 1839 bell tower before it was moved forward (west) in 1873.

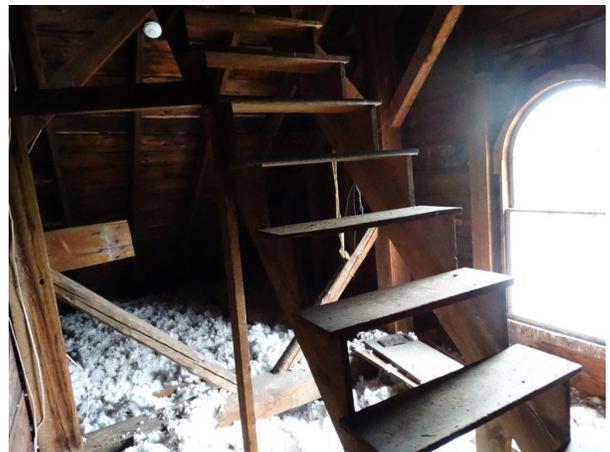
Figure 38: View of bell tower drum, interior, looking southwest and showing stair to bell tower.

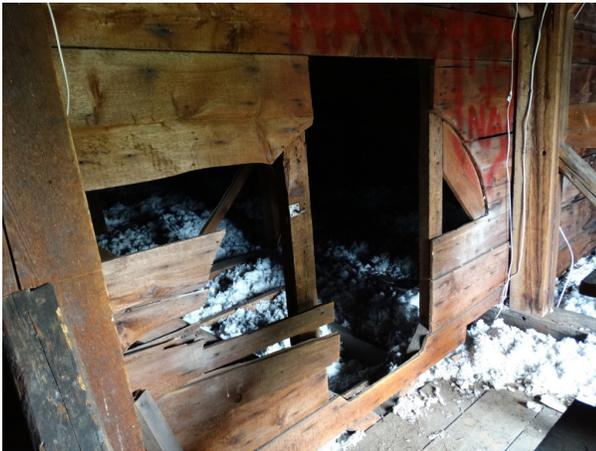
The east wall in this space is the original exterior gable of the 1839 church. Clapboards, trims and other architectural details were stripped away when the 1873 addition was constructed. However, the ghost outlines of the original boxed eaves and the partial cut-out for a demi-lune gable window are visible in the exposed sheathing boards.

Figure 39: View of attic: 1839 gable facade, encapsulated in the 1873 front expansion, showing opening for the original demi-lune fan gable detail, and footprint of the original eaves fascia.

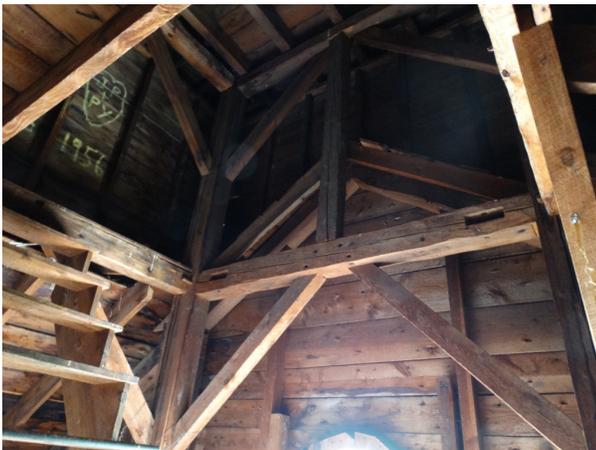
Figure 40: View of bell-tower drum framing looking up and south, showing 1873 framing with salvaged 1839 timber elements.

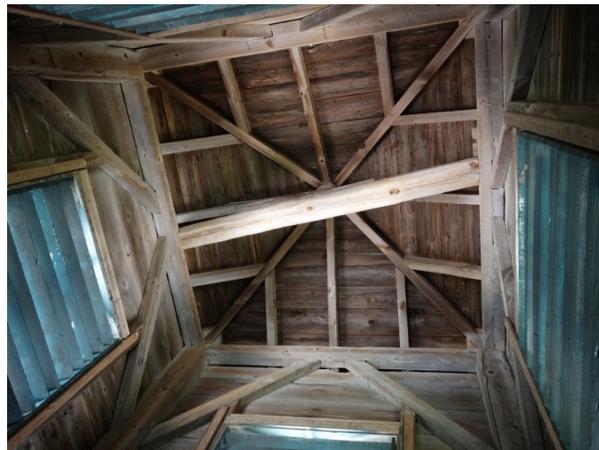
The roof of the tower's upper tier forms a shallow hip. This is essentially balloon-framed, with dimensionally-sawn lumber similar to modern standards. There are four corner rafters that form the hip ridges. Secondary rafters on regular spacings fill the voids between them, and are toe-nailed to them. At cornice level, a single transverse tie beam, set in at a slight angle, stiffens the frame.

Figure 41: View of belfry looking up and to the east, showing framing scheme.

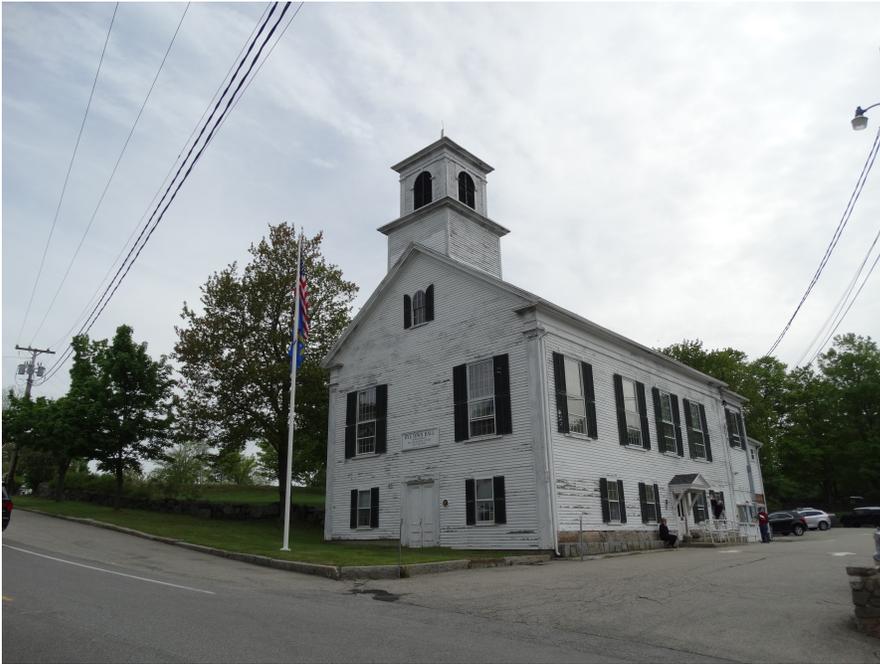
Figure 42: View of Rye Town Hall looking northeast, showing overall form and massing.

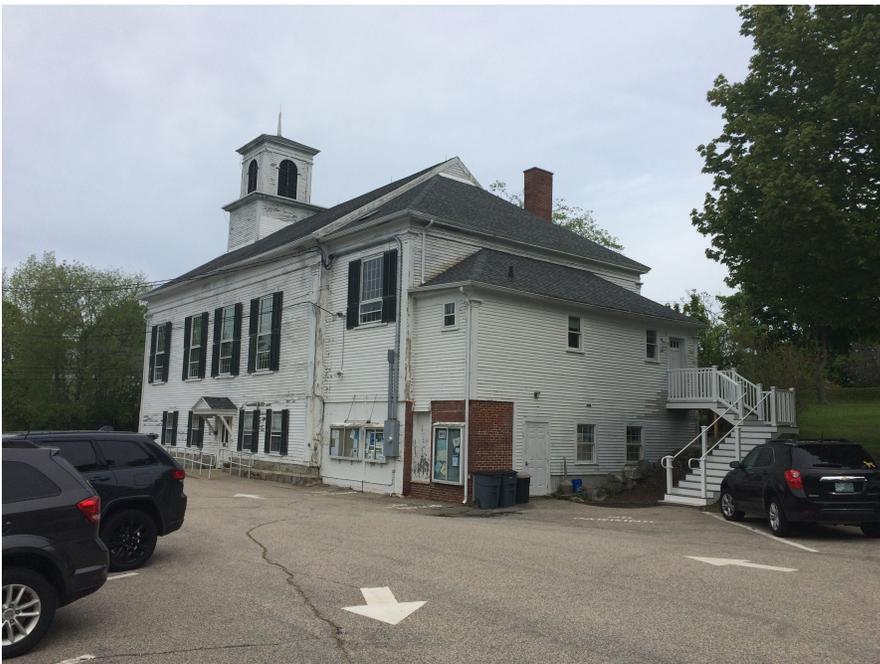
Figure 43: View of Rye Town Hall looking southwest, showing overall form and massing.

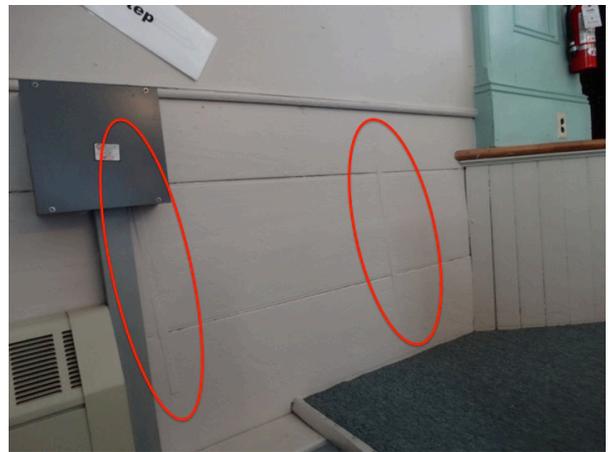
Figure 48: Detail of 1839 dadoes in the original sanctuary space of Rye Town Hall, showing filled-in pew mortises.

Though nearly all of the pews were removed in 1873, evidence for their layout as described above survives in the form of wooden plugs along the dados where the outer pew ends were mortised into them. These openings were filled when the pews were removed (Figure 48). Two pew fragments survive in place on the front or west end of the sanctuary, attached to the wall. (Figure 49) These indicate that the pews were extremely plain, with virtually no decorative elements, and were open-ended rather than boxed.

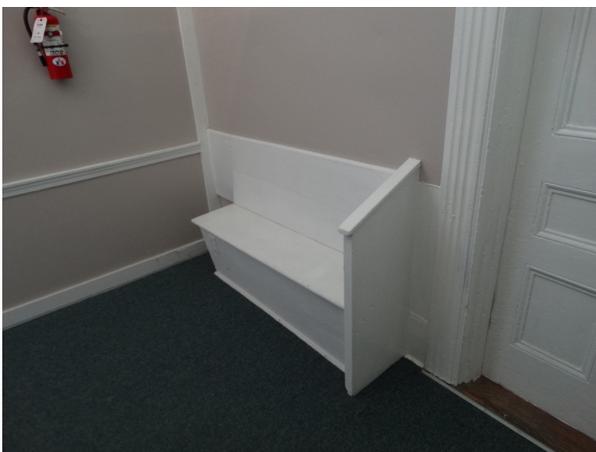
Figure 49: A surviving original church pew, west end of Room 205.

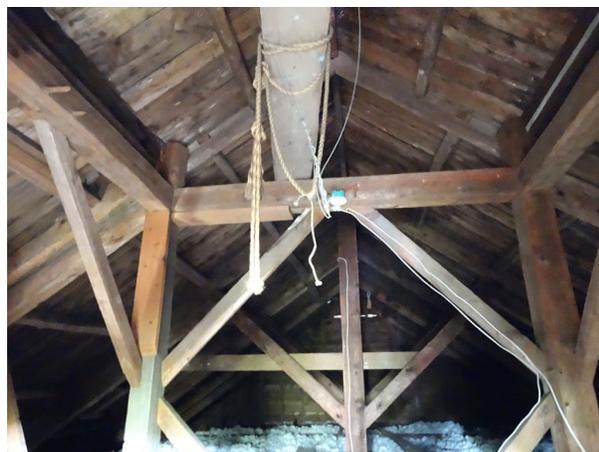
Some accounts suggest that the building did not have a bell tower initially. Physical evidence in the building refutes these claims. The framing scheme for the roof structure consists of six bays of modified king-post trusses, constructed of pine or hemlock, with a mix of sash-sawn and hewn elements (Figure 50) These trusses support the entire roof, and are spanned by horizontal purlins of similar material that support vertical pine or hemlock sheathing boards. At the west or front end of the attic is a pair of queen-post trusses that do not currently support anything, being located between the easternmost two main trusses; they were clearly cut off at the top sometime after initial construction. These trusses are original features, and their only purpose would have been to support a bell tower, with the posts forming its four corners.

Figure 50: View of 1839 bell tower queen-post trusses, attic looking east and cut off at the top in 1873 when the original tower was removed.

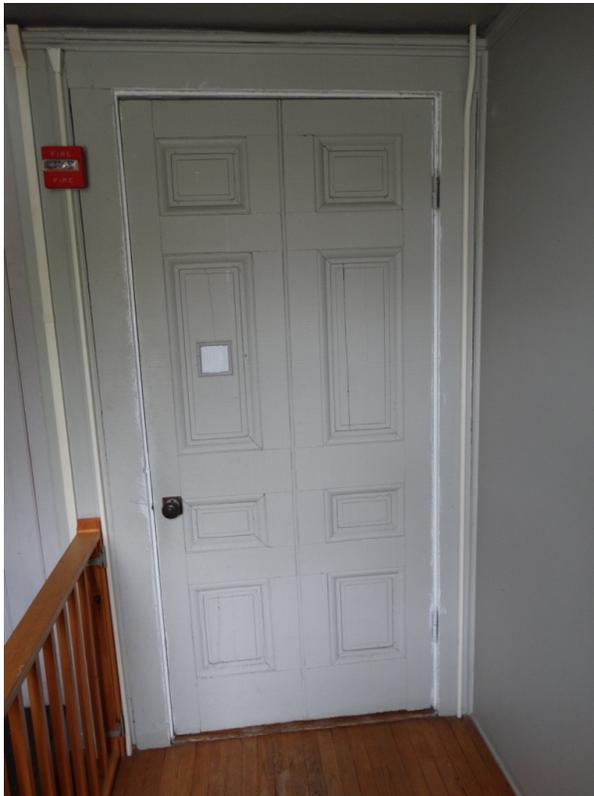
Though the original paired double leaf front doors survive within the 1873 addition, the nature of their architraves remains unknown because these details were removed in 1873 when the first-floor level of the 1839 façade became an interior wall and was finished with lath and plaster (Figure 51)

Figure 51: Detail of 1839 exterior doors, later enveloped into the 1873 addition as interior features. Room 203 looking east.

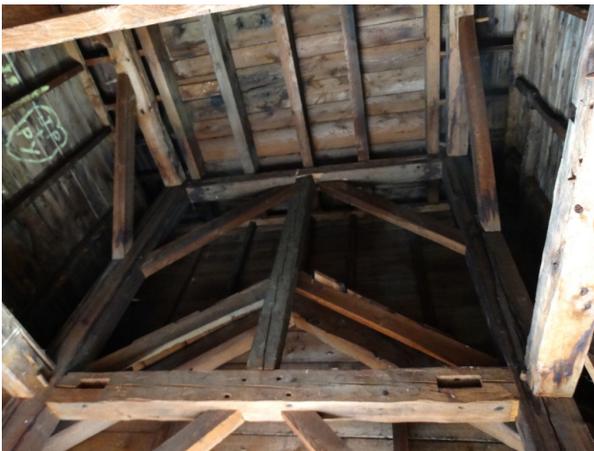
The 1839 bell tower was removed and components of it recycled in the construction of the new tower in 1873. The construction of the new addition and ground floor differs substantially from the construction methods used in 1839. Whereas the original structure was fully timber-framed in the square-rule method, the new additions were nearly all balloon-framed with dimensionally-sawn lumber similar to modern materials. They exhibit circular, rather than sash-saw markings. Walls are constructed of common studs and the roof of common rafters. Only the frame of the new bell tower - four three-story posts forming its four corners, and a network of braces and studs containing some 1839 bell tower components - is timber-framed. The 1873 timbers can be differentiated from re-used 1839 timbers because the former exhibit circular-saw marks and the latter are a mix of sash-sawn and hewn timbers (Figure 54).

Figure 54: View of 1873 bell tower framing, looking west. Note the mix of out-of-context, reused 1839 timbers (random, abandoned mortise joints, and both hewn and sash-sawn elements) compared to the circular-sawn elements from 1873.

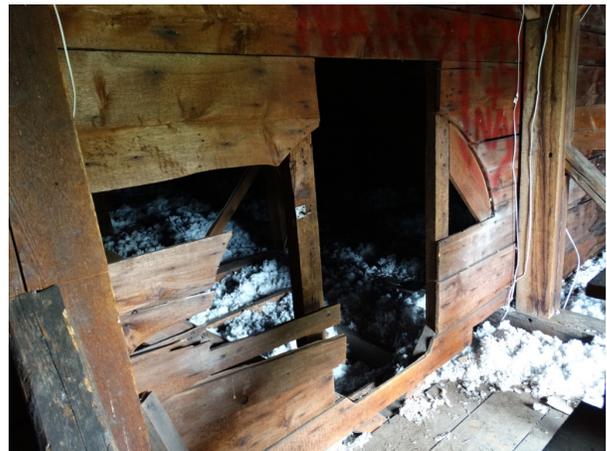
Figure 55: View of the 1839 front gable, encapsulated within the west addition of 1873. Note the sheathing divested of clapboards, and the rough opening for the original demi-lune gable feature.

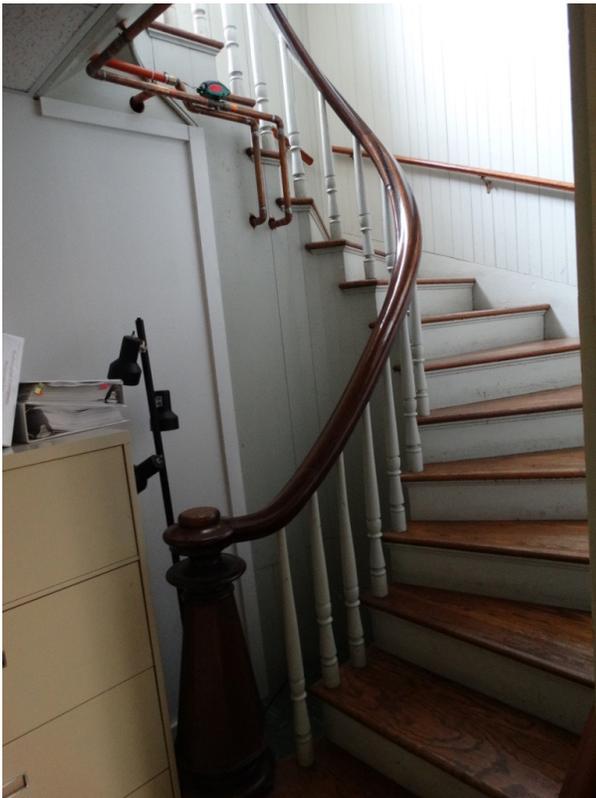
Figure 56: View of the northern example of a pair of winding stairs added in the 1873 expansion. Room 102 looking northwest.

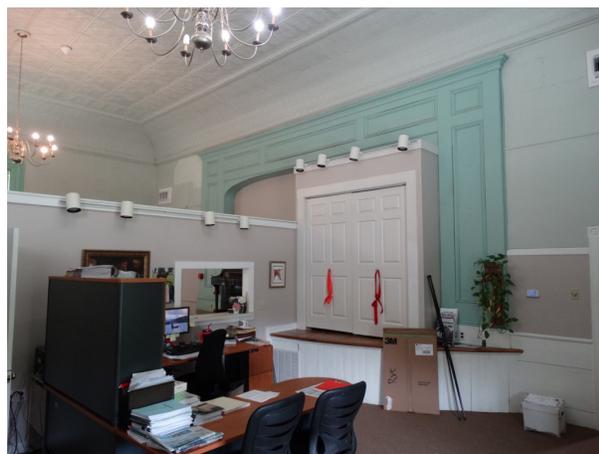
In 1875, a stage was constructed at the east end of the space. It remains intact today (Figure 57). We believe that only the projecting portion of the platform is the stage from 1875, because the main stage area and proscenium were added when the 1890 addition to the east was added and the wall cut through to create the stage opening. This is discussed more fully below.

Figure 57: View of main floor former sanctuary/ later auditorium looking northeast, showing 1873 stage, 1890 proscenium, 1912 embossed metal ceiling, 1986 office partitions.

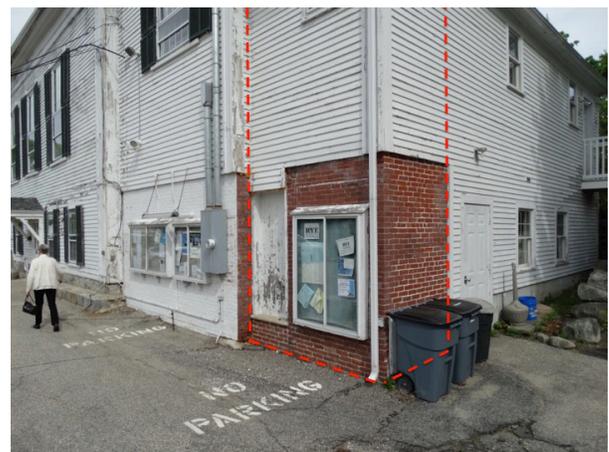
Figure 59: Annotated view of Rye Town Hall from the rear, looking northwest, showing the proportions of the two-story privy.

Historical records indicate that this is when the two-story privy was constructed at the southeast end of the new addition's rear wall (Figure 59, also 44). The first-floor was constructed of brick like the rest of the ground floor in the addition (Rooms 118b and 119c), and the second floor of wood (Rooms 215 b and c). The first-floor stall was accessed via doors on both the north and south elevations. The second-floor stall was accessed through the backstage area at second-floor level.

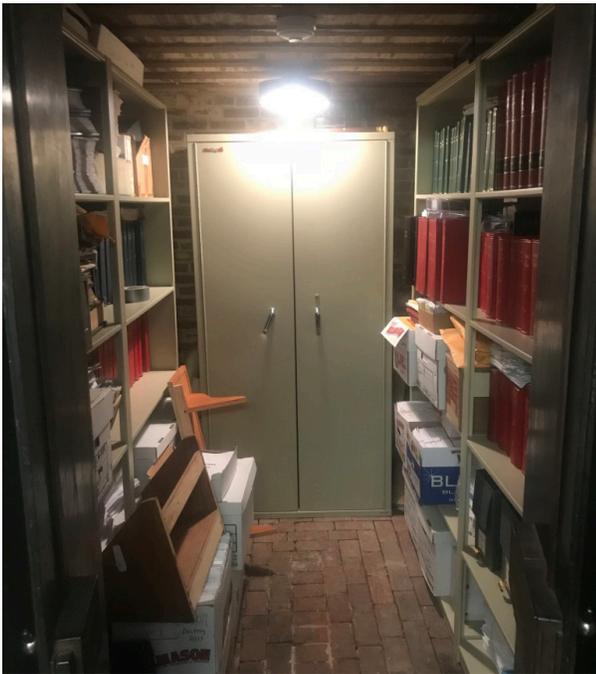
In 1890 the building was expanded to the east with a two-story addition (Figure 58, also 44). The addition features a hipped roof and a brick foundation at ground-floor level (Room 115). The southern end of the addition contained a vault, which survives today and remains in use. It has brick walls, a poured concrete ceiling, and a brick floor, and is accessed from the interior through two sets of heavy, locking metal doors. (Figure 60). This is the only ground-floor feature from the 1890 renovations that appears to survive.

Figure 60: View of the vault, Room 115, looking east.

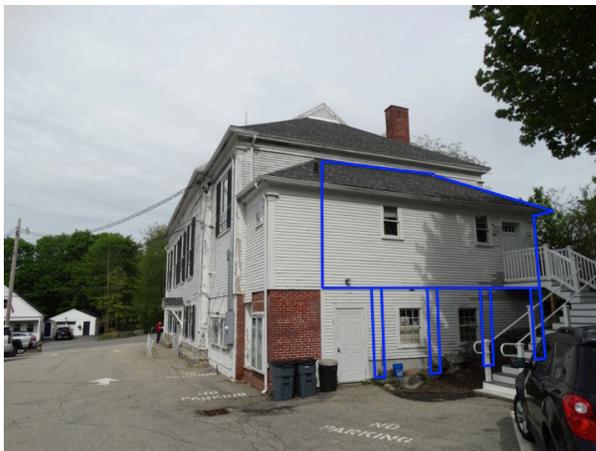
In 1911, a two-level porch was added at the east end of the 1890 addition (Figure 61). It was enclosed at second-floor level and open at ground-floor level, being supported by a series of brick piers (Room 215). The purpose of this porch was to provide shelter for the rear entrance to the 1890 addition and first-floor privy at ground-floor level, and to provide additional theater-related space at the main floor level: a dressing area or “green room.” Some have suggested that the second-floor level of the porch was originally open. We believe it was always an enclosed, but unheated space based on the survival of what appears to be original painted bead-board wainscoting not only on the ceiling but also the walls. (Figure 62). We believe references to the later enclosure of this porch refer to renovations in 1974, when wooden walls were added between the brick piers supporting the 1911 porch, enclosing it for use as office space (Room 118). Here the clapboards and modern windows at first-floor level with snap-in muntin grids date to 1974.

Figure 61: Annotated view of Rye Town Hall, east elevation looking northwest, showing the configuration of the 1911 second-floor porch addition and brick piers.

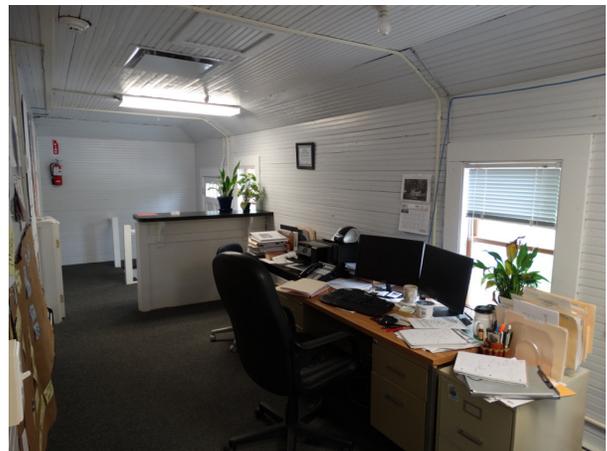
Figure 62: Interior view of the 1911 porch (Room 215) looking north and showing original bead-board wainscoting surfaces.

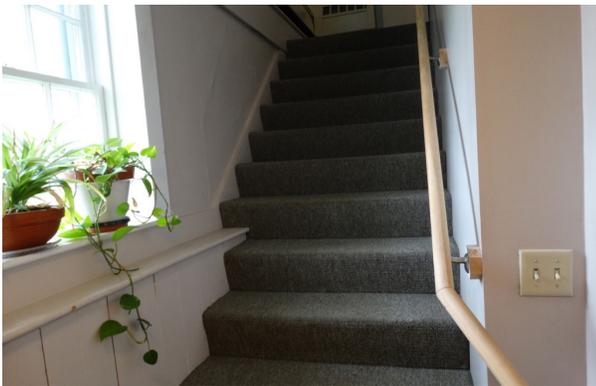
Most likely, the third set of stairs leading from the ground floor to the main floor were added at this time, located in the northeast corner of the ground floor (Room 114). The configuration appears to be original to this time, but any former railings or enclosures were modified to their current state when the boiler room was created in 1962. Its earlier appearance is unknown (Figure 63)

Figure 63: View of Staircase C (Room 114) looking east.

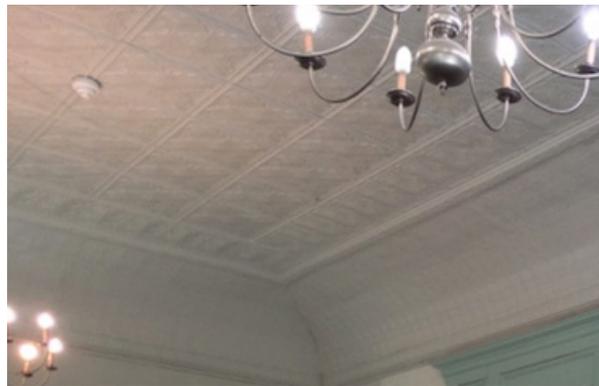
In 1912, other modifications were made to the building at large. Electrical lighting was installed, as well as a new coal-fired boiler system. The pressed metal ceiling was installed in the main auditorium space, originally the church sanctuary. It is still in place today (Figure 64).

Figure 64: View of embossed metal ceiling covering installed in 1912 to cover the original 1839 plaster tray ceiling.

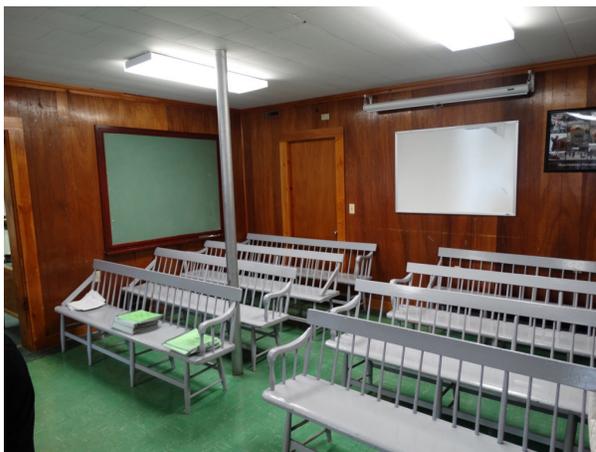
Figure 65: View of Room 104 looking northwest, showing intact 1962 surfaces. The benches depicted are probably some of the “settees” purchased in 1873 when the church pews in the 1839 sanctuary were removed.

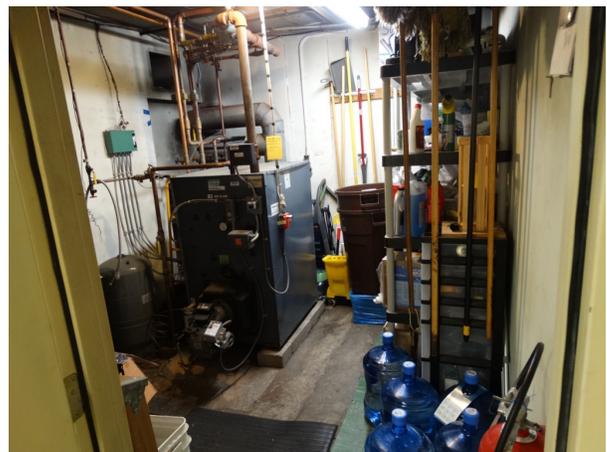
The current boiler room, located adjacent to the northeast stairs leading to the main floor, was most likely added in 1962, though no records survive (Room 113). It retains portions of green linoleum tile flooring like those in the Courtroom, and drywall walls from the same period (Figure 66).

Figure 66: View of the boiler room (Room 113), added c. 1962, looking northeast.

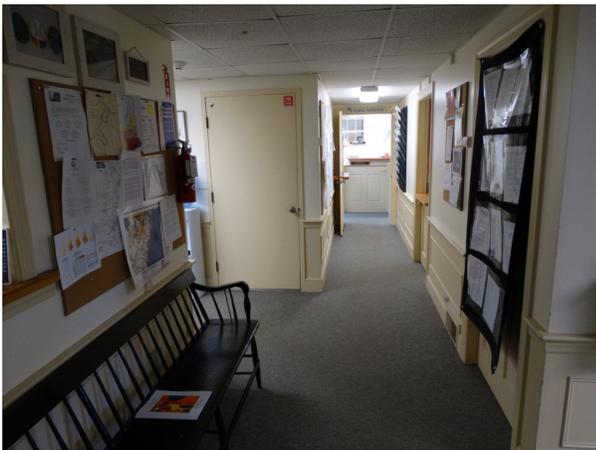
Figure 67: View of Lobby, Room 109 looking east, showing office partitions added between 1962 and 1974 on the ground floor.

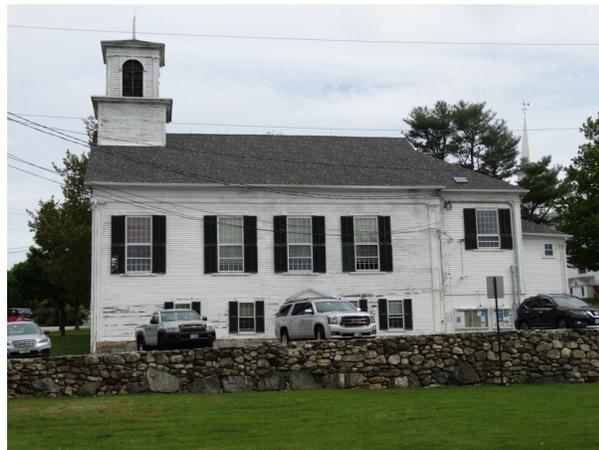
- 1976 A retaining wall, parking lot, and landscaping were added, probably the current parking lot and high retaining wall separating the Town Hall property from the adjacent cemetery (Figure 68).

Figure 68: View of the building's south elevation and landscape, showing the retaining wall added at the southern boundary of the parking lot in 1976.

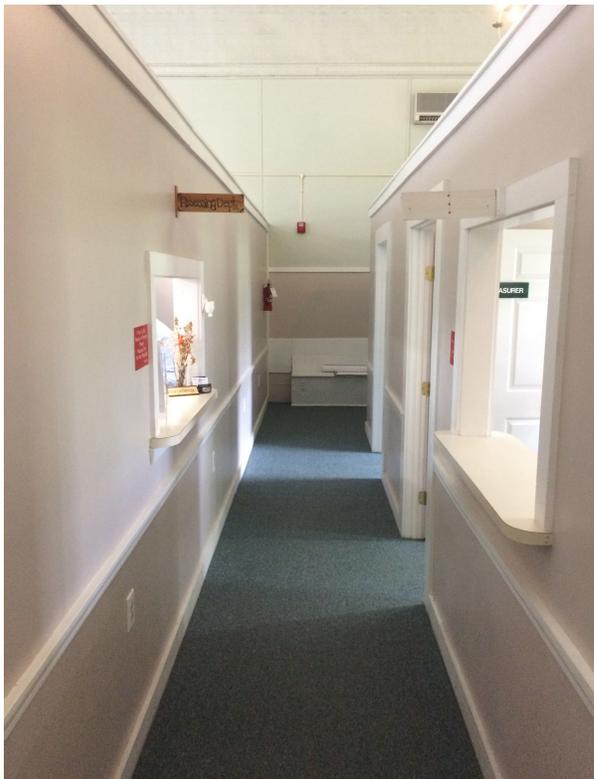
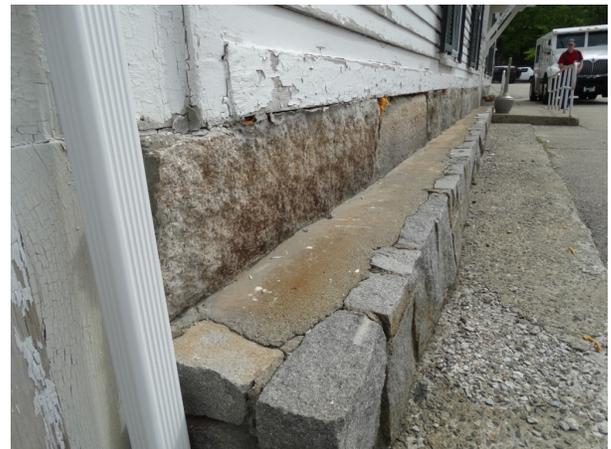
2011 Radon mitigation was undertaken and a "stone wall repointed". We believe this refers to foundation work on the south elevation (Figure 70).

Figure 70: Detail of the composite stone, brick and concrete foundation, south elevation looking east, showing re-pointing in 2011.

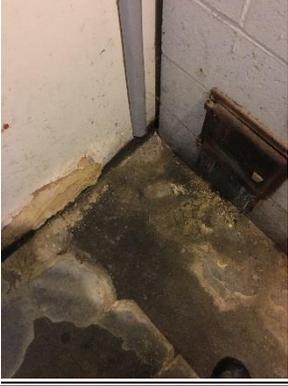
<p>Water Infiltration at base of Chimney</p>

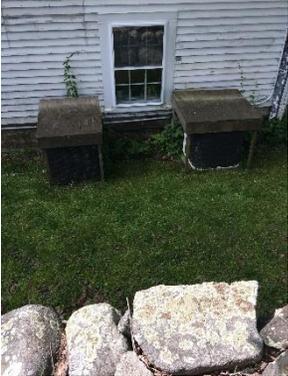
<p>Abandoned Condensing Units</p>

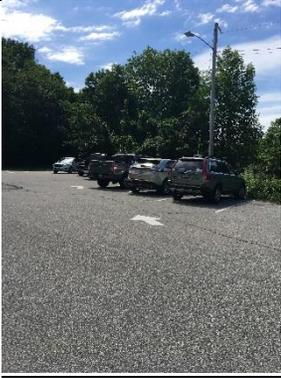
<p>Parking Lot Lighting</p>

1. Replace lighting with LED type and research possible incentives available.
2. Supplement exit and emergency lighting to be NFPA 101 compliant.
3. The existing coverage is only in the ceiling over the 2nd Floor Office and over the fire alarm panel. Supplement fire alarm system for complete coverage detection in all areas.

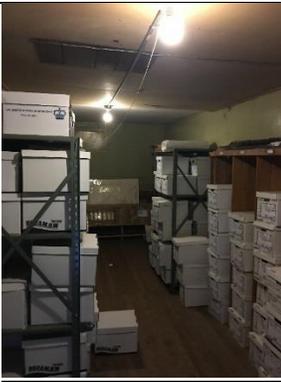
<p>Storage Room Lighting</p>

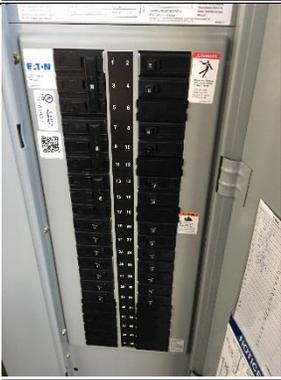
<p>120/208V 3 phase Main electrical Panel – plenty of space and capacity available.</p>

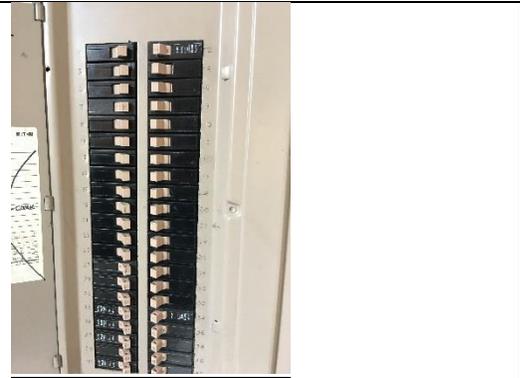
<p>2nd floor Subpanel – full no space</p>

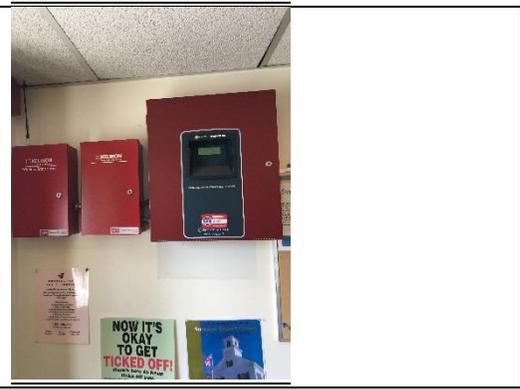
<p>Fire Alarm Panel – Fire Lite MSU-5D installed in 2010.</p>

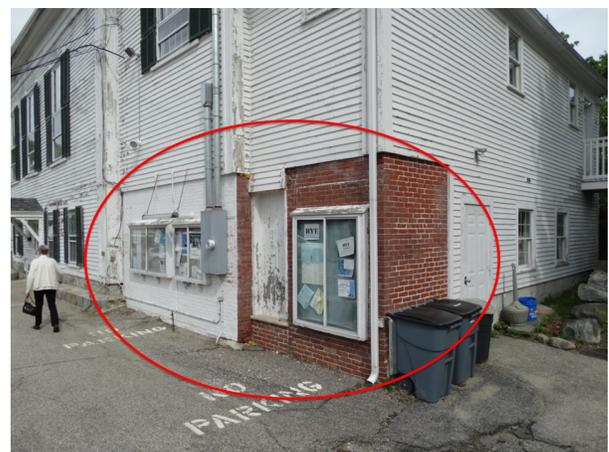
Figure 79: Detail of southeast corner of south and east elevations looking northwest, showing brick vault and privy foundation.

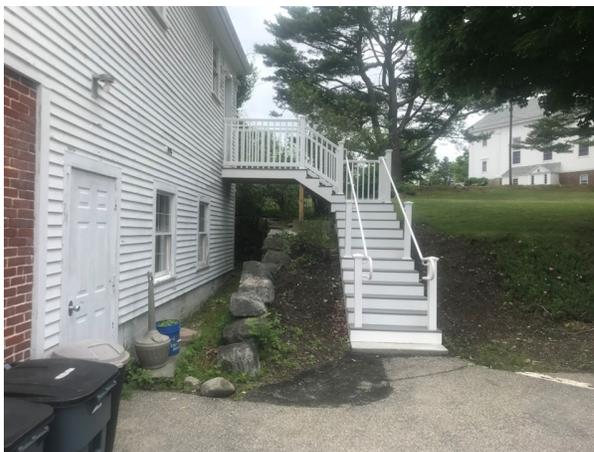
Figure 82: View of recently-rebuilt ancillary exterior stairs, east elevation.

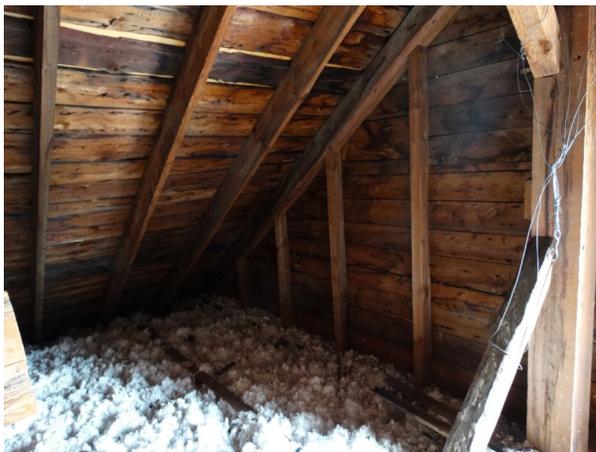
The attic, a space above the 1839 sanctuary, and above the 1873 addition, features exposed framing that shows the building's evolution. The main portion of the attic retains original heavy-timber roof trusses as well as vestiges of the 1839 bell tower. The western portion is balloon-framed except for the bell tower piers, which are timber-framed. Some sub-flooring exists, but the joists are mostly exposed with their spans filled by blown-in cellulose insulation. (Figure 87)

Figure 87: Detail of attic space above Room 302 showing 1874 balloon framing and recent cellulose insulation.

The framing elements in the attic and bell tower are primary character-defining features. They warrant careful preservation as not only a record of the building's history, but as a record of coastal New Hampshire building practices during the third quarter of the nineteenth. Any future renovation projects requiring bolstering of the building's framing system should be legible, reversible, and have minimum impact on the existing elements. The stairs and ladders are sparsely constructed. If strengthening is required, they should be reinforced rather than replaced.
