HISTORIC STRUCTURE REPORT

Rye Town Hall

10 Central Road
Rye, NH 03870

September 14, 2018

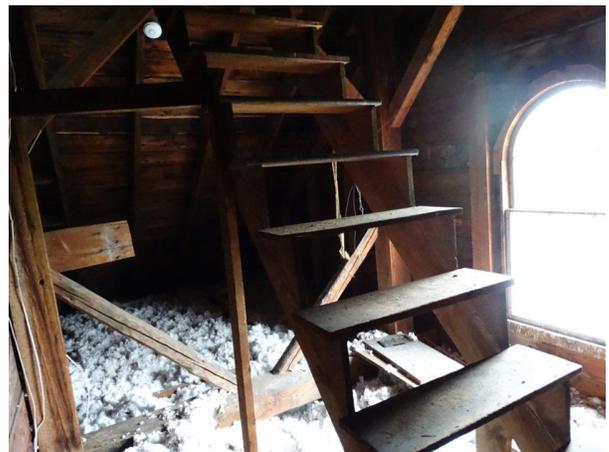
An original plain plank staircase ascends from the western (1873) portion of the attic to the drum of the bell tower. An original wooden ladder ascends from a catwalk, accessing the top tier of the bell tower. These are character-defining features. There is a secondary roof covering of unknown material (apparently an early form of tar or asphaltum) that protects lower areas of the tower from water infiltration. It was covered with debris at the time of this inspection. (Figure 88)

Figure 88: Detail of attic space above Room 302 showing original 1870s staircase accessing the bell tower.

The framing elements in the attic and bell tower are primary character-defining features. They warrant careful preservation as not only a record of the building's history, but as a record of coastal New Hampshire building practices during the third quarter of the nineteenth. Any future renovation projects requiring bolstering of the building's framing system should be legible, reversible, and have minimum impact on the existing elements. The stairs and ladders are sparsely constructed. If strengthening is required, they should be reinforced rather than replaced.

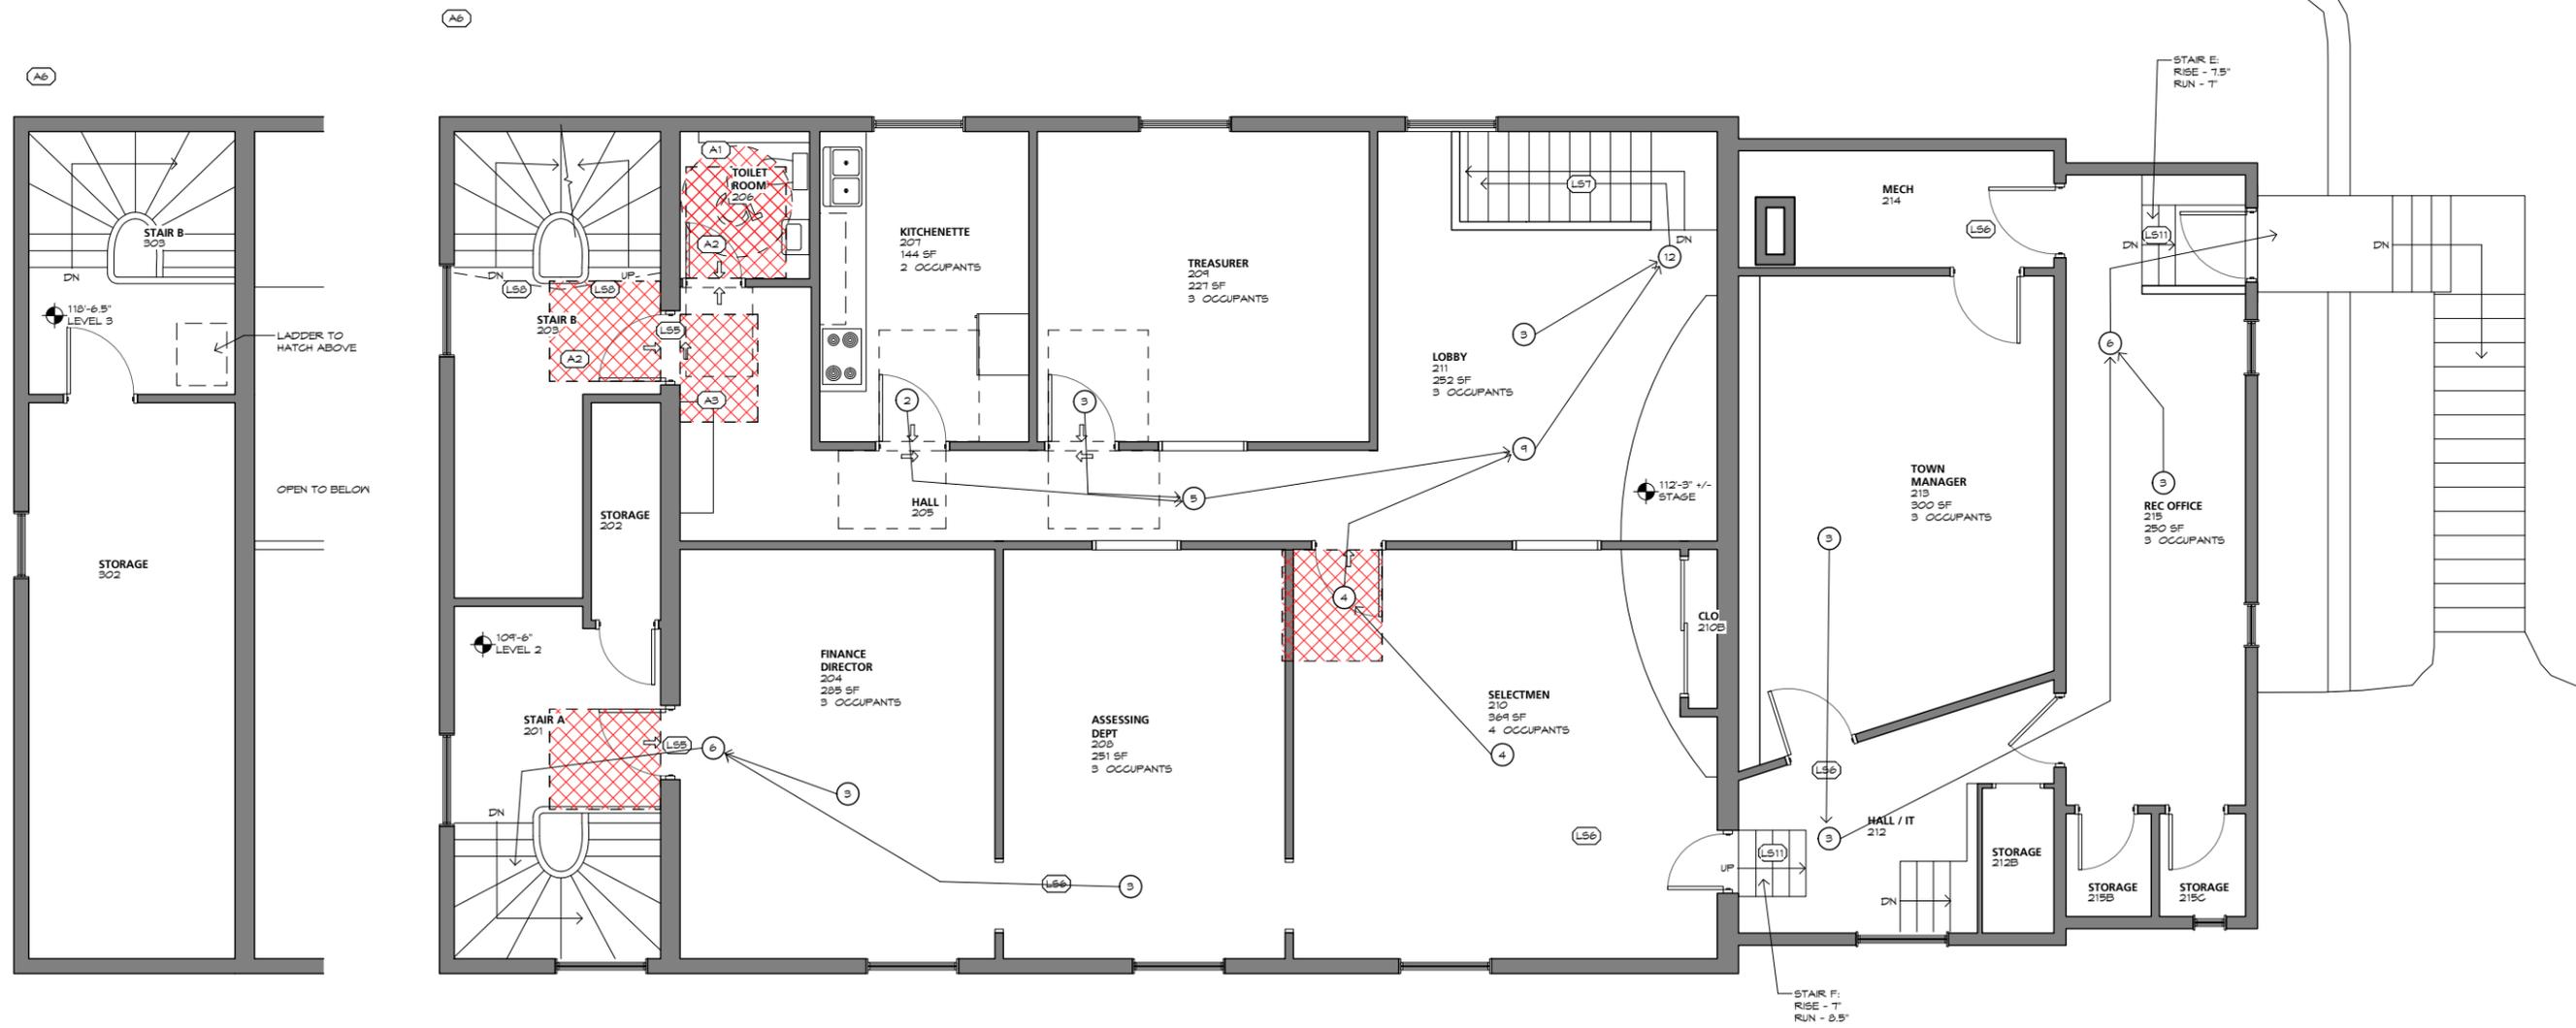
2 BELFRY FLOOR CODE DIAGRAM
ADA.2 1/4" = 1'-0"

The ground floor is currently accessed by a handicap accessible ramp. The second floor is currently not handicap-accessible. There are numerous locations where the maneuvering clearances at doors do not meet ADA 2010 requirements per Figure 404.2.4.1. The bathrooms are currently not handicap accessible. Lever hardware is missing in select locations. A comprehensive study by an ADA advocacy group such as AlphaOne would be prudent in helping to meet the governing Federal and State laws.

ADA KEY NOTES		
A1	DOES NOT MEET ADA TURNING RADIUS CLEARANCES	ADA 2010: 304.3
A2	FULL SIDE OF DOOR DOES NOT MEET ADA MANEUVERING CLEARANCES	ADA 2010: FIGURE 404.2.4.1
A3	PUSH SIDE OF DOOR DOES NOT MEET ADA MANEUVERING CLEARANCES	ADA 2010: FIGURE 404.2.4.1
A4	DOES NOT MEET ADA COUNTER HEIGHT	ADA 2010: 902.3
A5	DOES NOT HAVE ADA GRAB BARS	ADA 2010: 604.5
A6	FLOOR LEVEL HAS NO ADA ACCESS	ADA 2010: 306.404
A7	CLEAR WIDTH OF DOOR DOES NOT MEET ADA CLEARANCES	ADA 2010: 404.2.3

LIFE SAFETY KEY NOTES		
LS1	STAIR WIDTH DOES NOT MEET CODE	NFPA 101: TABLE 7.2.2.1.1 (b)
LS2	DOOR WIDTH DOES NOT MEET CODE	IBC 2009: 1005.1 / 1008.1.1
LS3	CORRIDOR WIDTH DOES NOT MEET CODE	IBC 2009: 1018.2
LS4	DEAD END CORRIDOR LENGTH EXCEEDS CODE	IBC 2009: 1018.4
LS5	DOOR EGRESS IS BLOCKED OR LATCHED	IBC 2009: CHAPTER 10
LS6	EGRESS IS NOT ALLOWED THROUGH ROOM	IBC 2009: CHAPTER 10
LS7	EGRESS SHOULD BE DIRECTLY TO EXTERIOR	IBC 2009: CHAPTER 10
LS8	GATE IS NOT ALLOWED TO BLOCK EGRESS PATH	IBC 2009: CHAPTER 10
LS9	OCCUPIED SPACES ARE NOT ALLOWED IN EGRESS	IBC 2009: CHAPTER 10
LS10	DOOR HAS EXISTING PANIC HARDWARE & CLOSER	
LS11	STAIR RISE / RUN DOES NOT MEET CODE REQUIREMENTS	NFPA 101: TABLE 7.2.2.1.1 (b)
